# Exploitation problems and diagnostic of heat recovery steam boiler OU-192

Grzegorz Olewicz<sup>1</sup>, Adrian Sobczyszyn<sup>2,\*</sup>, Kamil Staszałek<sup>3</sup>, and Przemysław Syty<sup>4</sup>

**Abstract.** Combined Cycle Gas Turbine (CCGT) use exhaust gases from gas turbine (GT), which in basic systems are ejected to environment as discharge loss, for steam generation in Heat Recovery Steam Generator (HRSG). Higher unit efficiency achieved inter alia by using in boiler low and high pressure circuit allow to greater use of turbine exhaust gases enthalpy. Modular design solutions with tight structure, preferred on construction site, may be a problematic for maintenance services during operation and overhauls. This paper presents general operational problems of HRSG as well as detailed solutions for boiler OU-192. We discuss scope and results of diagnostic tests required to assess technical condition of the pressure elements, after 100 000 hours operation, with the support of the software LM System PRO+.

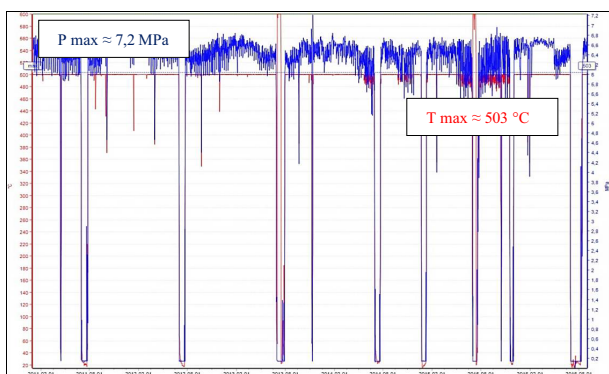
**Fig. 4.** Chart of steam temperature behind HP superheater II with pressure.

Steam temperature and pressure values, registered by LMSP+®, are not exceeded for following boiler elements:

- LP drum LP,
- HP superheater II,
- HP drum.

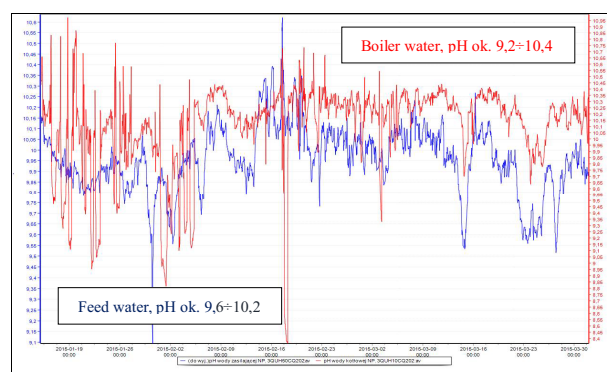
It has also been prepared additional charts which show work of CCGT in two-shifted adjustment and change of feed water and boiler water pH values (low-pressure circuit). Results of analysis report show that pH values are close. It's very important because of magnetite layer protection durability. It allows to stop dosing boiler water alkalizer (sodium hydroxide). Charts are shown in figures 5 and 6 below.

**Fig. 6.** pH values of feed water and boiler water – low-pressure circuit.

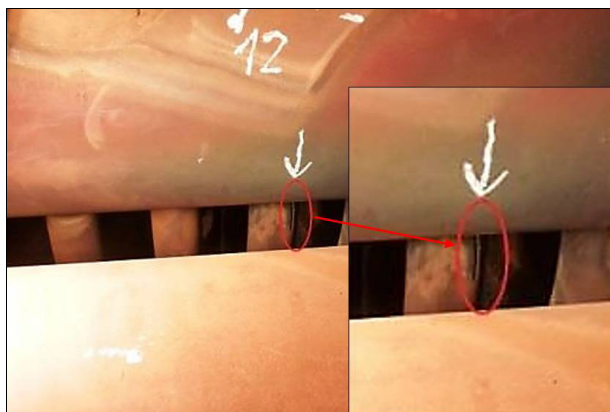
After summary boiler work time, failure mainly occurred on top evaporator headers [9] and HP superheater II headers [10, 11, 12] areas. Damages were on evaporator bend tubes (fig. 7) and welded joints connecting tubes with HP superheater II headers (fig. 8,9,10). This helped to create a diagnosis scope of above elements. For this purpose all available evaporator bend tubes were tested by ovalization measurement and all fillet welds were tested by magnetic particle test. Repairs were done by replacement and welding. Example damages placed below.

**Fig. 7.** Top HP evaporator headers – bend tube damage.

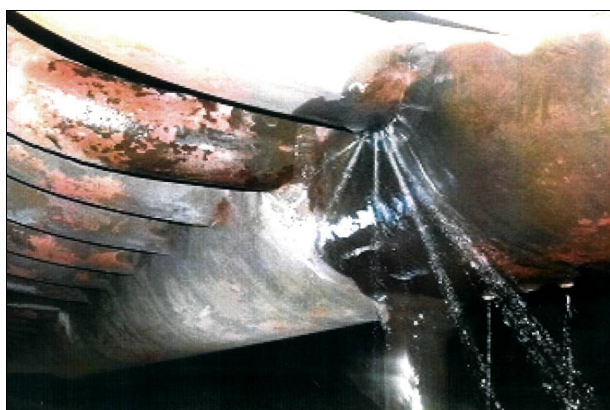
**Fig. 10.** Indirect (lower) HP superheater II header – fillet weld damage.

- 70 bends (of all pipe coils) of the superheater SH2 were exchanged at the intersections with the lower indirect headers.

Renovation works have been conducted in accordance to executive project approved by UDT (Office of Technical Inspection). After replacing bends performed testing of 100% welded joints. Bends  $\varnothing 51.6 \times 3.6$  mm were replaced by bends  $\varnothing 51.6 \times 6.3$  mm with material 13CrMo4-4.

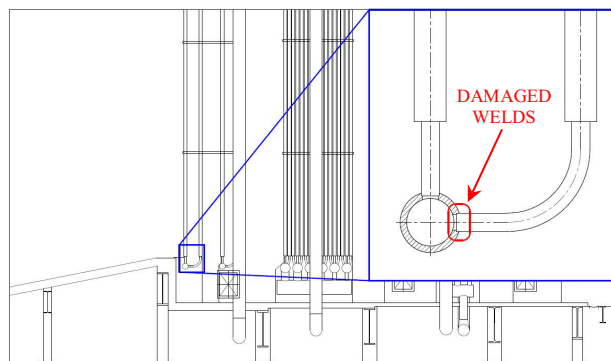
**Fig. 11.** SH2 – indirect superheater headers in the area of damage.

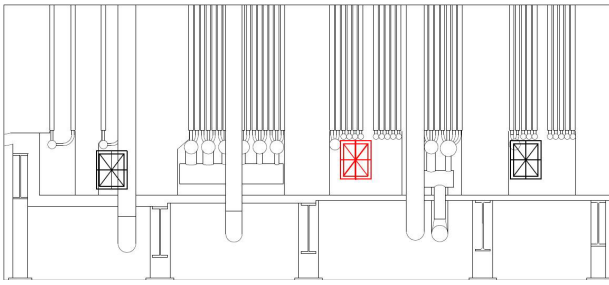
Fig. 12. Enlarged hatch in the bottom part of the boiler.

Installation of the external inspection hatches has been completed (fig. 12) due to the difficult access to the individual modules of the boiler during previous shutdowns and when troubleshooting an evaporator in 2014.

As a result, in the years 2015-2016, 3 hatches was installed:

- made 2 new hatches: the level +18 m side wall, the level +24 m ceiling under HR drum,
- expanded inspection hatch at 0 m level, which will allow to build scaffolding.
