# Cause Analysis and Countermeasures of a Breakdown Failure of Flexible 110 kV Cable Terminal

Feng Huang

Electric Power Research Institute of Guangxi Power Grid Co., Ltd., Nanning, Guangxi 500023, China

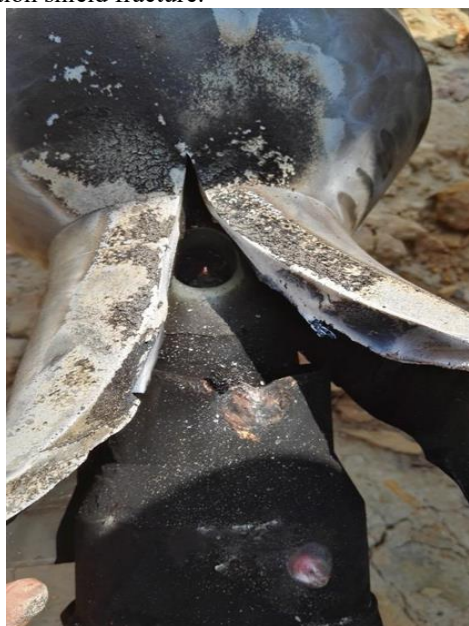
The cable terminal surface has obvious flexible burn holes after disassembling, and most of the region outside the surface have been blackened, careful inspection shows that the main insulation has complete breakdown, as shown in figure 1. The fault point is located in the insulation shield fracture, and the stress cone has a certain distance of abnormal displacement with the insulation shield fracture.

**Fig. 1.** Failure Cable Terminal.

As we all know,  $f$  is integrated with corrugated aluminium, so it will generate relative displacement between cable body and flexible terminal when the cable body has relative displacement with the aluminium ripple sheath. And it will lead to that the stress cone of flexible terminal can't get in touch with the insulation shield fracture normally because of the abnormal displacement. Then the suspended discharge can be generated because the electric stress can't be evacuated. Finally, the flexible terminal breakdown happened.

1) when the cable terminal is installed, only the cable aluminium sheath layer is fixed. The weight of the cable causes the phase displacement of the body and the aluminium bellows sheath, and the stress cone of the flexible terminal can't connect with the insulation shield fracture properly. It resulted in the breakdown of the terminal.

1) Cable hoisting is carried out before the installation of the flexible terminal. Before installing cable accessories, cable should be pre hung to install position. Then cable will be put down, so repeated 3 times. Thus the displacement of cable body and the aluminium corrugated sheath will be generated in advance so as to prevent the relative displacement between the two after installation.

2) Improve the space layout of the flexible cable terminal. The flexible cable terminal on the tower should avoid bending as far as possible. Under ideal condition, the cable terminal should be perpendicular to the ground. In cases where the site conditions are not allowed, the proper fixed method should be used to ensure that the bending angle of the terminal is not more than 30 degrees in the long run.

3) The insulation state detection of the flexural flexible terminal should be strengthened. For the flexural flexible terminal, the operation and maintenance personnel can evaluate the running state through infrared thermal imaging, partial discharge test and ultraviolet imaging in order to prevent terminal breakdown.

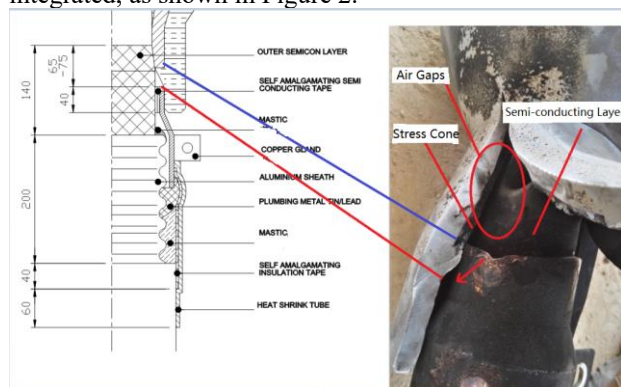
Inspection and measurement showed that there was a 2~3 mm gap between the cable aluminium bellows sheath and the longitudinal water blocking buffer layer (the water blocking zone), they were not tightly integrated, as shown in Figure 2.

**Fig. 2.** Internal Gap in the Failure Terminal.

is manufactured on the ground and then hoisted to the installation position. When the hoisting is fixed, only the aluminium sheath of the cable is fixed. For the cable whose type is ZR-YJLW02-64/110-1×500mm<sup>2</sup>, its weight is about 10kg per meter. Then the carrying weight of cable terminal can reach more than 150kg. If the cable aluminium corrugated sheath is not closely combined with the longitudinal water blocking buffer layer (the water blocking zone) of the cable, it may cause the phase displacement of the cable body and the aluminium bellows sheath due to the weight of the cable.

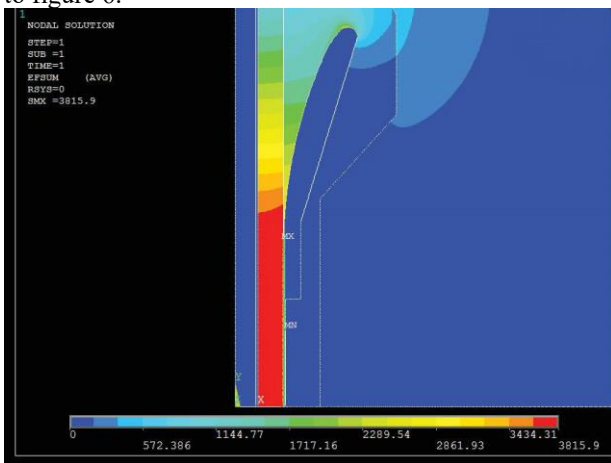
**Fig. 4.** Electric Field Distribution When the Semi Conducting Layer Overlap the Stress Cone Completely.

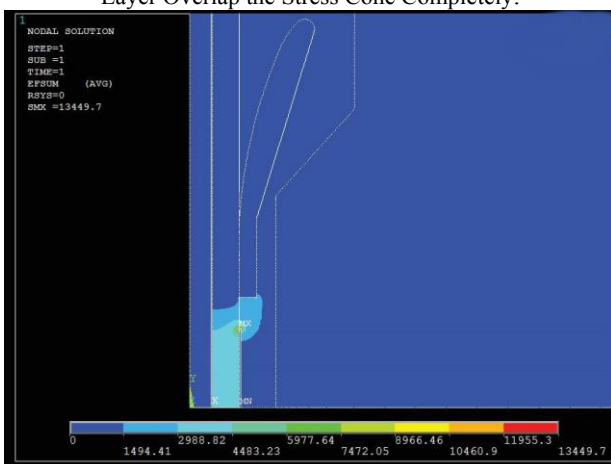
**Fig. 5.** Electric Field Distribution When Semi Conducting Layer Dislocate the Stress Cone 20mm.

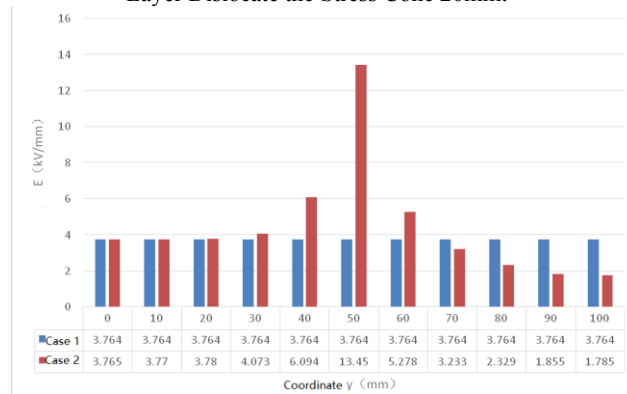
**Fig. 6.** Diagram of Electric Field Variation Trend.

According to Fig. 6, the electric field is seriously distorted when the semi conductive layer is misaligned with the stress cone. When  $y=50\text{mm}$ , the maximum electric field value reaches  $13.45\text{kV/mm}$ , which is 3.57 times of the normal case. It is far more than the breakdown electric field intensity of air (about  $3\text{kV/mm}$ ), and it also exceeds the electric field intensity of design interface between the cable insulating layer and the stress cone (about  $11\text{kV/mm}$ ). It can be seen that the main cause of the cable terminal breakdown is that the inner semi conductive layer of the stress cone and the fracture of the semi conductive layer of the cable insulation can't lap normally.
