# Case Analysis of Damages to Control Hydraulics of the Leg in the Powered Roof Support Section

Janina Świątek<sup>1,\*</sup>, and Kazimierz Stoiński<sup>1</sup>

<sup>1</sup> The Central Mining Institute, Poland

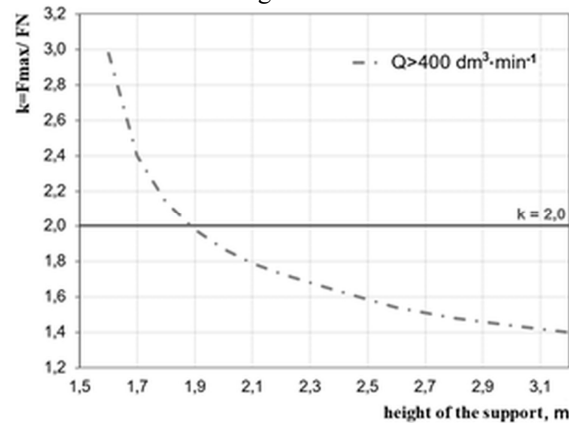
**Fig. 2.** Predicted overload of powered roof support's leg in the analysed case (for  $n_{tz}=1.22$  and application of hydraulic system with a flow of at least  $Q>400 \text{ dm}^3 \cdot \text{min}^{-1}$ ).

According to the assessment of flows of the safety system of the leg [9, 11, 12], the flow of the leg's safety system,  $Q=400 \text{ dm}^3 \cdot \text{min}^{-1}$ , was assumed for calculations of the load of the powered roof support, at a pressure of 1.5 times the working load. Expected overloads for the above mentioned flows are shown in Fig. 2.

The results indicate that the powered roof support should be yielded from a height of 1.9 m, using a system with a minimum capacity of  $400 \text{ dm}^3 \cdot \text{min}^{-1}$ . This requires maintaining the liquid column under the first stage piston with a minimum height of 0.35 m, with the correct section geometry.

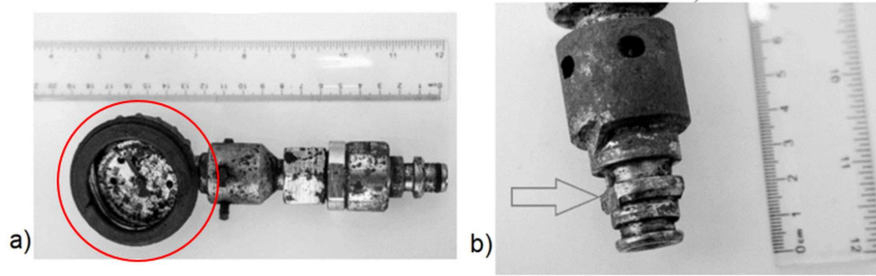
**Photo 1.** Damaged manometers

- damage to five pressure gauge systems (cutting off connection DN12 and damage to pressure gauges) – Photo 1, Fig. 3;
- damage to pressure limiting valves (loss of tightness, damaged seals) – Photo 2, Fig. 3;
- slip off two sections of the support due to damage to the pressure gauge systems (backrest of the canopies on the conveyor);
- roof rock fall.

As a result of the thinning of the deck, the height of the support operating area was successively lowered, which led to its operation on the 2<sup>nd</sup> stage of extension of the leg, without maintaining the appropriate column of liquid under the piston at 1<sup>st</sup> stage position. The tests results indicate that in this case the support does not have adequate bearing capacity and operates in the *hazardous area* in which the entire system is excited and, consequently, adverse effects occur in the form of water hammers in the control system.

Immediate safety measures were applied successfully. They were aimed at minimizing the conditions dangerous to the crew. The section was withdrawn and spragged again. As a result, the leg operated in full extension mode of the 1<sup>st</sup> hydraulic stage, obtaining the required strength and geometry of the section and the leg.

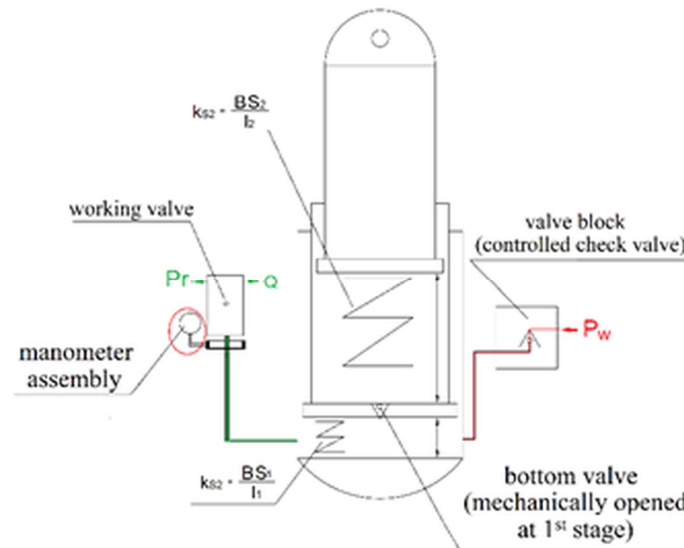
In the case of leg operating in the range of shifting from 1<sup>st</sup> to 2<sup>nd</sup> stage and clamping of the leg at 2<sup>nd</sup> stage, the relations given above change. The load-bearing capacity of the leg changes (due to the smaller surface of the second stage of the leg), its rigidity changes rapidly, which often leads to vibrations in the control system, as well as difficulties in maintaining the roof. Fig. 4 schematically shows the cases described.

As presented in Fig. 4, during the shift of the leg from 1<sup>st</sup> to 2<sup>nd</sup> stage, the work of the leg is unstable, which can be described by the following formulas:

In addition, as shown in Figure 4, an area where dangerous phenomena may occur is formed during the shift from 1<sup>st</sup> to 2<sup>nd</sup> stage, i.e. at the height of support of 2.3 to 2.6 m. The research team estimates that the whole system excites within this range, which causes the occurrence of adverse phenomena in the form of impacts.

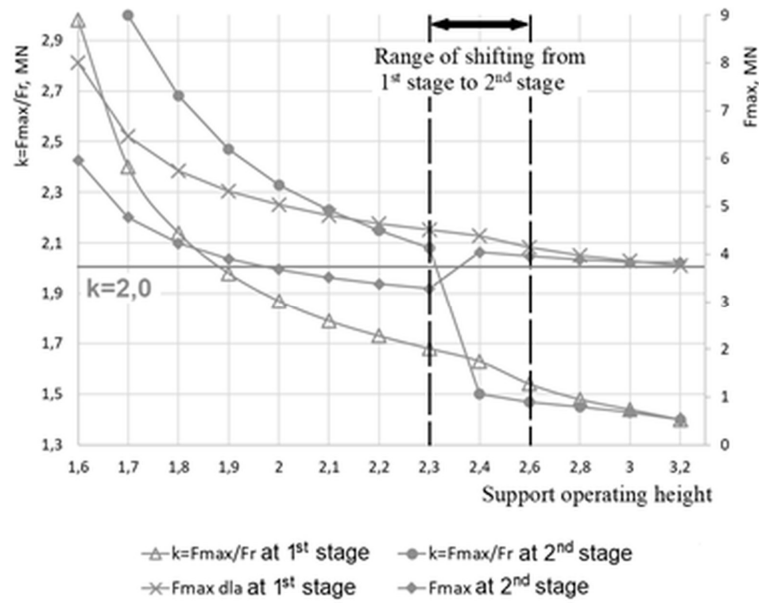
**Fig. 5.** Expected overload during operation of the hydraulic leg at 1<sup>st</sup> stage and during operation at the time of shift from 1<sup>st</sup> to 2<sup>nd</sup> stage.

The calculations presented indicate that the bearing capacity of the leg significantly decreased and corresponds to the load capacity of the leg with the diameter resulting from the second stage, which in the given case is  $\varnothing 0.23$  m. The reduced working load was taken into account in further analysis regarding the condition for the support to be yielded. A back analysis of the condition of the section's positive state was made using a valve with a capacity of  $400 \text{ dm}^3 \cdot \text{min}^{-1}$ , as shown in Fig. 5.

As can be seen in Figure 5, in the case of proper support (1<sup>st</sup> stage), it is compressed in the range from the height of 2.0 m, while maintaining the liquid column under piston at the 1<sup>st</sup> stage  $PT \geq 0.42$  m. During incorrect operation (2<sup>nd</sup> stage) the support is yielded from the height of 2.35 m, which results from the diameter of the 2<sup>nd</sup> stage cylinder, while maintaining the height of the liquid column under the 2<sup>nd</sup> stage  $PT \geq 0.78$  m. It should be noted, however, that in this case the height of the liquid column under the first stage piston is practically nil, in which case the leg is not working properly.

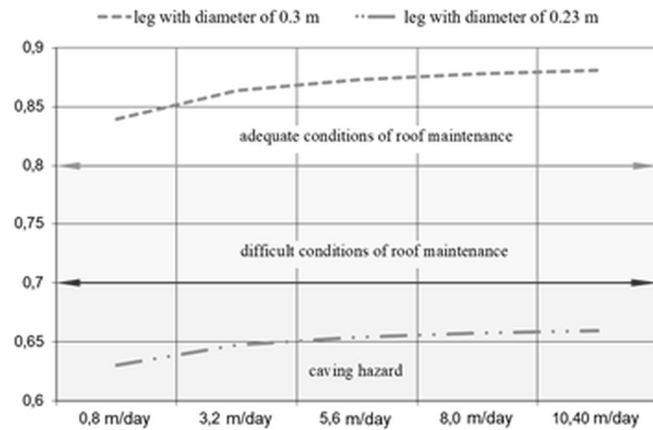
**Fig. 6.** Index of load-bearing capacity of the  $g$  roof during the operation of the leg at the 1<sup>st</sup> and 2<sup>nd</sup> stage.

The operation of the support at the 2<sup>nd</sup> stage also significantly affects the roof maintenance conditions, as shown in Fig. 6, using the load capacity index of the ceiling  $g$  according to the method developed at GIG [4, 5].

The calculations indicate that when the operating parameters of the leg are correct, the bearing capacity of the roof support will be sufficient to protect the excavation against the dynamic impact of the rock mass, which largely depends on the diameter of the leg  $\varnothing 0.30$  m – the  $g$  factor  $\geq 0.84$ . In the case when the load-bearing capacity of the operating support resulting from the diameter of the 2<sup>nd</sup> stage, the  $g$  indicator significantly decreases –  $g \geq 0.63$ , and in accordance with the method developed at GIG, there is a risk of caving. This was confirmed in practice. The drop in the value of the  $g$  indicator in this case results mainly from the size of the 2<sup>nd</sup> stage cylinder’s diameter,  $\varnothing 0.23$  m (too low bearing capacity of the support).
