Sinkhole hazard in the post-mining area of Old Copper District, Lower Silesia, Poland

Abstract. This study discusses the occurrence of sinkholes and the removal of their effects in the territory of the Old Copper District in the municipality of Lubków, Warta Bolesławiecka, located in the voivodeship of Lower Silesia. Three sinkholes appeared more than 25 years after mining activities ceased with the closure of the “Konrad” Mine of KGHM Polska Miedź S.A. The sinkholes appeared in the former mining areas in the years 2017 – 2018: the first in the area of the Lubichów III shaft located in the municipality of Lubków – the downcast and transport shaft of the “Lubichów” and “Konrad” mines; the second in the area of Lubichów IVa in Lubków – the ventilation shaft of the “Lubichów” and “Konrad” mines; and the third in the area of the Lubichów IVa shaft - in the village of Lubków. The “Lubin” Mine of KGHM Polska Miedź S.A. commissioned development of projects to mitigate the risk and to secure the areas and remove the dangers.

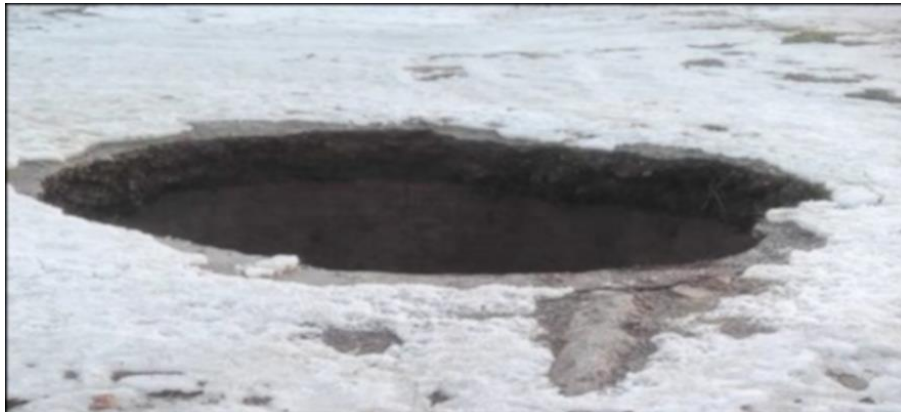
Fig. 2. Open part of the Lubichów III shaft on the day of the mining damage occurrence

The surveying services of "Lubin" Mine determined the size of the sinkhole using laser scanning. The diameter of the sinkhole was about 4.1 m and roughly corresponded to the diameter of the closed shaft. The gap after the shaft barrel was exposed in the sinkhole and the trunk part of the shaft was 0.45m below the ground. There were no deformations found in the ground around the shaft lining except for the bottom edge part of the shaft hole resulting from damage to its integrity on the edge of the cave-in. There was no depression of the surface outside the shaft, which indicates the stability of the orogen around the shaft barrel [16]. The following steps were taken to establish and document the ground-water conditions: core drilling of seven holes in the area from the bottom of the shaft to a depth of about 20 - 22 m; laboratory tests of the properties of the ground collected from the cores; and two tests by impact probing. The results indicated the physical and mechanical properties of the terrain in the area of the shaft; no basic groundwater level; absence of any cavities or hollow ground in the surveyed ground. This was a very important observation for the assessment of land stability around the shaft. A space in the shaft barrel unfilled with the filling material was exposed in the cave-in, with a water surface at a depth of about 39 m below the surface level.

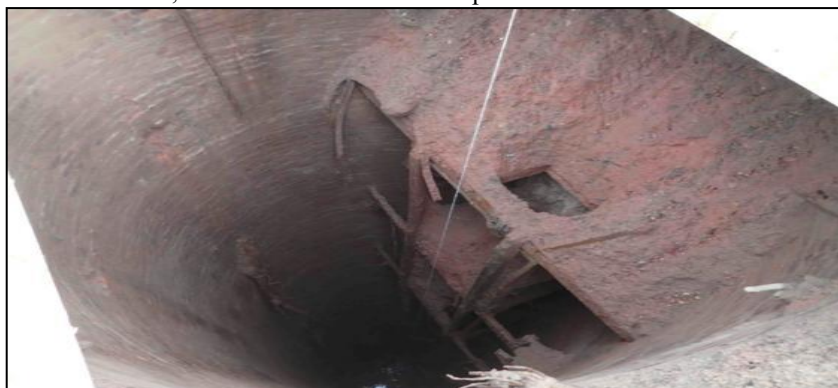
Fig. 3. The inside of the Lubichów III shaft – the entire shaft lining

On visiting the site, it was observed that the construction for the ladder compartment as well as the shaft girders and the hoisting shaft guides were built on the side of the ladder compartment. The presented section of the lining lacks beams that would separate the hoisting compartment. There was a visible overhang on the remains of construction of the ladder compartment which probably was a left-over after backfilling the shaft with rock material from the mining dump (Fig. 3).

This overhang prevented the identification of the integrity of the shaft inlet located at a depth of 6.0m under the ground level directly below the deck of the ladder compartment [16]. KGHM Cuprum performed indicative measurements of the level of the water mirror on 30 March 2017. They showed stabilisation at a depth of approximately 39 - 40m, with a test based on lowering the sinter below the mirror of the water at a depth of about 54m below the surface.

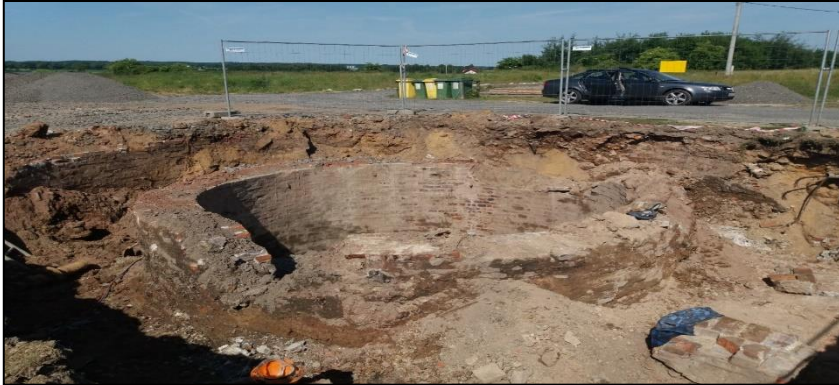
Fig. 4. Exposed Lubichów III shaft barrel.

The liquidation of the mining damage in the region of Lubichów III included the capping of the shaft inlet at its trunk and safeguarding the trunk part of the shaft with a reinforced concrete slab cap. This ensured full security of the shaft, both for the users of facilities located in its vicinity as well as for the environment. For the duration of the time needed to prepare the project fully and analyse the results obtained from the drilled holes, the shaft was fenced and secured with a wooden structure. The site was also monitored. The following actions were taken on the basis of the project to liquidate the collapsed Lubichów III shaft: uncovering of the shaft barrel (Fig. 4); filling the cavity in the shaft barrel; filling the interior of the shaft with crushed basalt stone to the depth of approximately 55m; making of a reinforced concrete slab of 7.5x7.5x0.5m in a central position above the shaft, including insulation and placing of an inspection hole (Fig. 5); to monitor the interior of the shaft, with an inspection planned for July 2019 to determine whether the filling material level has changed and requires further filling; covering of the reinforced concrete slab with soil and return of the land for use by the owner of the property.

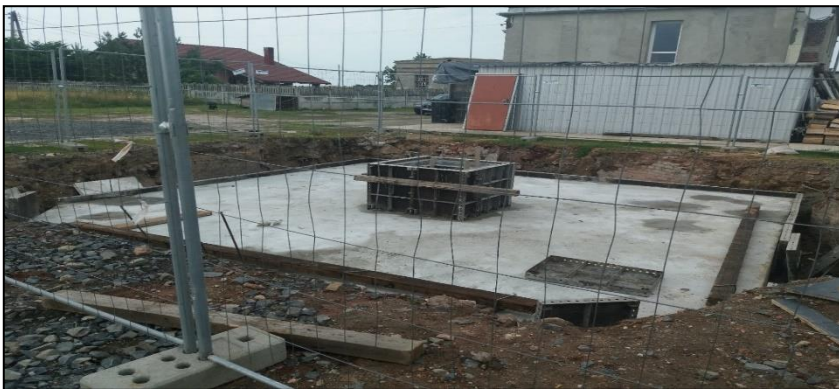
Fig. 5. Reinforced concrete slab with inspection hole securing the Lubichów III shaft barrel.

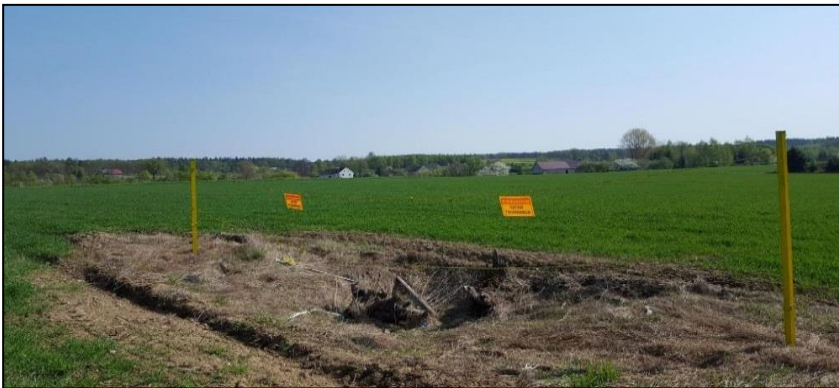
Mining damage in the form of a collapse of the terrain in the trunk part of the Lubichów IVa ventilation shaft (Fig. 6) was observed on private agricultural land in Lubkowo [17]. The exact date of its occurrence is unknown. The cave-in was reported by the owner of the parcel in April 2018 and a notification delivered concerning its location (Lubichów IVa shaft area).

The size of the sinkhole was determined by the "Lubin" Mine surveying services. The cave in is 0.74m in its deepest part with a diameter of approximately 4.0m. The trunk part of the shaft was invisible and the space of the shaft barrel remains covered. It was not possible to identify the material used to fill the shaft barrel [17]. The integrity of the ground on the edge of the deformation was unspoilt and there was no sedimentation of the surface in the area around the shaft. Due to the way the area was used the surface of the land was covered with vegetation, with dead shrubby vegetation visible in the sinkhole.

Fig. 6. The sinkhole in the trunk part of the Lubichów IVa shaft.

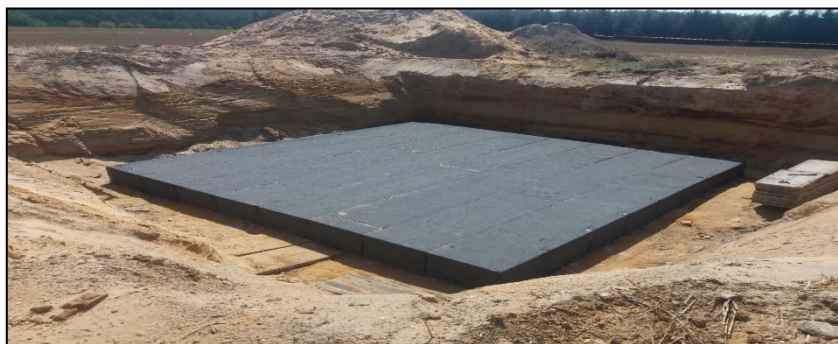
Fig. 7. Reinforced concrete slab approx. 3m under terrain level, dimensions: 7.0x7.0x0.5m

The site was monitored throughout the preparation of the project, for the time needed for the ground-penetrating radar survey (GPR) and the analysis of the results. The following actions were taken following the project: a 10.5m x 10.5m excavation (approx. 3 m deep) to uncover the shaft barrel which in turn was not found at the designated depth; it was decided not to continue the excavations after consulting the company implementing the project; at the level reached by excavation works a 7.0x7.0x0.5m reinforced concrete slab without a revision hole was placed in the central position over the shaft - the slab was insulated (Fig. 7); the cave-in was filled with sand of appropriate fraction and humus to restore the land for use by the owner of the parcel.

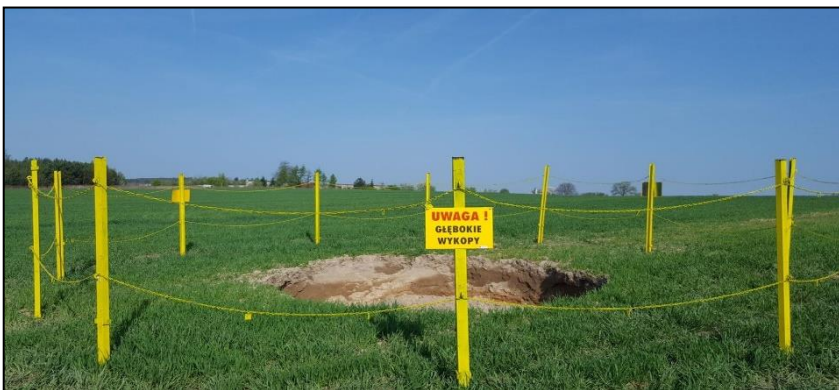
Fig. 9. Secured sinkhole in Lubichów IVa shaft area.

The site was monitored throughout the preparation of the project, for the time needed for the ground-penetrating radar survey (GPR) and the analysis of the results, the sinkhole was adequately secured. It was decided to secure the sinkhole by deepening it and filling with crushed basalt rock of the indicated fraction (Fig. 10) and to build a fence around about 0.10 hectares of the parcel (Fig. 11) in order to monitor the position of the level of the upper surface of the filling for a period of three years until 06 September 2021 based on part II of

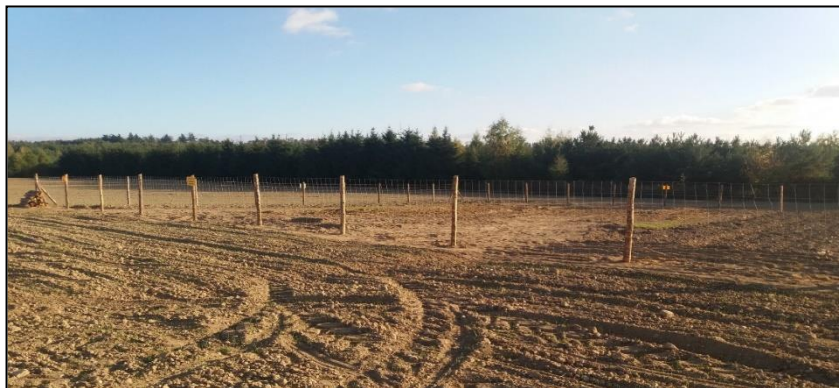
Fig. 11. The fence around the area of the landslide under surveillance.
