# Analysis of the displacement of road embankments and bridges located in areas prone to landslides

*Elżbieta Pilecka\**, and *Karolina Tomaszekiewicz*

Cracow University of Technology, Faculty of Civil Engineering, Cracow, Poland

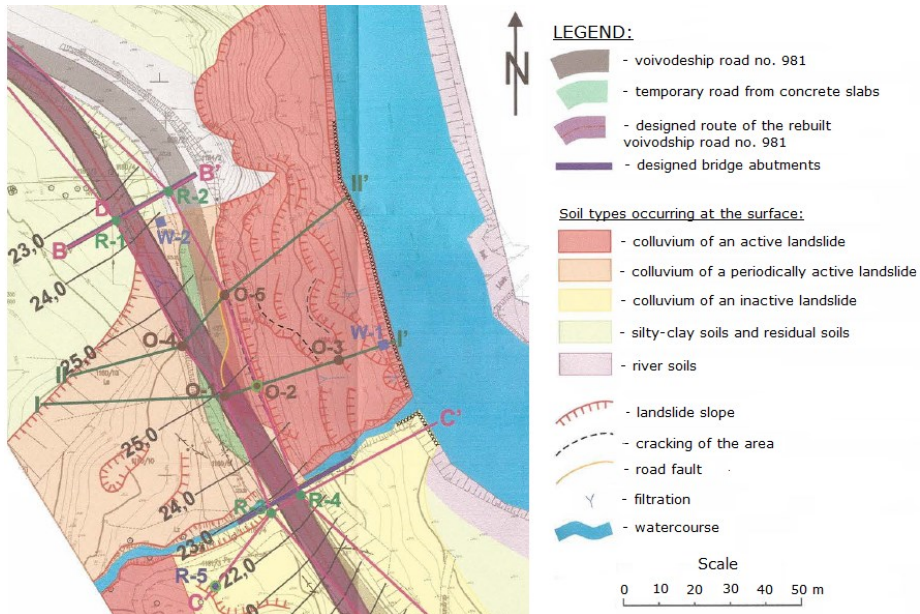
Before the bridge structure was built, voivodeship road No. 981 was a single carriageway, with two lanes leading in opposite directions, along the road embankment. It passed through a vast landslide prone location with an area of over 4 hectares, which consists of 5 activity zones. Within the ground, three active zones were found, one periodically active and one inactive. The range of landslide activity zones near the bridge is shown in Figure 3.

**Fig. 3.** Range of activity areas of the colluvium near the bridge structure [5].

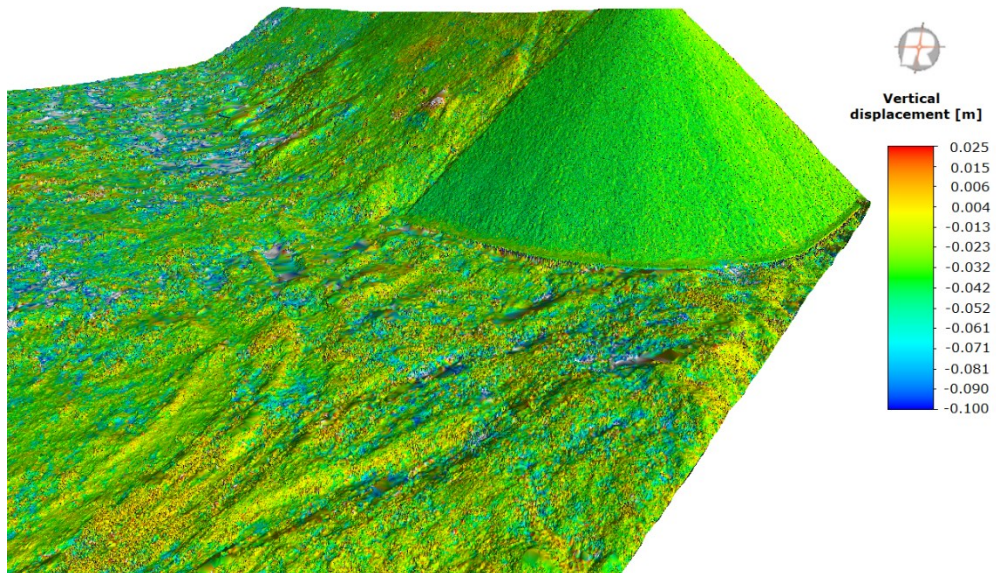
The slope cone (area "A") reinforced with a stone pavement on the south-eastern side of the structure (Fig. 5) shows displacements within +3cm to +4cm, similar to the embankment slope. Locally, the slope surface has displacements from +2.5cm to -10cm. Deformations of the terrain surface between the road and the river are very diverse - locally there are uplifts of about +1cm, as well as lowering in the area to -8cm.

**Fig. 5.** Laser scanning differential model - vertical displacements of the "A" area.

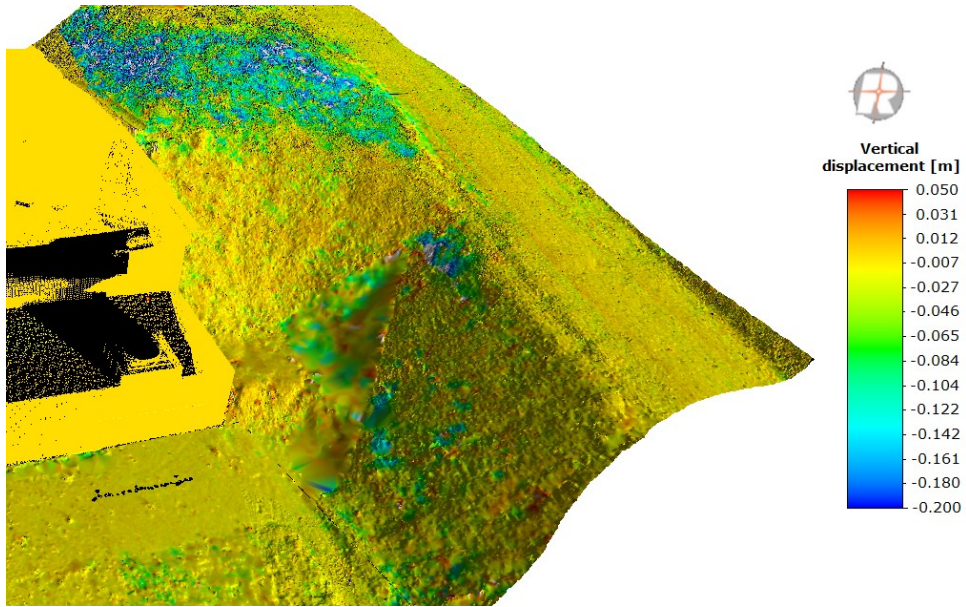
**Fig. 6.** Laser scanning differential model - vertical displacements of the "B" area.

The slope at the northern side (Fig. 6) is dominated by a +1 cm displacement. Locally there are displacements from -5cm to -15 cm. The largest displacements (up to -20cm) occur at the slope next to the road.

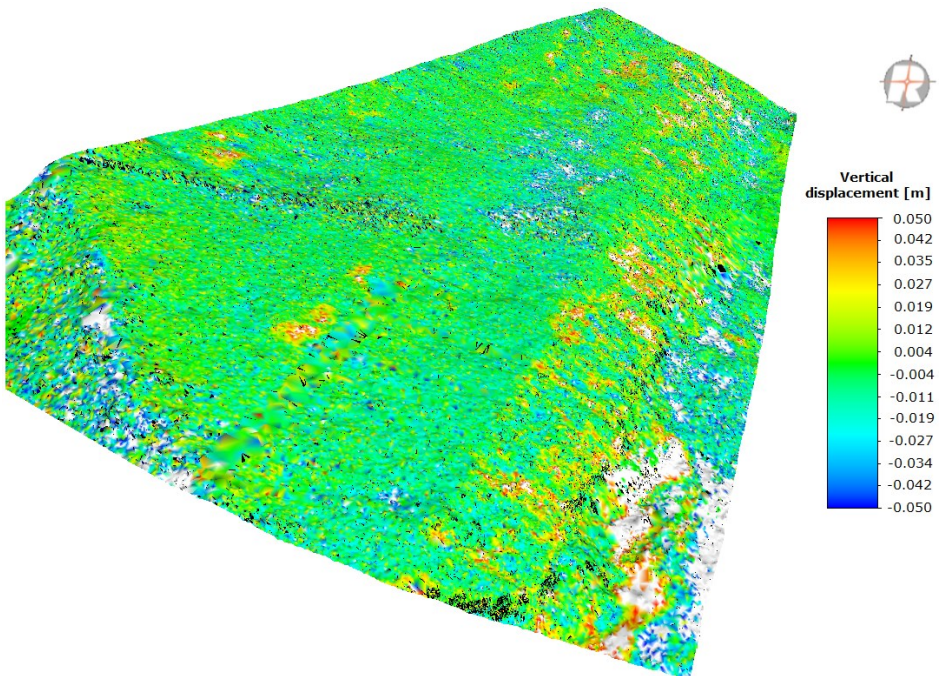
The slope on the west side (Fig. 7) in the lower part shows displacements of up to +5 cm. In the upper part of the slope, land depression of -2cm to -5cm is visible.

**Fig. 7.** Laser scanning differential model - vertical displacements of the "C" area.
