Risk analysis of seismic bridge damage: case study after Lombok and Palu earthquake

Risma Putra^{1,*}, and Winarputro Adi Riyono¹

¹Institute of Road Engineering, Agency of Research and Development, Ministry of Public Works Republic of Indonesia

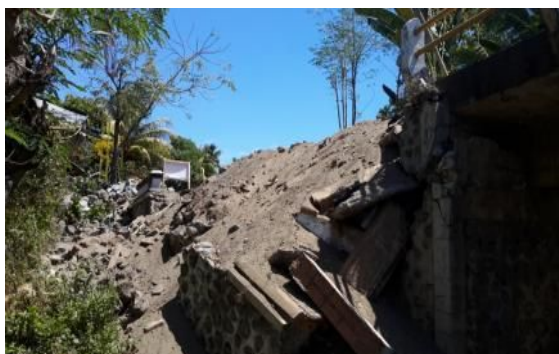
Fig. 1. Subsidence of embankment near the Tampes bridge [7]

The settlement causes the access disruption at the bridge location. The truck carrying gasoline and logistics was difficult to reach the affected area. This makes a serious problem to accelerate the recovery process after a seismic event.

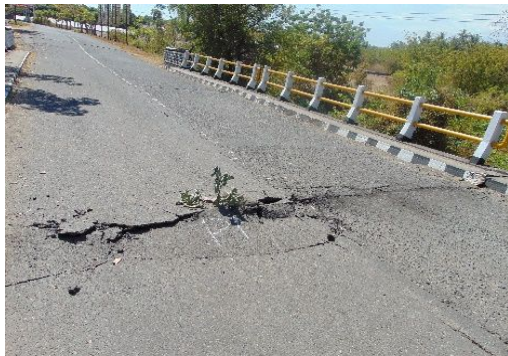
Fig. 2. Damage at the expansion joint in LUK bridge [7]

According to Fig. 5, damage to the expansion joint is the most often damages that occur on the bridges. This type of damage is caused by the movement of the upper

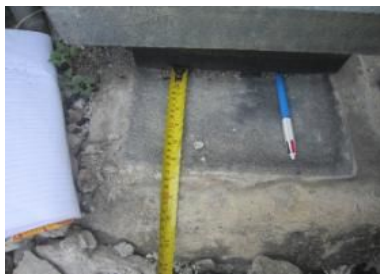
Fig. 3. Excessive superstructure displacement in Batusuya bridges [8]

The superstructures of floor elements, girder, frame, and placement is one of the main structural components of the bridge. These elements can experience movement due to earthquake, especially bridge support. The central issues are to limit the seismic energy entering the structure from the ground in the first place and then to dissipate as much of it as possible by damping devices. The seismic damage impact can be reduced by using a

particular device to absorb seismic forces. By decoupling the structure from seismic ground motions, it is possible to minimize the earthquake-induced forces in it, that can be done in two ways. Firstly, increase the natural period of the structure by base isolation and, secondly, increase the damping of the system by energy-dissipating device as proposed by Tandon [9].

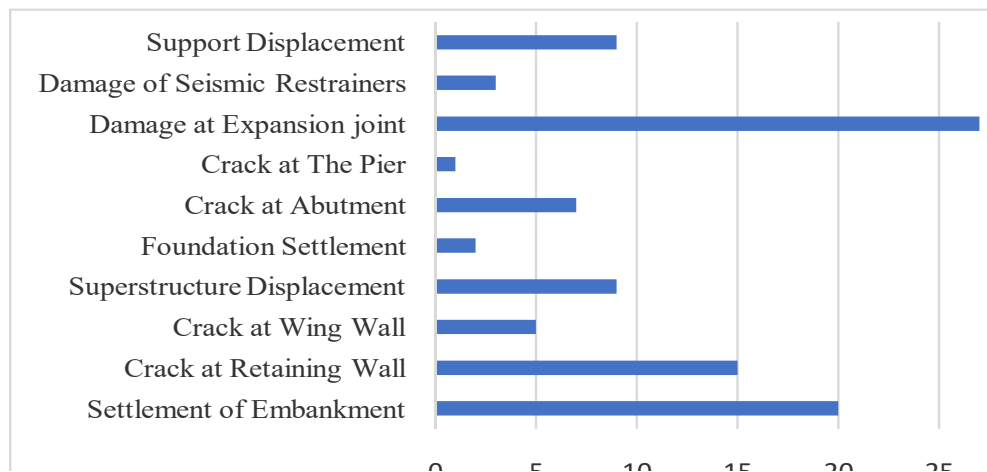
There are 10 (ten) types of damage observed on the existing bridges during the field survey, as shown in Fig. 5. Those include damage of expansion joint, settlement of the landfill, damage of retaining walls, excessive displacement of the upper structure, sliding of the support, cracks in the abutment, damage at seismic restrainers, foundation settlement, and cracks at bridge piers.

Fig. 5. Statistics of bridge element damage observed after Lombok and Palu earthquake [7,8]

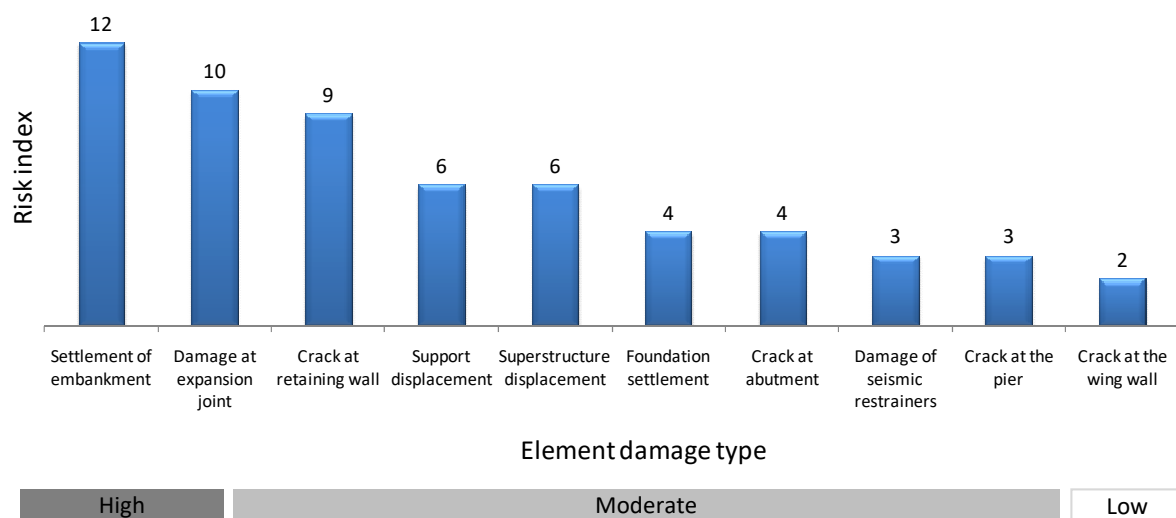
Fig. 6 shows the results of the risk analysis of damaged bridges in Palu and Lombok. It is concluded that the settlement of embankment in the approach road is found to be the most potential element with the highest risk of damage due to earthquakes. In addition, the excessive superstructure displacement and crack in the retaining walls are at moderate risk.

Fig. 6. Risk distribution after Lombok and Palu earthquake
