Seismic capacity evaluation of the damaged reinforced concrete building during Palu earthquake 2018

Fajar Nugroho^{1,2*}

Abstract. This paper presents an evaluation of the seismic capacity of the Dean Building of The Faculty of Social and Political Science of Tadulako University due to the Palu Earthquake 2018. The building was built in 2016 and went into use in 2017. The building is made from a reinforced concrete frame consisting of three floors and collapsed after the earthquake. Data for the analysis are taken from the Detail Engineering Design of the Dean Building of The Faculty of Social And Political Science of Tadulako University in 2015. Seismic capacity evaluated based on Standard for Seismic Evaluation of Existing Reinforced Concrete Buildings issued by the Japan Country. The analysis are done on the 1st-floor structure because the most significant sliding force happens on the first floor. Seismic capacity is invoked in the form of a link between the lateral strength and the ductility index. By using Japanese standards, the building's seismic capacity is relatively small in withstanding the earthquake load and collapsed the building. Based on observations in the field

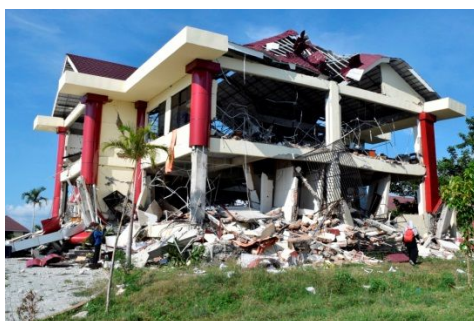
Observation was done by examining reinforced concrete structures in Fisip Dean buildings (Fig. 4). The strength of the existing concrete is obtained by conducting non-destructive testing using the hammer test. Reinforcement bars used in the damaged structure are measured in the diameter of the reinforcement used, the type of reinforcement, and the length of the dispensing. The stirrups of reinforcement bar is measurement in the distance between the stirrups and the large angle and the length of the curve in the stirrups. The Dean building has a soft story. The building was originally 3 floors, and after the earthquake changed to 2 floors, the ground floor was totally collapsed.

Fig. 4. The Dean Building of the Faculty of Social and Political Science (FISIP) of Tadulako University in Post-Earthquake 2018

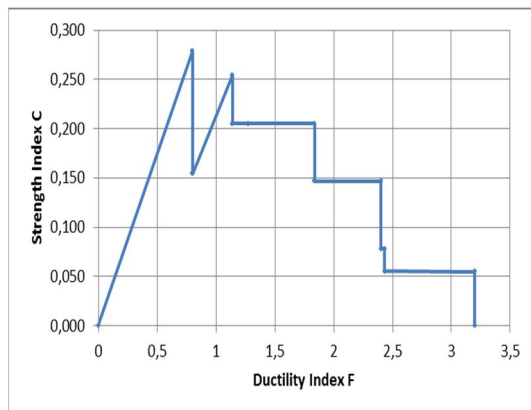
a. C and F Relations North-South

Fig. 6.a shows the phase collapse of the North-South direction column. The building has a total strength index of 0.379. At the index of ductility 0.8, the building suffered the collapse of the column before the plastic boundary by reducing the strength index by 0.125. The collapsed column in the 0.8 ductility index is a sliding column. This column has a sliding collapse because there is a brick wall that curbs so that it is a short column with a net height of 1.8 meters. The collapse of this column caused the building to drastically decrease its strength index so that the building's strength index became 0.154. The decline in this strength index is likely the reason why it collapsed when it was shaken by the massive earthquake. Furthermore, on the index of ductility 1.14, the building again underwent a collapse

of the column by reducing the strength index to 0.205. Furthermore, the building's 1.84 ductility index underwent a collapse of the column by reducing the strength index to 0.147. The building continues to experience the collapse of the column until all the columns collapse on the ductility limit of 3.2.

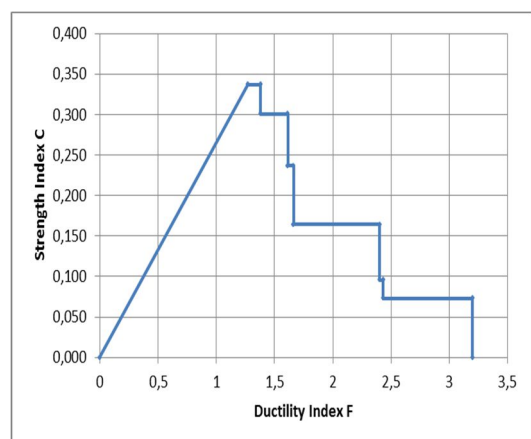
b. C and F Relations East-West

Fig. 6.b shows the phase of collapse of the column east-west direction. The building has a total strength index of 0.337. At the index of ductility 1.38, the building suffered a collapse of the column by reducing the strength index to 0.301. The type collapse column is a bending collapse. Most of the columns on the east-west are experiencing bending collapse. At the next ductility index, the building continues to experience the collapse of the column until all the columns collapse at the index limit of the ductility 3.2.

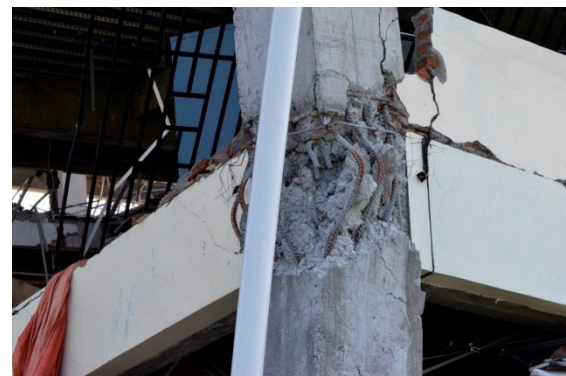
The results of observations in the field showed that the Dean building was experiencing the collapse of the Palu post-earthquake 2018. The quality of the concrete is relatively low, and the reinforcement details do not conform to standards.

Fig. 7. The Damage in The Column Beam Connection

Fig. 7 shown that the consequences of not being properly installed at the join of beams and columns resulted in the main reinforcement of the column experiencing bent (broken). The size of the existing stirrups and curve is insufficient. The width dimensions of the beam should be designed smaller than the column, and column dimensions should be designed more strongly than beams. It is aimed at the main reinforcement of the beam to be restrained by the main reinforcement of the column. Also, the column beam join should be mounted in the field as the main reinforcement of the column to avoid damage after receiving the earthquake load. Based on the floor plan, the Dean Building of the Faculty of Social and Political Science of Tadulako University has a large column spacing of 9 m and 8 m.

In the earthquake-prone area for reinforced concrete buildings is recommended to use in minimum diameter 10mm for reinforcement bar (D10) and the quality of concrete K-300 (f_c' 25 MPa). Rainwater drain pipes should not be entered into the column because it will reduce the column cross-section so that the column strength will also decrease. Based on SNI 2847:2013 [10], the length of the main reinforcement of the beam to the column is 12d with a curvature of 90°. Overlapping distance on a major reinforcement connection is 40d. The length of the stirrups latch is 6d, with a curve of 135° [10]. The distance between the columns in the building should not be too large for the building to become more rigid, so it is expected to withstand the earthquake load.
