# Analysis of school damage due to Lombok earthquake on August 2018

**Abstract.** The Lombok earthquakes on 5 and 19 August, 2018 have caused fatality and damage buildings including houses and schools. It was reported that the Lombok earthquake had caused damage to at least 606 schools in West Nusa Tenggara. Following the earthquake, the field survey was carried out in a few days to collecting data of damaged schools in Lombok. The global positions of surveyed schools were recorded during the survey to identify the geological and seismicity condition surrounding area. The data were analyzed to understand the cause of the damaged. The damage pattern of the schools is also analyzed and then compared to the other related studies. The damage on the schools in Lombok Island generally has a result of insufficient quality of the building materials. Further, understanding the earthquake resistant building for earthquake prone areas is the most basic knowledge to be informed to the Local Government who has authority to manage the schools. This study suggests for establish Local formal rule of related to minimal requirement for earthquake resistant school building following the microzonatio

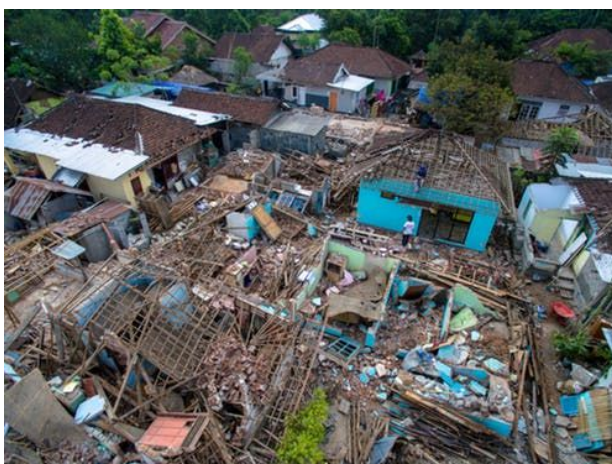
**Fig. 1.** The Damage in Lombok earthquake 2018 [2].

The damage caused by the earthquakes was in the form of collapsed building and houses, cracked soil, and liquefaction. The main recent damage and collapse of buildings due to earthquakes occurred generally due to the weakness of the buildings for anticipating the ground motion.

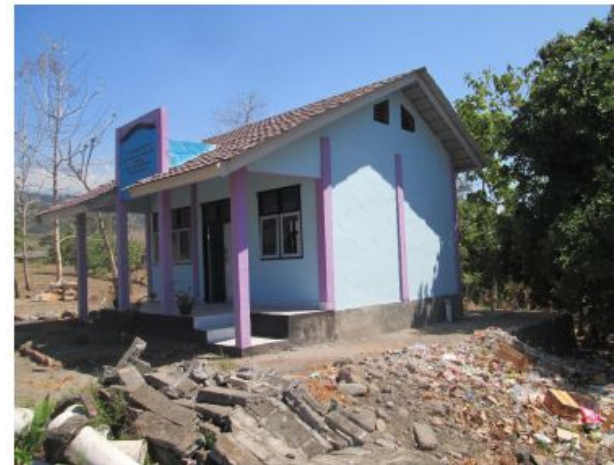
The main structure of observed building of SD Negeri 02 Obel-obel (Fig. 4) is made of brick masonry wall. This building is used for reading class. The main structure of the building may also be categorized as confined wall (Fig. 5).

**Fig. 5.** The general structure of SD 02 Obel-obel

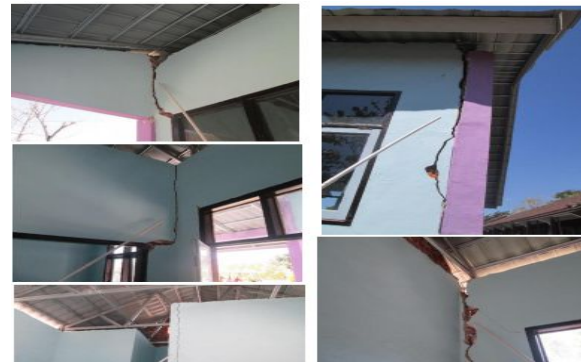
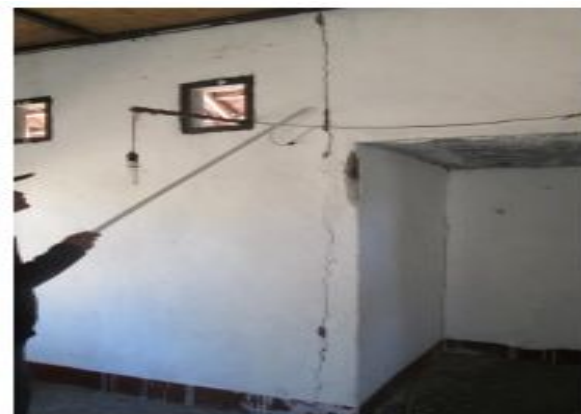
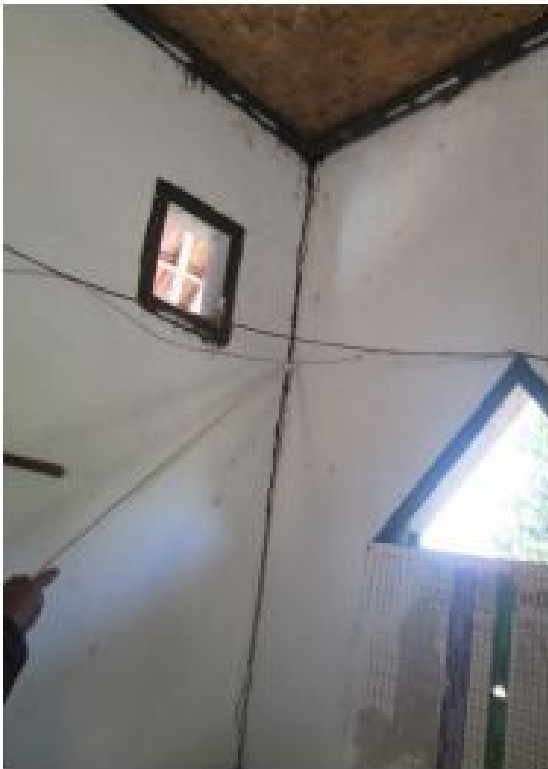
**Fig. 6.** The Damage type of SD 02 Obel-obel

This building is still firmly standing but it suffered from detail damage. It can be categorized as light to medium damage. First, the connection between the wall and the confining reinforce (RC) concrete was cracked (Fig. 6). It seems there is not enough steel bar to connect the walls and the main RC columns. Second, the overlaps main steel bar is to short. It is at least 40 time of the main bar diameter. Since then, the joints of perimeter beam and column was pulled out during the earthquake.

(a) Reading Room

(b) Praying Room

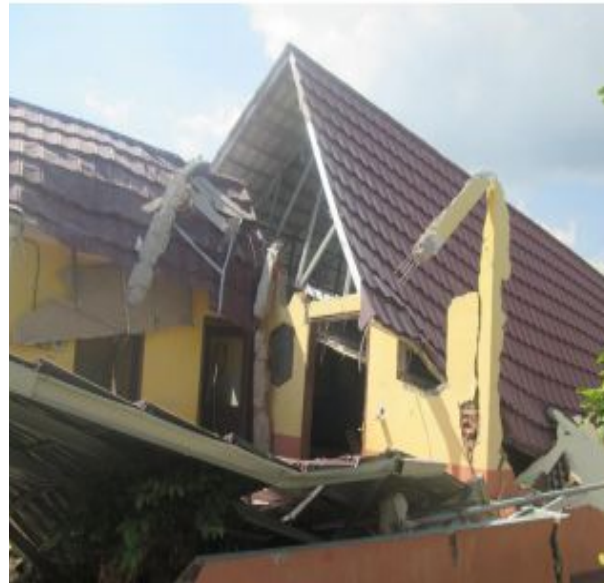
**Fig. 8.** The total damage structure of Paud Terpadu PB

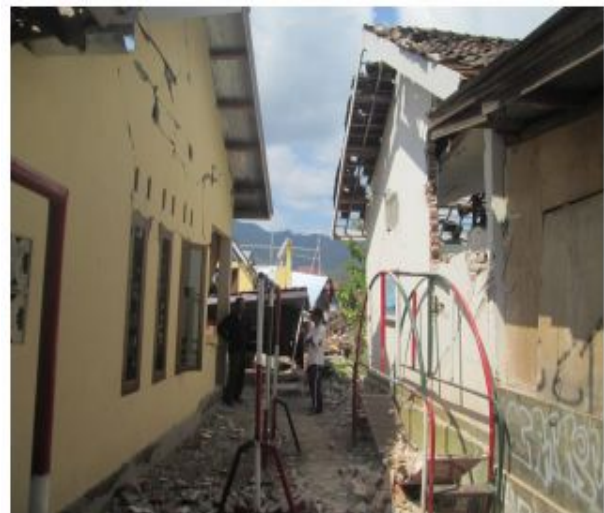
Second building, there are many cracks on the wall connected to the confining reinforce (RC) concrete (Fig. 9). It indicates there is not good enough connection between the walls and the main RC concrete. Since the crack also existed in horizontal direction where generally no need connected bar, in shows the material of the building is not in good quality. Moreover, the roofs of the buildings are made of burned clay which may have a relatively weight compared to the metal roofs.

**Fig. 9.** The Heavy Damage type of Paud Terpadu PB

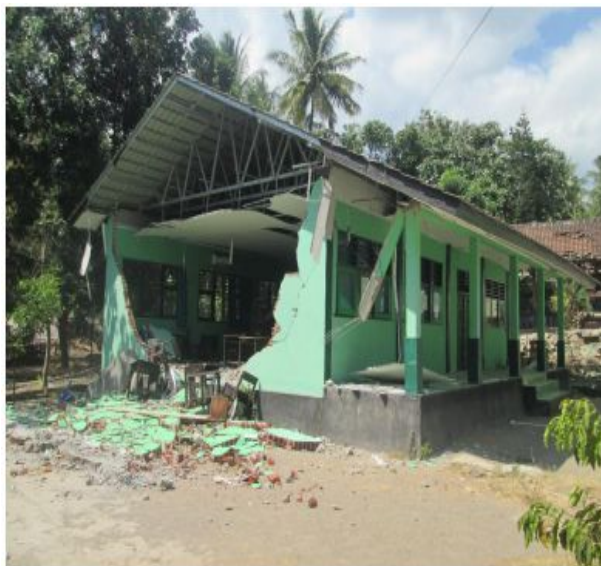
The structure of observed building of SMP Negeri 1 Pemenang (Fig. 10) is made of confined brick masonry wall. The building is used for learning classes. The building collapse badly in one side (Fig. 11). The rest of the building can be said still firmly standing even it suffered from small detail damage. This building relatively new building which can be seen from the

material used. It uses the light formed steel for roof construction and uses light metal roof material as well. The side damage indicates the low quality of material and its connection. The wall - roof connection just only 'simple touch' each other. Structurally it is considered to be No Connection at all.

**Fig. 11.** The damage of of SMP N 01 Pemenang.
