# Resource-saving preparation of the 38KHGNM steel surface for heading of automobile components

**Abstract.** To produce high-quality fasteners for motor group components of automobiles it is necessary to follow the increased requirements to calibrated rolled stock in terms of surface defects. Therefore, the goal of this paper is to study the reasons, types and depth of the surface defects on the calibrated rolled stock from steel 38KHGNM Ø 12.0 mm on the basis of the metallographic analysis. Before cold upsetting, the hot-rolled products are subjected to metal flow and removal of unacceptable surface defects by means of expensive turning operation during which the screw cuts and cracks might appear. It has been defined, that the hot-rolled stock from steel, grade 38KHGNM, diameter 12.0 mm has nonuniform mechanical properties, grooves, laps and partial decarburization on the surface. The heat treatment of the rolled stock with a decarburized layer on the surface contributes to its further decarburization. Poor alignment of calibrated stock during its turning at the turning machine does not enable to completely remove the decarburized layer with minimum skinning of rolled stock. It

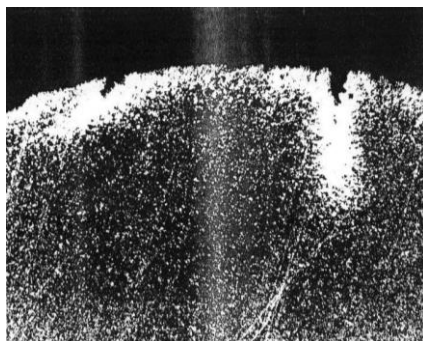
3. Batch No. 1 of metal rolled products does not comply with GOST 10702-78, since one sample has the laps of 0.1 mm deep and on the second sample the lap is 0.09 mm (Fig. 1). The laps on the rolled products surface are not allowed.

**Fig.1.** Laps at the surface of hot-rolled stock of 38KhGNM steel. Transverse microsection. Etching by 4% HNO<sub>3</sub> in alcohol. Magnification x200.

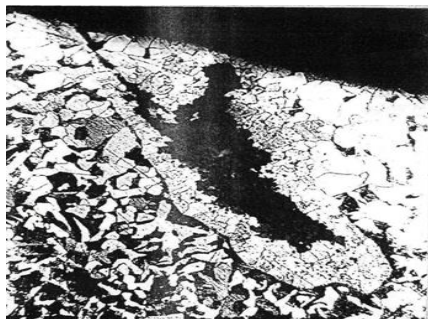
**Fig 2.** Rolled gas blowhole at the surface of stock material. Transverse microsection. Etching by 4% HNO<sub>3</sub> in alcohol. Magnification x100.

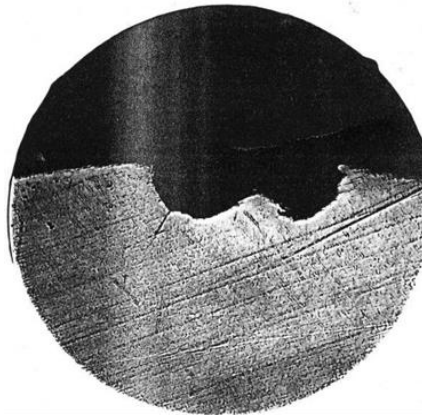
Batch No. 2 of the rolled products complies with GOST 10702-78; a groove, 0.1 mm deep has been detected on one sample.

**Fig. 3.** Grooves on the surface of hot rolled metal. Unetched transverse microsection. Magnification x100.

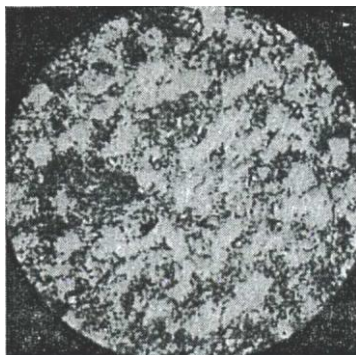
It has been established that the microstructure of calibrated rolled stock of 38KHGNM steel of 10.15 mm diameter is granular perlite, in the transition stage to granular with ferrite (Fig. 4).

**Fig. 4.** Microstructure of calibrated rolled stock of 38KHGNM steel of 10.15 mm diameter.
