Possible in-service damages of steam generators at VVER-1000 and VVER-1200 NPP units and their impact on long-term operation

Abstract. Specific features of corrosion-mechanical damages of primary circuit header to steam generator vessel branch welds at VVER-1000 NPPs and their impact on safety and economic efficiency during long-term operation are analysed. Measures to avoid the damages for similar zones of VVER-1200 steam generators are discussed.

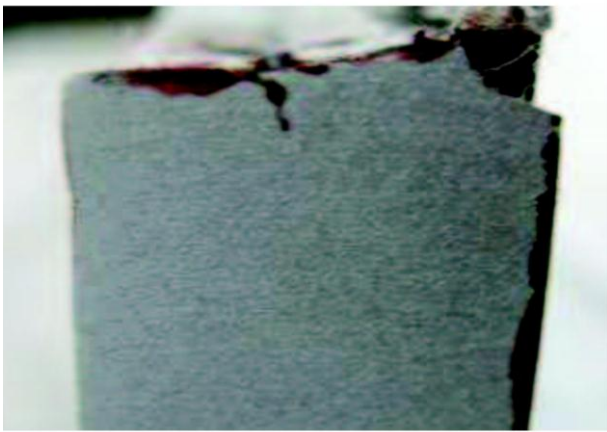
Damage in the SS-111 zone of cold SG collector of Kalinin NPP unit No.1 had specific features as long chains of pitting (Fig.2).

Fig.2. Pitting areas in the SS-111 zone of cold SG collector of Kalinin NPP unit No.1 [3]

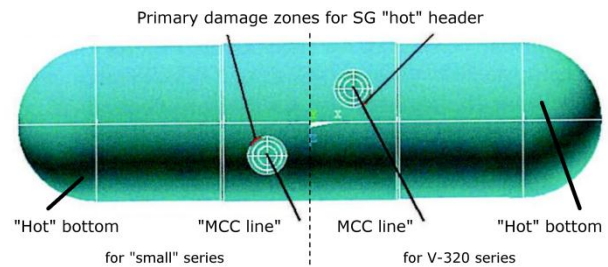
Characteristically, the position of the primary damages in the SS-111 zones of "cold" headers is also close to so-called "MCC line" as for "hot" headers (Fig.3) both on VVER NPP Units of "small" series, and on VVER NPP Units of the project V-320 (according to JSC NPO "CNIITMASH" reports [4, 7]).

Fig.3. Zones of primary damages for VVER-1000 of "small" series and V-320 series from [8]

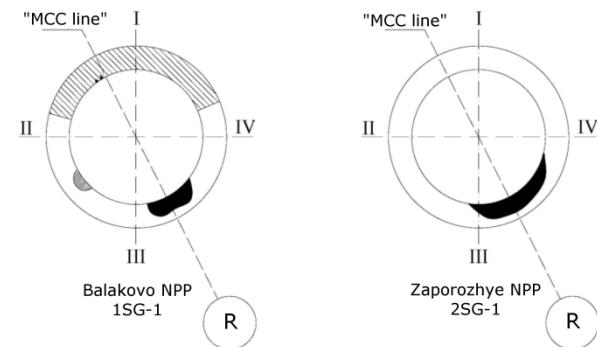
The results are consistent with the hypothesis that there is a directed mechanical impact of the MCC piping on the SS-111 zones, which should be considered as the main factor in the formation and growth of primary cracks in the direction of the "MCC line" (Fig.4-6). Fig.4 shows caption comments that are common to Fig.4-6.

- - primary damage (1st repair)
- ▨ - secondary damage (2nd and other repairs)
- ⊙ (R) - reactor

- I - long forming line (FL) of the Ø1200 SG branch
- II - FL of the Ø1200 SG branch near SG "cold" bottom (Figure 4)
- III - short FL of the Ø1200 SG branch
- IV - FL of the Ø1200 SG branch near SG "hot" bottom (Figure 4)
- "MCC line" connects centers of reactor and each SG header

Fig.4. Zones of primary and repeated defects in SS-111 of VVER NPP Units of the project V-320 ([2])

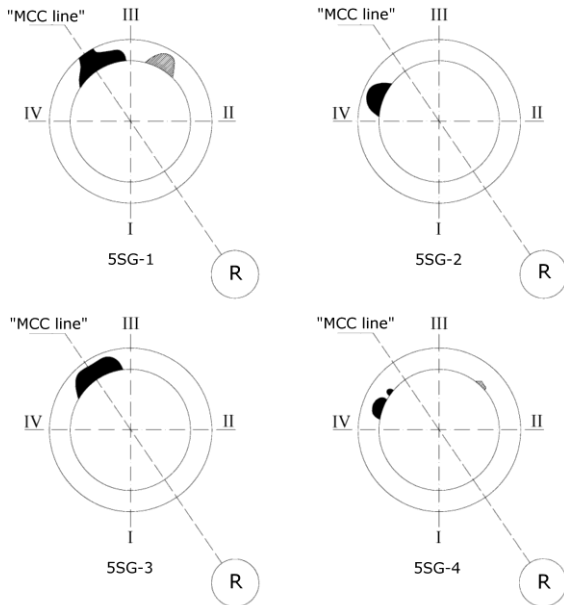
Fig. 5. Zones of primary and repeated defects in SS-111 of the unit No. 5 of Novovoronezh NPP ([2])

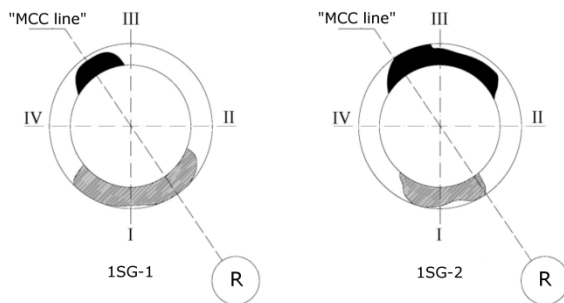
Fig. 6. Zones of primary and repeated defects in SS-111 of the unit No. 1 of South Ukrainian NPP ([2])
