Possible corrosion-mechanical damages of welded joints and their impact on long-term operation of equipment

Abstract. Specific features of corrosion-mechanical damages of primary circuit header to steam generator vessel branch welds at VVER-440/1000 NPPs and their influence on safety and economic efficiency during long-term operation are analysed.

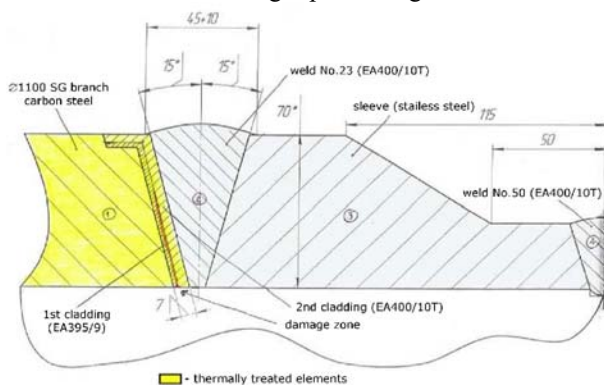
Fig.1. Sketch of the SS#23 zone of primary circuit header to SG PGV-4M vessel branch weld.

Damage to **SS#23** and **SS#111** was initiated on the inner surface from the "pockets" under corrosion impact of the secondary circuit coolant. In the "pockets" of SGs (Figures 1 and 2), the parameters of the water chemistry may differ for the worse with accumulation of corrosion products and increased content of impurities.

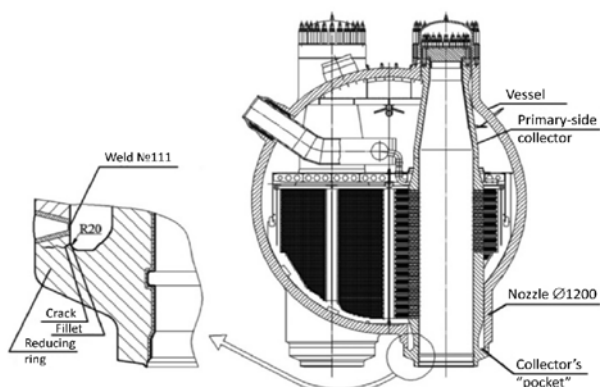
The considered units of SGs have design differences: **SS#23** - Figure 1 from [1] and **SS#111** – Figure 2 from [2]. A typical view of the "pocket" in the area of the **SS#111** is shown in the right part of Figure 2.

Fig.2. Steam generator PGV-1000M [2].

The paper analyzes accumulated data that allows to explain the primary damage to **SS#111** by high level of loads caused by the restricted movement of SG along the supports, combined with water chemistry features in the SG "pocket" (Figure 2).

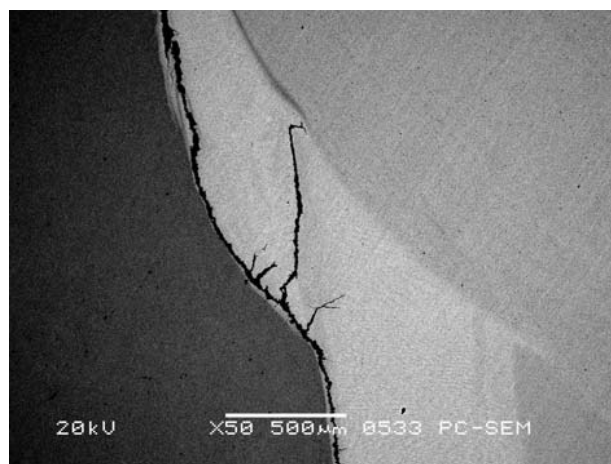
During investigation of the nature and causes of **SS#23** damage at unit No. 3 of Novovoronezh NPP, it was found that in all cases the main cause of damage associated with the formation of cracks in the first layer of cladding (surfacing), made by electrodes EA-395/9, heat treated after welding and being in contact with the coolant during operation (Figure 3).

Fig.3. Damage to the first layer of cladding welded by electrode EA 395/9 (Figure 1).

In almost all cases, the damage was initiated from the inner surface of the welded joint and grew along the zone near the fusion line of the first layer of surfacing by mechanism of intergranular corrosion [3, 4]. According to the results of later studies, the damage mechanism was clarified as intergranular stress corrosion cracking (IGSCC) [1].

Formation of circumferential cracks along the entire perimeter of the welded joint created potential for guillotine destruction of the **SS#23** zone.

The detected circumferential cracks were repaired by 100% removing the defective ones and welding a new welded joint.

To ensure the operability of SGs of NPP units with VVER-440 for up to 60 years in Russia has been developed an effective set of compensating measures, the use of which on-site has allowed to eliminate the main cause of SCC in areas of **SS#23** and provide post-repair conditions for long-term operation of NPP units with VVER-440.

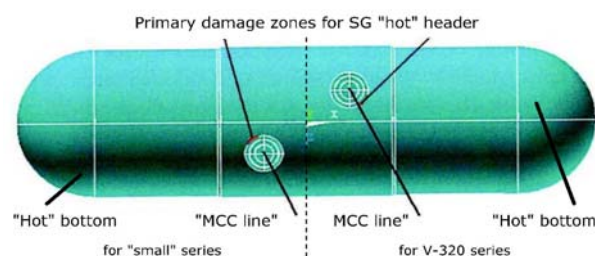
Characteristically, the position of the primary damages in the **SS#111** zones of "cold" headers is also close to the so-called "MCC line" as for "hot" headers (Figure 4) both on VVER NPP Units of "small" series, and on VVER NPP Units of the project V-320 (according to JSC NPO "CNIITMASH" reports [6, 10]).

Fig.4. Zones of primary damages for VVER-1000 of "small" series and V-320 series from [11].

A negative assessment of the dynamics of damage in 2010-2014 is too pessimistic, since many of these damages are repeated, that is, after the use of repair technology with through-thickness metal removal and subsequent volume filling by welding. However, the detection of leakage in almost the same place (Figure 4) of through damage to the 5SG-1 hot collector at unit No. 5 of Novovoronezh NPP, first ~9 years after the replacement of the SG, and then ~15 years after the repair of this defective zone by welding, shows that the main factors that led to through damage were not identified and eliminated during the period from 1998 to 2013.

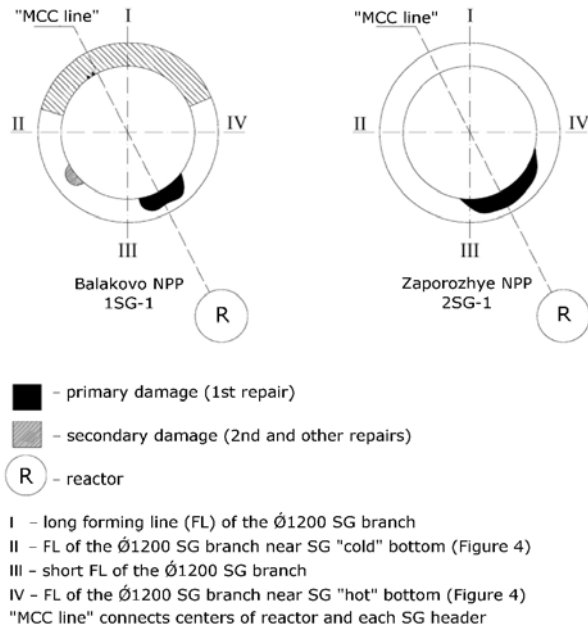
This is consistent with the hypothesis that there is a directed mechanical impact of the MCP on the **SS#111** zones, which should be taken as the main factor in the formation and growth of primary cracks in the direction of the "MCC line" (Figures 5-7). Figure 5 shows the caption comments that are common to Figures 5-7.

Fig.5. Zones of primary and repeated defects in SS#111 of VVER NPP Units of the project V-320 ([2]).

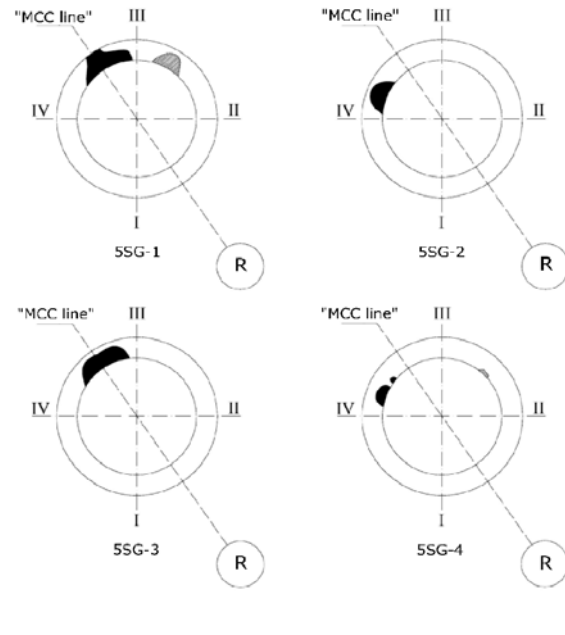
Fig.6. Zones of primary and repeated defects in SS#111 of the unit No. 5 of Novovoronezh NPP ([2]).

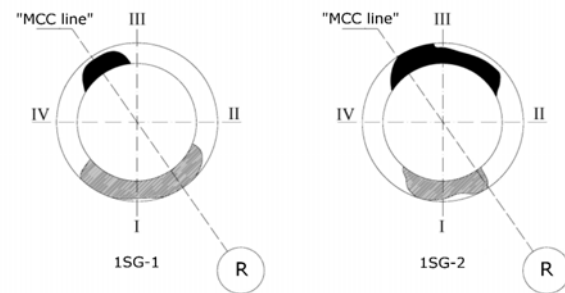
Fig.7. Zones of primary and repeated defects in SS#111 of the unit No. 1 of South Ukrainian NPP ([2]).
