# Investigation of increased corrosion wear of heat exchange equipment pipes

**Abstract.** The article discusses the stages of research to determine the possible causes of increased corrosion wear of tube bundles of heat exchangers. The most typical types of damage to heat exchanger pipes are shown, depending on the operating conditions. Recommendations aimed at reducing the corrosion wear of pipe bundles for typical operating conditions at oil refining enterprises.

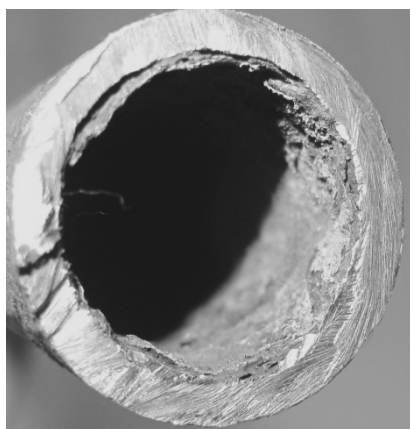
Figure 1 shows the nature of deposits and the type of corrosion damage on the inner surface of the pipe. The inner part of the pipe is covered with gray deposits, a dense layered structure, on the surface of which there is a thin precipitation of light-brown iron oxides, characteristic of such a compound as goethite  $\alpha$ -FeOOH. On the surface of the metal, there is a continuous nonuniform corrosion with signs of the origin of ulcers of a rounded shape, with a diameter of up to 3 mm and a depth of about 0.5 mm. There is an intense wear of the surface.

**Fig. 1.** The nature of deposits and the type of corrosion damage on the inner part of the pipe surface.

Chemical analysis of the deposits showed the content of soluble iron sulfates, which are usually formed as a result of chemical decomposition of water-insoluble iron sulfides under the action of moisture and air oxygen during equipment downtime. Thus, it follows that the cause of failure of the pipes of the tube bundle of the condenser-refrigerator is the tendency of working environments to cause ulcerative corrosion of carbon steel in the inter-tube space.

It should be noted that for the operating conditions of the refrigerator, it is recommended, according to RTM 26-02-42-78 "Methods of protection against corrosion and the choice of materials for the main elements and components of devices for catalytic reforming installations" [2], the following material design, provided

that such compounds as ammonia and hydrogen chloride are not present in the medium: a brass tube bundle.

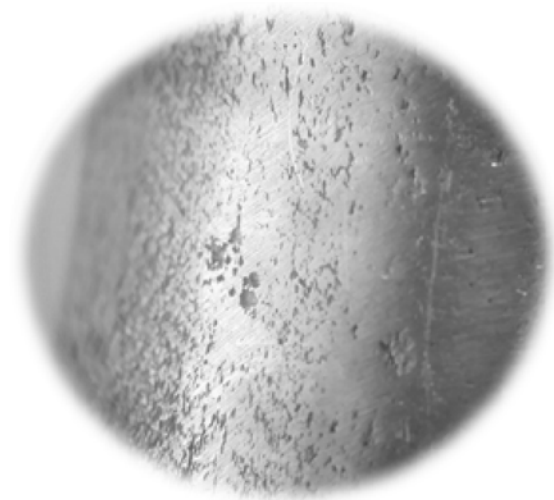
After cleaning the tube, it was found that the nature of the corrosion effect, both from recycled water and hydrocarbons, has an uneven character with elements of local corrosion damage in the form of pitting (figure 3), destroying the surface oxide film. The difference is in the amount of local damage on the tube surfaces. The density distribution of pitting on the inner surface of the tube is 2-3 pieces per 50 mm of tube length.

**Fig. 3.** General view of the tube surface after Stripping of deposits from the hydrocarbon side.

The occurrence of pitting is associated with a violation of the passive state on certain areas of the metal surface as a result of the action of chlorides. At these sites, accelerated destruction of oxide films occurs, which causes local sensitization. Violation of the passive state in certain areas leads to an increase in the rate of corrosion with the further development of pitting and in the case of external stresses can provoke the development of chloride corrosion cracking.

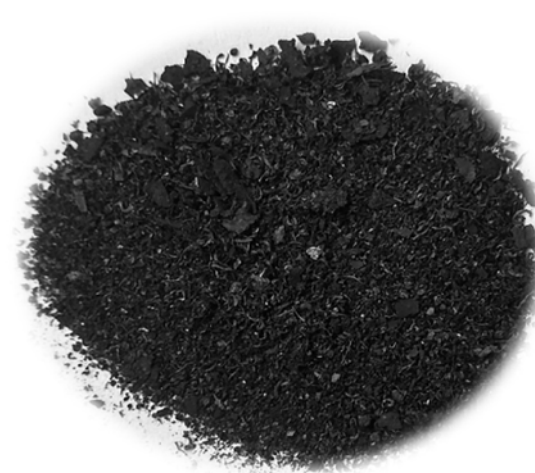
After cleaning, it was found that the nature of corrosion from the tar on the entire inner surface of the tubes is uneven with a tendency to form ulcers, with different shapes and penetration depth up to 0.2-0.3 mm. Figure 4 shows that the deposits are particles of various sizes of dark brown and black color, which is typical for a mixture of iron sulfides and oxides of the goethite - FeO(OH) type.

**Fig. 4.** The appearance of the sediments from the tar.

Based on morphological, x-ray fluorescence and chemical analysis of the composition of deposits on tar and desalinated oil, it was found that the main damaging factor is hydrogen sulfide corrosion, and for tubes from the contact with tar, it has the character of high-temperature (HTSC), which causes more significant corrosion damage compared to the impact on the metal from desalinated oil. HTSC iron proceeds by the reaction  $Fe+H_2S=FeS+H_2$ . In this case, the protective properties of the metal will have the resulting sulfide film. But at temperatures from 260 to 650°C, FeS films gradually turn into porous layers that do not represent a barrier to hydrogen sulfide. As a result, the controlling role of the diffusion of iron ions through the sulfide layer finally disappears, and the corrosion kinetics begins to be determined by the rate of reaction of iron with hydrogen sulfide with the formation of ulcerative lesions characteristic of the studied metal cuts. The difference in the nature of ulcerative lesions on the inner and outer surfaces of the tubes is due to different temperatures in the tube and inter-tube space of the heat exchanger. The higher the temperature, the greater the corrosion wear of the surface, which is characteristic of the studied tubes. The service life of the device from the moment of its commissioning is 22 years. There is no data on replacing the tube bundle in the passports. The long service life of the device, combined with minor corrosion damage, indicates a fairly high corrosion resistance of carbon steel tubes in the operating conditions of the heat exchanger.

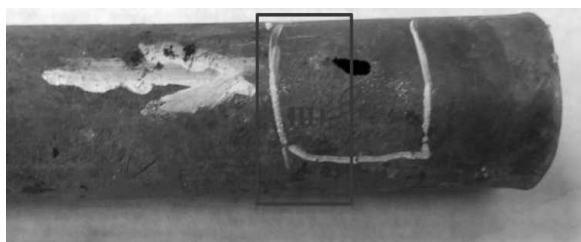
Visual inspection revealed single through holes on the tube fragments (figure 5). The defects have an oval shape, and are elongated along the generative.

**Fig. 5.** The nature of the corrosion damage to the tube.

The cause of through damage to the tubes of the heat exchanger in the adjacent zone to the pipe grid is the formation of specific deposits from the desalinated oil, under which ulcerative corrosion develops. This condition of the surface causes the formation of differential aeration pairs, which stimulates increased corrosion in certain places, in our case under porous deposits near the grid. In areas far from the pipe grid, the corrosion is uniform and tube wear is not significant.

The type of tube surface corrosion from desalinated oil is hydrogen sulfide. In this case, a significant amount of iron sulfides with pyrophoric properties is formed. From the diesel fuel side, the corrosion of the tubes is uniform with signs of local pitting that breaks through the protective oxide film. Recommended technology departments to assess the possibility of entering the plant oil with high content of organochlorine compounds and possibly other substances, which caused the accumulation in the sediments of substances with a pungent odor. Perhaps the sharp smell is associated with the use of new chemical agents in oil fields or oil treatment plants with unexplored behavior in the area of elevated temperatures, which identification is possible at the stage of analysis of the raw material - crude oil.

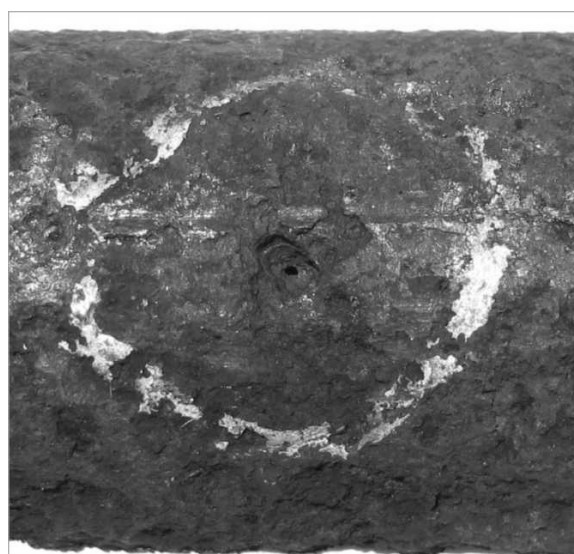
7) The object of research was the metal tube of the heat exchanger. During hydraulic tests, a missing heat exchange tube was detected, and further inspection revealed ulcerative corrosion (figure 6). Working environment of the pipe space - oil, operating temperature - 160°C, material version - steel 15Cr5Mo; inter-pipe space - diesel fuel, operating temperature - 200°C, material version - steel 15Cr5Mo.

**Fig. 6.** The nature of the corrosion damage to the tube.

Corrosion damage to the tubes from diesel fuel is specificity, not previously observed in such working environments of CDU installations. Ulcerative corrosion on the surface of the fragments of the tube is probably associated with the presence of chloride compounds in the working environment, which are both products of hydrolysis of calcium and magnesium salts that remain in the oil during the established and stable operation of the CDU unit in small quantities, and organochlorine thermostable compounds. This is evidenced by the nature of the detected defects - the presence of a dense layer of deposits, ulcerative through-corrosion, the development of local corrosion damage not under the layer of deposits.

It is recommended that the plant's technological services analyze the possibility of receiving oil with an increased content of organochlorine compounds that contribute to the formation of hydrogen chloride, with further development of recommendations for reducing this corrosive component in the medium (multiple dilution with raw materials with a low content of organochlorine compounds).
