Research on Metal Supervision and Inspection Standards for Gas-steam Combined Cycle Units

SHI Yan*, XIANG Wenguo, CHEN Shiyi

Southeast University, Nanjing 210096, China

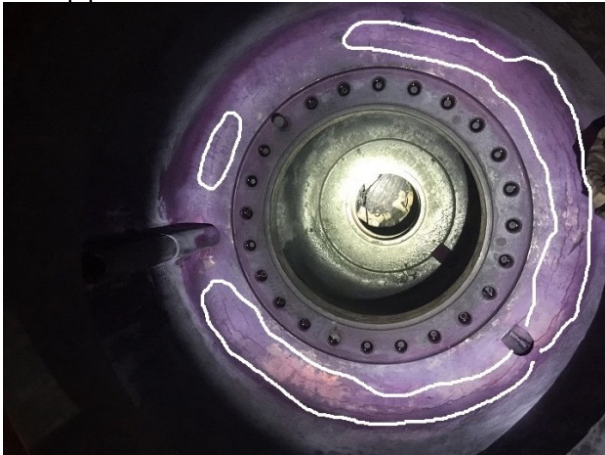
penetration test of the bottom joint surface of the high-pressure main steam combined valve casing. The oxide scale around the crack was polished and then colored and penetrated again. It was clearly found that the crack surrounded the valve casing and the length reached about 4/5 of the inner circumference of the valve casing. Further inspection showed that the crack starting point was located in the trap hole, as shown in Figure 4. Subsequently, the endoscope was used to detect the cracks inside the hydrophobic hole, and it was found that the cracks extended 4mm along the hydrophobic hole.

The analysis shows that the drain flows backward into the valve from the trap of the valve seat and is deposited on the side of the trap. Generally, when the unit starts, steam flows through the valve seat, and the valve seat expands with heat. However, due to water accumulation in the trap side of the valve seat, the temperature rise on the trap side of the valve seat is obviously slower and the expansion is smaller than that on the sealing surface, resulting the tensile stress on the sealing surface. Conversely, when the unit is shut down, the sealing surface side shrinks relatively faster than the drainage hole side. Hence, the sealing surface side is subjected to additional compressive stress, and such alternate stress changes eventually lead to the cracking of the sealing surface. In all, the reasonable drainage pipe layout of the valve seat and timely drainage is of great significance for the long-time range stable operation. or combined cycle [8-9].

Fig3. Cracks at the bottom of the valve casing.

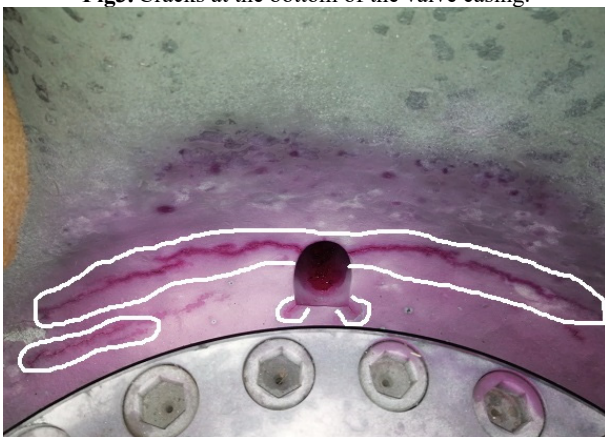
Fig4. Cracks on the hydrophobic port location.

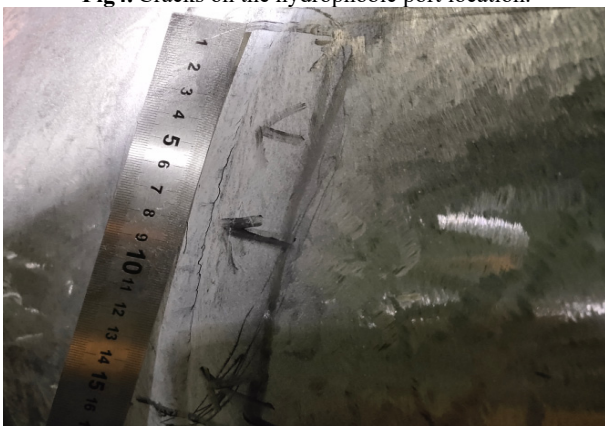
A 9F gas-steam combined cycle generator set was put into production in 2013. It adopts a single-shaft combined cycle type and consists of a PG9351FA gas turbine, a dual-cylinder dual-flow steam turbine with a D10 three-pressure reheat system, a 390H hydrogen-cooled generator, and a three-pressure reheating system. During the maintenance period in April 2019, the metal supervisory inspection of the butt joint girth weld was carried out, and it was found that there was a pipe weld fusion line. The crack defect is about 150 mm long and the depth is about 10 mm. Typical defects are shown in Figure 5.

According to the survey data, the unit has been in operation for about 10,500 hours, and started and stopped 675 times, which frequently participates in peak-shaving variable load operation. In addition, the desuperheater often sprays water to adjust the high-pressure steam parameters. Frequent and drastic changes in temperature have brought great challenges to the service materials of the unit, causing multiple high-parameter steam leaks in the pipes, which has brought great harm to the safe and stable operation of the unit.

Fig5. Cracks on weld fusion line of the high voltage bypass desuperheater pipe.

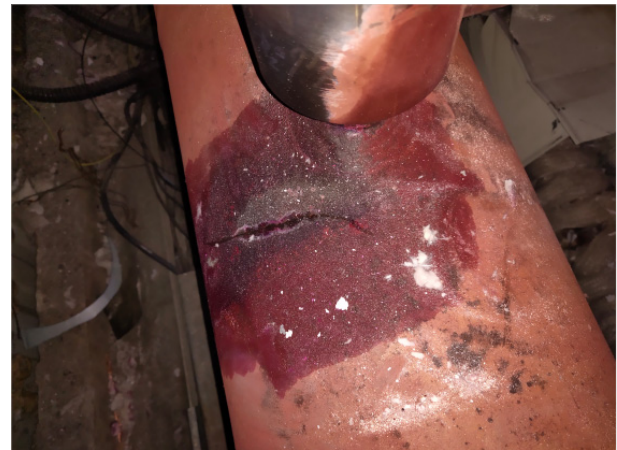
Figure 6 shows a SGT5-2000E cogeneration unit of a Siemens company. During operation, it was discovered that there was steam leakage in the pipe of the high-pressure heat supply desuperheating and pressure reducer. The pipe material was 12Cr1MoVG and the specification was $\Phi 273 \times 14$ mm. According to the shutdown inspection, circumferential cracks and through cracks were found in

Fig6. Circumferential cracking of the base material of heating and desuperheating pressure reducer pipe.

the pipe base material, and these cracks were located at the rear end of the nozzle head in the desuperheating water 150 mm. It can be seen that, in view of the characteristics that gas units frequently start and stop to participate in peak adjustment operation, the metal inspection cycle of complex stressed parts of high-parameter pipelines, such as elbow weld, tee, temperature reducer, pipe base fillet weld and other key positions, should be shortened and special inspection of high-temperature and high-pressure steam pipelines should be carried out.
