# Analysis of Leakage Cause of L415M Spiral Submerged Arc Welding Pipe

**Abstract.** The causes of longitudinal crack in gas pipeline during pressure were analyzed by means of mechanical property test, microstructure analysis, sem analysis and energy spectrum analysis. The results show that the leakage of L415M spiral submerged arc welded pipe is caused by the contact between the base material of steel pipe and low-melting copper alloy in the process of high temperature, resulting in the brittleness of liquid metal. Specifically, when the leakage site of the steel pipe is heated at an abnormal high temperature, copper penetration along the grain boundary causes embrittlement, strength reduction and crack along the grain boundary, finally leading to the crack and leak of the steel pipe.

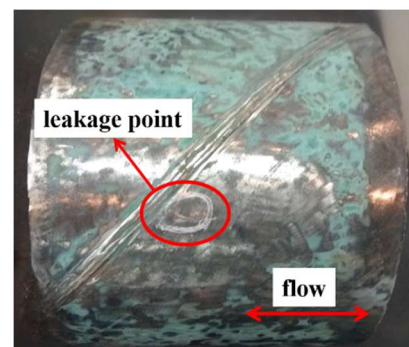
(a) Morphology of steel tube outer wall

The sample is the pipe section at the leakage site cut by a flame, and the leakage point is about one meter from the nearest pipe end. The morphology of the steel pipe after stripping the external coating is shown in Fig. 1. There are obvious cracks in the inner and outer walls of the steel pipe at the leakage point, and the cracks are distributed

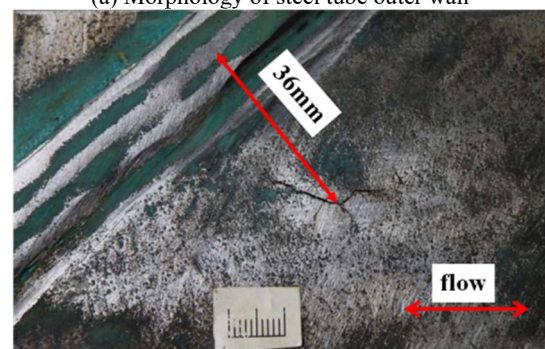
(b) Morphology of steel tube outer wall leakage point

along the longitudinal direction of the pipe body. The crack center is 36 mm away from the center of the spiral weld, as shown in Fig. 1(b).

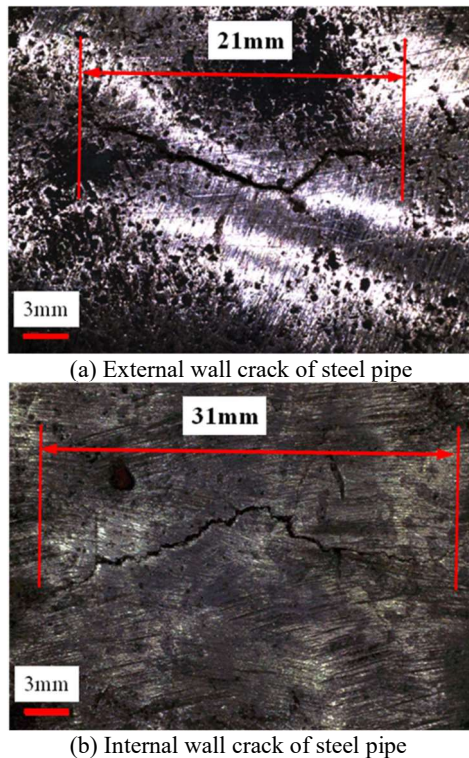
**Fig 2.** Macromorphology of cracks

The Smartzoom5 super-depth digital microscope was used to observe the cracks at the leakage, and the results are shown in Fig 2. The length of the outer wall crack is 21 mm, and the length of the inner wall crack is 31 mm. Fig. 2 (b) shows that there is a pit in the inner wall of the

steel pipe, 6 mm from the crack, and the maximum diameter is 2.4 mm. The wall thickness of the steel pipe near the crack was measured by ultrasonic thickness gauge. The wall thickness of the pipe at the pit was 5.9 mm, and that at other locations was about 7.1 mm.

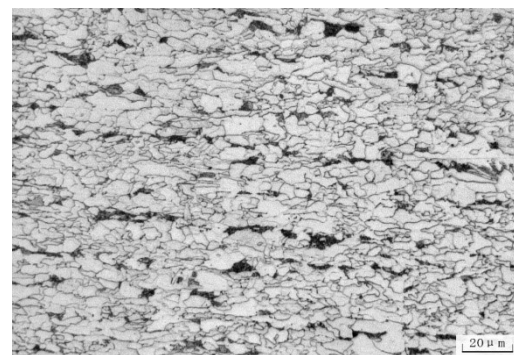
**Fig 3.** Tube structure away from leakage point

The microstructure of the tube far from the defect position is shown in Fig. 3, which is ferrite and a small amount of pearlite. The grain size is 11.0, and there is no obvious abnormality.

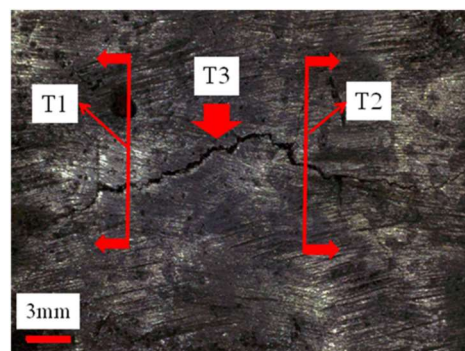
**Fig 4.** Sampling position of steel pipe leakage point

In order to understand the causes of cracks at the leakage of steel pipe, the T1 and T2 sections are intercepted along the direction perpendicular to the crack, as shown in Fig. 4. The full-thickness metallographic specimens are processed and observed by Smartzoom5 ultra-depth digital microscope and OLS 4100 laser confocal microscope.

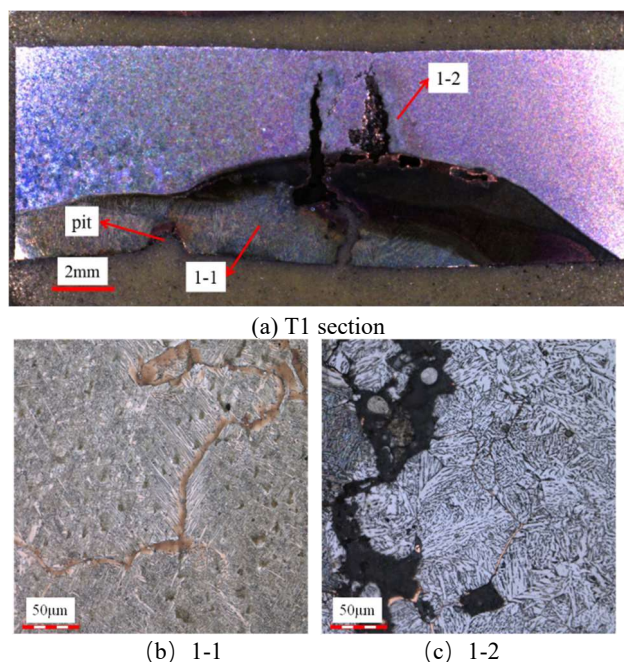
**Fig 5.** T1 section metallographic examination results

Fig 5 (a) is a photograph of the T1 section. The pit in the lower left corner corresponds to the inner wall pit found by the macroscopic inspection. The depth of the pit is about 1.2 mm, and the color of the pit and its adjacent cross section is abnormal, and the local color is purple yellow. The abnormal area is semi-elliptical, and the deepest part is close to the central position of the steel tube

wall thickness. There are holes at the interface between the color abnormal area and the tube matrix. The crack originates from the color abnormal area and extends to the outer wall. The microstructure at 1-1 is shown in Fig. 5 (b). The grains are abnormally coarse, and the color is different from the normal microstructure of the steel pipe, especially at the grain boundary. Fig. 5 (c) is 1-2 metallographic photographs. The grains near the main crack are coarse, the fine cracks propagate along the grain boundaries, and some purple inclusions exist in the grain boundaries.

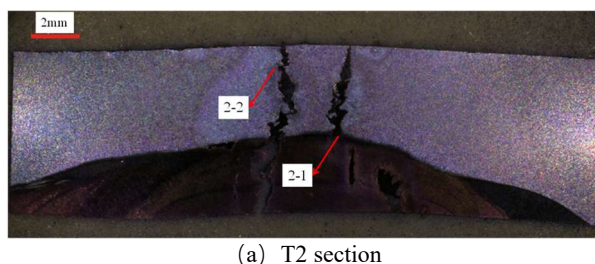
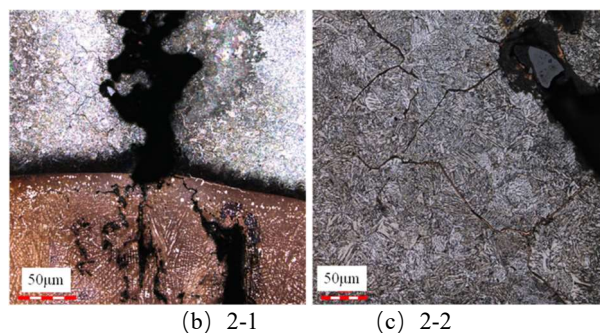
**Fig 6.** T2 section metallographic examination results

Fig. 6 (a) shows the photograph of T2 section, and there is still an abnormal area in the cross section of steel pipe. Fig 6 (b) is 2-1 metallographic photographs of the tube, which is located at the interface between the abnormal area and the normal tissue of the tube. The interface gap is obvious, and there are holes near the inner wall. The microstructure near the crack of the tube near the outer wall is overburned. Fig. 6 (c) in 2-2 metallographic photos, visible part of the grain boundary cracking, there are purple foreign bodies between grain boundaries, microstructure is overheating.

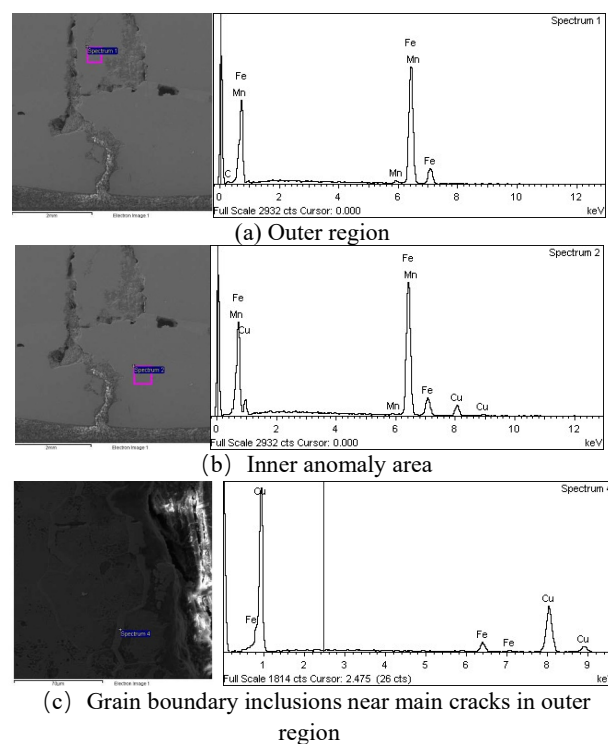
**Fig 7.** T1 section morphology and energy spectrum analysis

The INCA 350 spectrometer was used to analyze the energy spectrum at different positions of the T1 section. The results are shown in Fig. 7. The main elements in the outer region are Fe, C and Mn, while the main elements in the inner color anomaly region are Fe, Cu and Mn. Among them, the copper element is abnormally high.

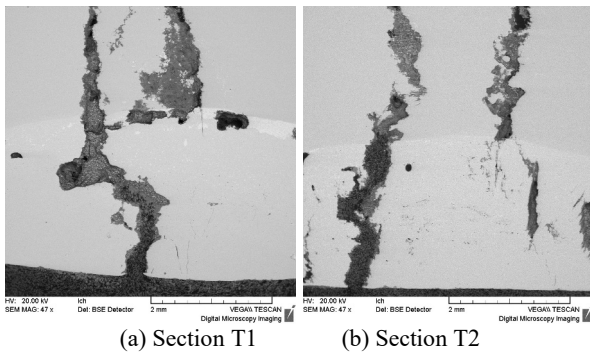
**Fig 8.** Backscattered electron imaging morphology

In order to better understand the distribution of Cu element, the T1 section and T2 section were analyzed by backscattered electron imaging. The results are shown in Fig 8. The contrast of backscattered electron imaging is caused by the difference in atomic number, so the distribution area of Cu element can be clearly distinguished. The area is consistent with the cross-sectional abnormal area found in metallographic observation, and it is semi-elliptical. In backscattered electron imaging, the contrast between the inner abnormal area and the outer tube interface area is higher, reflecting the higher content of Cu element.

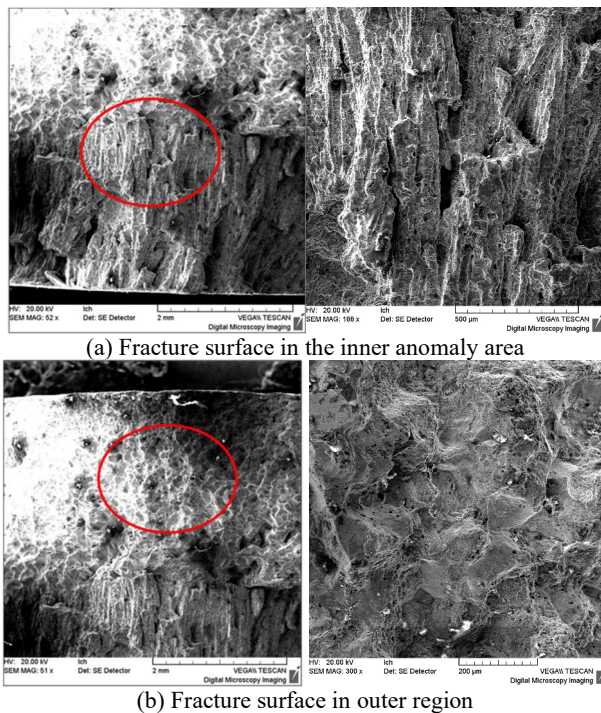
**Fig 9.** T3 Fracture Surface Morphology

The cracks between T1 and T2 sections in Fig 7 were broken off, and the morphology of T3 fracture surface was observed, as shown in Fig 9. The fracture surface is obviously oxidized at high temperature. Fig 9 (a) is the fracture surface morphology of the inner layer, and Fig 9 (b) is the fracture surface morphology of the outer layer.

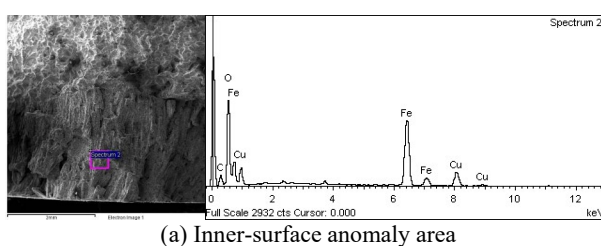
**(a)** Inner-surface anomaly area

The energy spectrum analysis of the inner and outer layers of the T3 fracture surface is carried out. The results are shown in Fig. 10. There are Cu elements in the abnormal area of the inner layer and the outer layer of the fracture surface, indicating that Cu elements are enriched in the crack area.
