# Study on the damage analysis of 110kV cable structure

Dongguan Power Supply Bureau of Guangdong Power Grid co, LTD , 523000 Dongguan, China

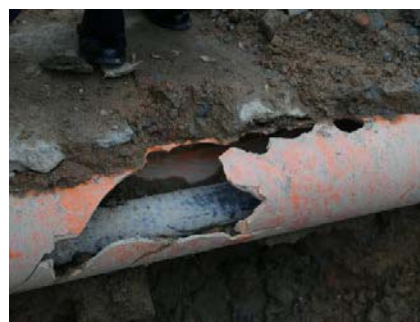
During daily inspection, the cable team found that the buried pipe section of 110kV cable line was damaged by construction machinery, and the buried pipe section of the cable line was damaged by external force. It is found that a damaged cable buried pipe, about 1.1m long and about a third of the circumference wide, had a depression on the surface of the cable sheath due to external extrusion impact. The sheath depression is 0.8mm after measurement. As shown in Figure 1 and Figure 2.

**Fig. 1.** buried tube after mechanical damage.

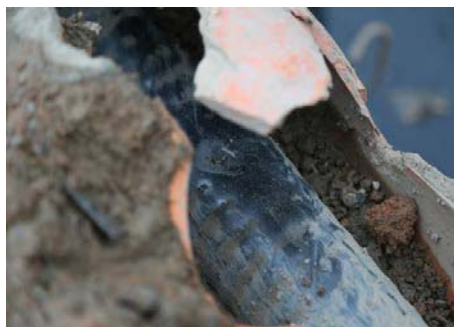
**Fig. 2.** Outer sheath depression

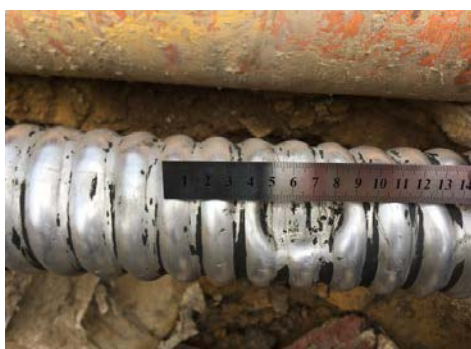
According to the “grading standard of transmission equipment defects”, the damage to the insulation shielding layer is classified as "major". As shown in Figure 3 and Figure 4, the aluminium sheath and insulation shield of 110kV cable line are damaged. The impact dent damage occurs at the body of the cable, and the metal sheath and internal insulation shield are damaged by the impact. The stress concentration generated by the depression reduces the fatigue life of the cable structure, and the existence of the depression also reduces the yield strength of the cable structure [7-13]. In summary, the static strength and fatigue life of the existing cable structure in the sag area have a significant impact on the power supply reliability of the cable. According to the standard, the defect and the insulation shield layer are rated as "significant" and should be locally strengthened for maintenance and replacement.

**Fig. 3.** Damaged aluminum sheath

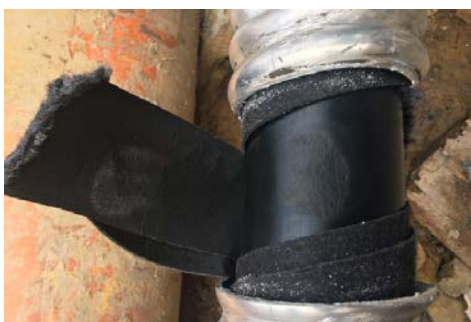
**Fig. 4.** Damaged insulation shield

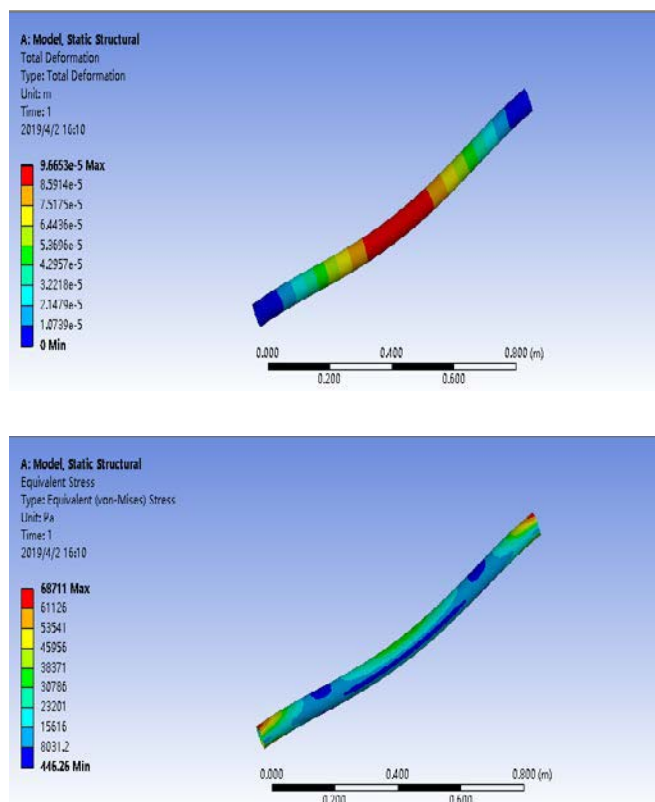
As the buried pipe section of the cable was damaged by water supply emergency repair construction machinery, the inspection found that a damaged cable buried pipe, about 1.1m long and about one third of the circumference, had a depression on the surface of the cable outer sheath. It can be inferred that the cable section is subject to external impact. This simulation simulates the steel ball with  $M = 4\text{kg}$ , releases the steel ball at the height of 0.5m, 1m, 1.5m, 2m, 2.5m and 3m, and observes the sag and stress of the cable under the impact of the steel ball. As shown in Figure 5, the sag and stress distribution of the cable under the height of 2m are shown.

**Fig. 5.** Cable depression and stress distribution at a height of 2m

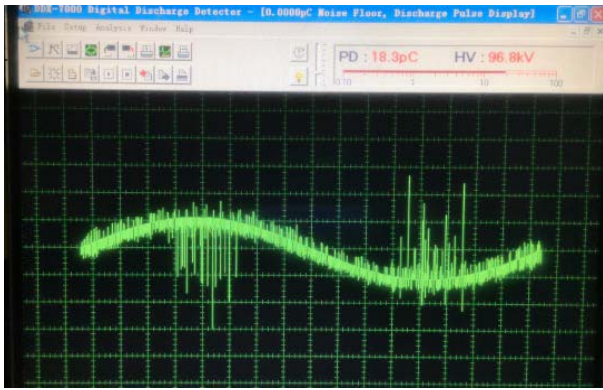
This test instrument adopts series resonance withstand voltage test system, model: MSR700-21000, DDX digital partial discharge detector, model: DDX-7000, to test 110kV cable line damaged by external force. Partial discharge is used to indicate the severity of partial discharge of high-voltage cable. To test the partial discharge of high-voltage cable, the test system must be calibrated first. After testing, the amplitude of partial discharge signal is compared with the calibration information, and the value of partial discharge is calculated to judge the damage degree of partial discharge. Among them, the background signal of not closing the cable is 1.6pC, and the background signal of closing with cable is 2pC. When the voltage is raised to 70kv, the partial discharge signal is 5pC, and when the voltage is increased to 96kV, the partial discharge signal is 18pC, as shown in Figure 6.

**Fig. 6.** 96kV partial discharge diagram

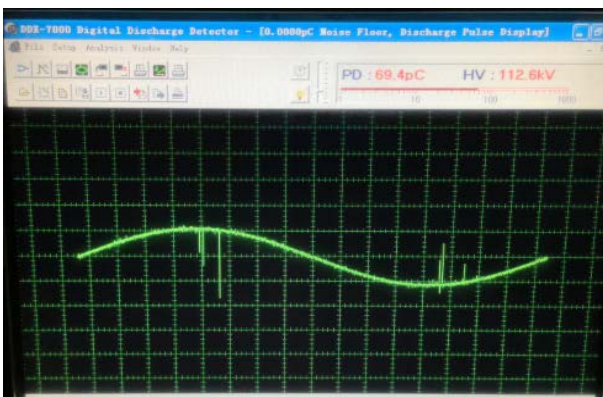
When the voltage is increased to 112 kV, the partial discharge signal is 50-70 pC. as shown in Figure 7, the partial discharge signal is 69.4 pC when the voltage is increased to 112.6 kV.

**Fig. 7.** 112kV partial discharge diagram

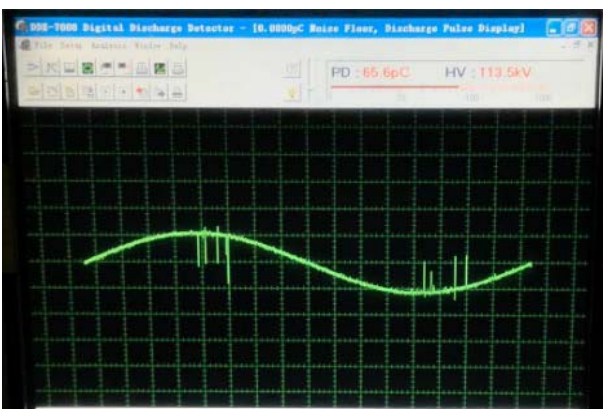
As shown in Figure 8, when the voltage is increased to 113.5kv, the partial discharge signal is 65.6pC.

**Fig. 8.** 112kV partial discharge diagram

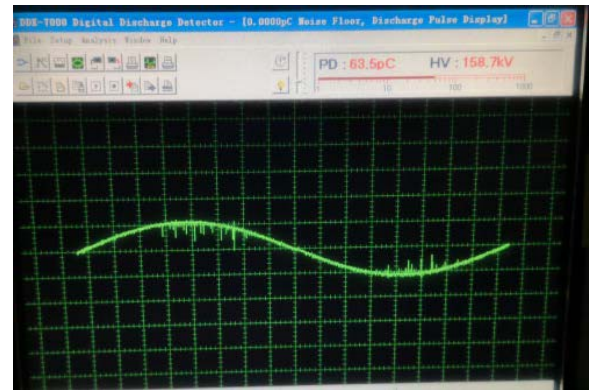
When the voltage is increased to 160kV, the partial discharge signal is between 53-70pC. As shown in Figure 9, when the voltage is increased to 158.7kV, the partial discharge signal is 63.5pC.

**Fig. 9.** 160kV partial discharge diagram

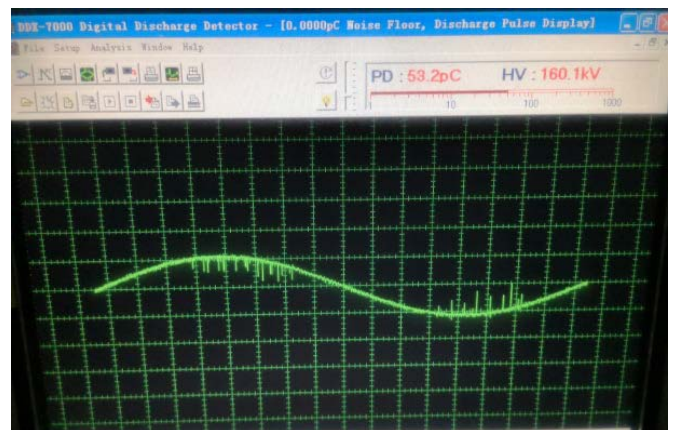
As shown in Figure 10, partial discharge signal of 53.2pC appears when the voltage is raised to 160.1kv.

**Fig. 10.** 160kV partial discharge diagram

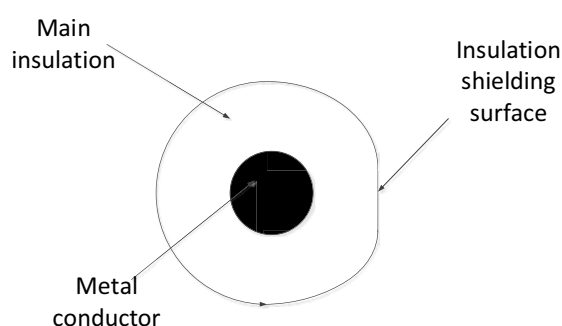
According to the laboratory measurement, the structural dimensions of the cable insulation core depression are as follows: the normal outer diameter of the insulated core is 65.2mm, the minimum outer diameter of the depression is 64.3mm, and the hollow area of the insulated core is  $39 \times 27$ mm (length  $\times$  width). The average insulation thickness of cable is 17.8 mm, and the minimum insulation thickness at depression is 17.0 mm. It can be seen that the damage of insulation shield of 110kV cable is more than 0.8mm.

**Fig. 11.** Schematic diagram of the fault cable
