# Pitting corrosion of galvanized pipes in hot water supply systems

Alexey Andrianov\*

**Abstract.** The mechanism of pitting corrosion of galvanized pipes in hot water supply systems is considered. The analysis of the literature to determine the conditions and mechanism that cause abnormally rapid corrosion of steel galvanized water pipes in water supply systems is carried out. The results of a laboratory study of the initial stage of corrosion of galvanized pipes are presented. The results of a survey of hot water supply systems of a number of residential buildings are presented. Recommendations and measures to reduce the impact of corrosion in hot water supply systems are presented.

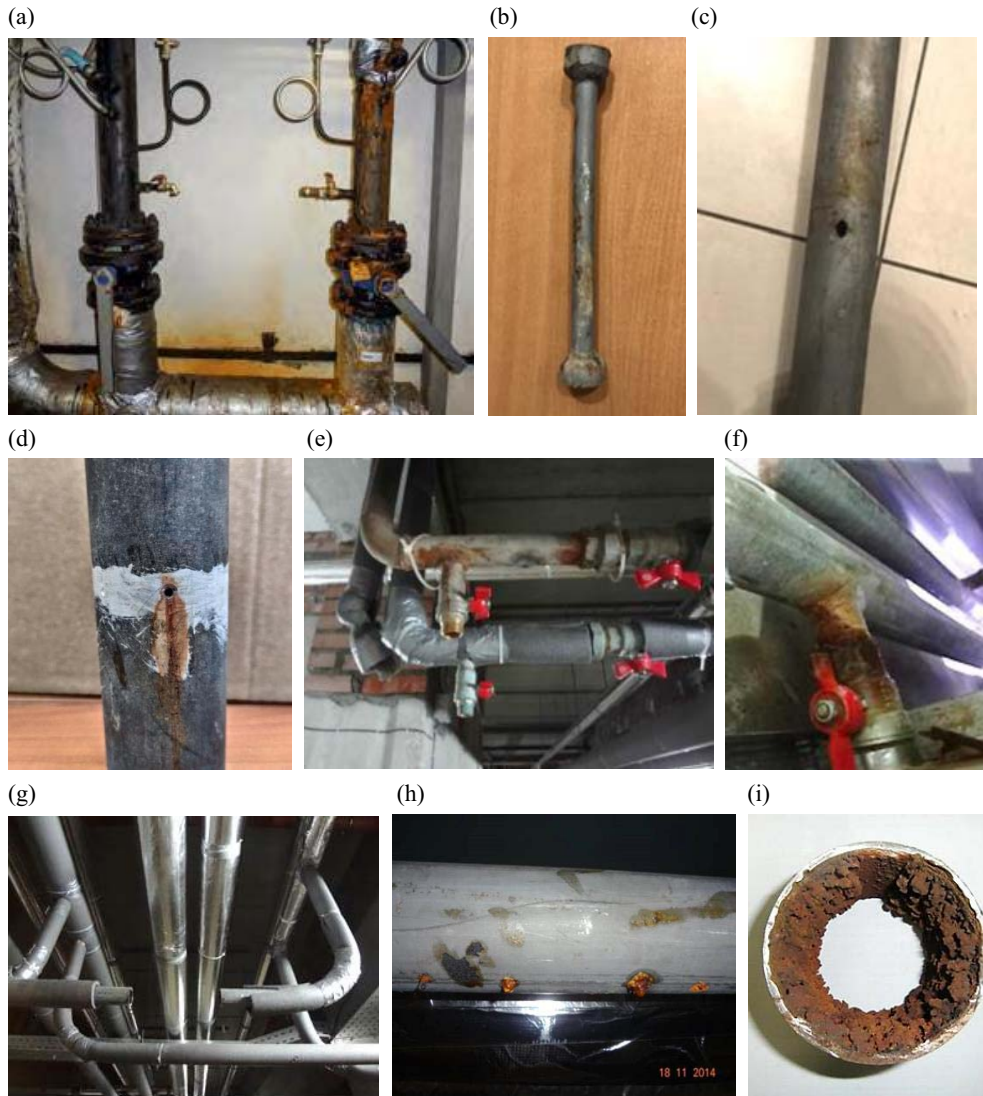
Figure 1 shows examples of pitting corrosion of new galvanized pipes, the service life of which does not exceed 3-4 years. These photographs were obtained by the authors in 2014-2020 during the surveys of water supply systems in various buildings. The surveys were carried out in five large residential multi-apartment buildings with one and two-zone water supply systems. Residential buildings are located in Moscow, the Moscow region and Ryazan. The main reason for the survey is the appearance of rusty water in consumers' taps and / or an abnormally high corrosion rate of hot water pipes. Below in this work, we will not consider the cases of corrosion caused by current leakage.

**Fig. 1.** Examples of pitting corrosion of galvanized pipes in hot water supply systems: (a) pipe section in the piping of hot water supply pumps; (b), (c) a jumper at a heated towel rail on a standpipe, transition from a diameter of DN 32 to DN 15; (d) section of the standpipe DN 32; (e) standpipe base with a drain valve; (f) section of the main pipeline with a branch to the standpipe; (g) pipes of the hot water supply system with cut out sections with through-wall pinholes; (h) pinholes along the welded seam of the horizontal main pipeline DN 100; (i) distribution of corrosion deposit along the pipe perimeter DN 100

The main places where pitting corrosion are most often observed are: long-distance main pipelines (Figures 1f and 1h); pipe sections adjacent to shut-off valves (Figures 1e and 1f); standpipes at the points of connection of heated towel rails (Figures 1b and 1c). Quite often, pitting corrosion manifests itself on the branches to the risers when the water supply pipes bypass other pipelines, which leads to the appearance of U and U-shaped sections or T-shaped vertical connections to horizontal pipelines (Figure 1g). For large diameter pipes the characteristic locations of the pinholes are the weld seams located in the lower part of the horizontal pipes (Figure 1h).

The use of welding when installing a jumper for a heated towel rail is also a common cause of pitting corrosion (Figures 1b and 1c). In this case, the total number of joints on the riser is four for only one heated towel rail.

The appearance of pinholes in the pipes shown in Figure 1 caused by a hydraulic failure. In one case, this was due to a partially open ball valve (Figure 1a), and in the other, due to the transition from a larger pipe diameter to a smaller one (Figures 1b and 1c). Partially closed valves or a sharp change in diameter cause the appearance of vortex flows inside the pipe, which lead to uneven aeration of the inner surface of the pipe and the appearance of pinholes. The high speed of water flow, on the one hand, promotes the passivation of the metal surface, and on the other hand, increases the rate of diffusion of metal ions from corrosion spots. Destruction occurs locally, in places where the protective film is damaged or has insufficient thickness, or there are inclusions in the zinc coating that is serve as cathodes. The turbulent regime of water flow can also lead to the destruction of tubercles, as shown in Figure 6 and form nascent pits.

Corrosion in horizontally located pipes, laid practically without a slope due to their long length (Figures 1f and 1h), can be explained by the low water velocity during periods of reduced water consumption. The low capacity of the circulation pump contributes to this process. On the inner surface of the pipe, in its upper and lower parts, there is a difference in oxygen concentrations. In this case, the upper surface (Figure 1i), in contact with oxygen in the air phase, becomes the cathode, and the lower, in contact with oxygen dissolved in water, becomes the anode. The presence of a welded seam in the lower part of the pipe accelerates the development of pitting corrosion (Figure 1h).

Figure 1g shows a photo taken in one of the surveyed houses, where the direction of water movement in some areas occurs along a U-or U-shaped trajectory in the vertical plane. With a T-shaped connection of pipes and with the movement of water from top to bottom, the air moves in a countercurrent and at a low speed of water flow, it collects along the top of the horizontal pipe, causing intense corrosion in the pipe sections which are contact with water with a lower oxygen content. In the presence of risers located far from circulation pump, hot water can enter them at a lower temperature, which in some cases leads to overturning of the circulation, i.e. to the appearance in the risers of counter flows simultaneously from the mains T3 and T4 (when hot water is supplied from above) [14]. In this case, pinholes may appear directly on the risers (Figure 1d).

- if there are no slopes, additional automatic air vents should be installed at the highest points on the main pipelines;
- replace (and not weld) pipe sections when pinholes appear;
- increase the water consumption in the circulation mode, if necessary by replacing the circulation pump with a more powerful one;
- when rusty water appears, it is necessary to regularly flush the main pipelines with an increased flow rate in accordance with [15].

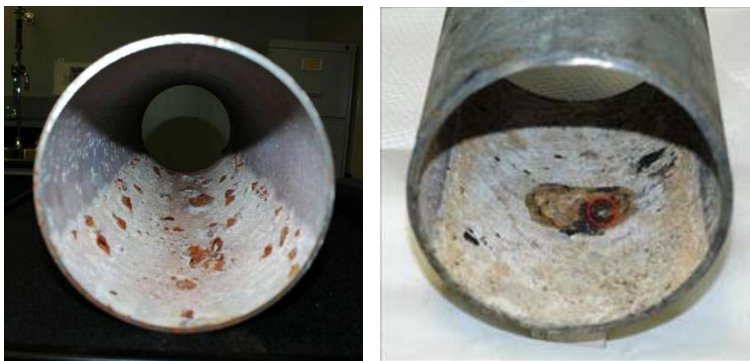
**Fig. 2.** Photograph showing tubercles and pinhole (circled) leakage of galvanized steel sprinkler pipe in dry pipe systems [8].

The role of oxygen in the appearance of pitting corrosion is especially noticeable in pipes partially filled with water. The photographs in Figure 2 obtained during the survey of fire-fighting water supply systems [8]. The illustration shows the corrosion of a galvanized steel sprinkler pipe (DN 150) in dry pipe system where residual water fills about 40% of the pipe volume.

According to the authors of [8], residual water in dry pipes is the main reason of corrosion and leakage of galvanized steel pipes in these systems. The presence of an air gap above the residual water leads to a high content of dissolved oxygen and carbon dioxide in the water and makes it corrosive towards the galvanized steel pipe.

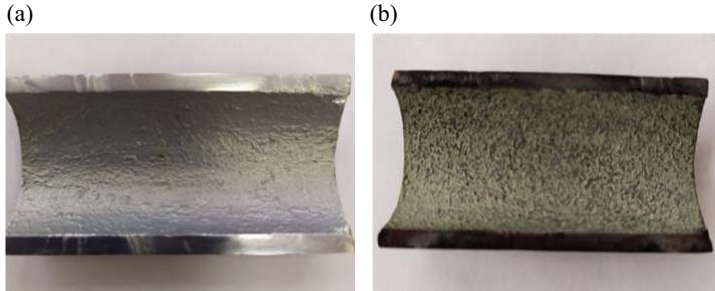
Figure 4a shows a photograph of the surface of a sample of a new galvanized pipe, and Figure 4b shows a sample that was in an open container for 25 hours, into which a thin stream of hot water came from a water supply.

**Fig. 4.** The surface of galvanized pipe sample: (a) new pipe; (b) after 25 hours in hot water

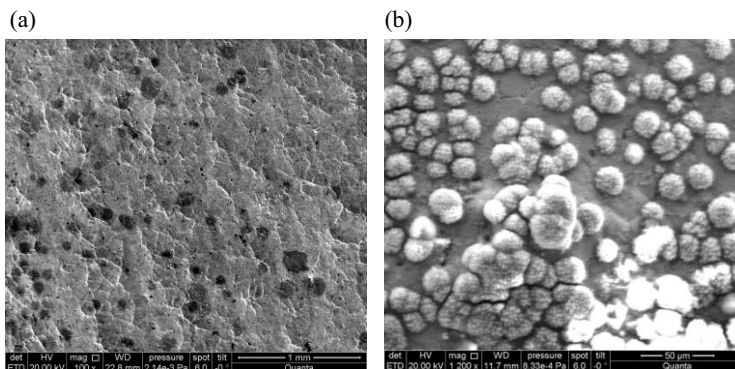
**Fig. 5.** SEM photos of the inner surface of a galvanized pipe sample: (a) new pipe; (b) after 25 hours in hot water

Figure 5 shows micrographs of the surface of a new galvanized pipe (a) and the same pipe after being in hot water for 25 hours (b). From the Figure 5b it can be concluded that the sediment is formed in the form of tubercles and has a crystalline, dendritic structure. In this case, corrosion occurs with oxygen depolarization.

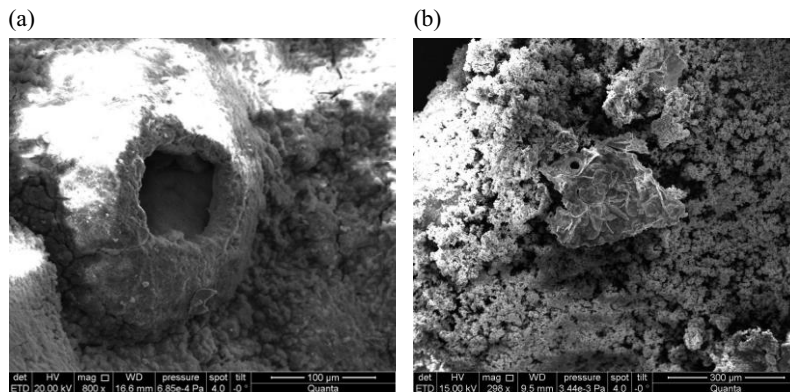
**Fig. 6.** SEM photos of tubercles on the surface of galvanized pipe (DN 15): (a) the base of the tubercle, (b) the reverse side of tubercle apex with a hole.

The further development of corrosion of galvanized pipes can be illustrated by the example of the following photos. Figure 6 shows micrographs of the sediment formed on the surface of a sample of a galvanized pipe DN 15 after 70 days of being in the hot water supply system with a continuous flow of hot water at a low flow rate of 30 l/h, a temperature of  $50 \pm 2$  °C and a flow velocity of 6 cm/s.

Figure 6a shows that the morphology of the sediment changes over time, the entire surface of the sample is covered with tubercles, and some of them have holes in the upper part. Figure 6b shows the upper part of the tubercle carried away by the water flow. Apparently, after the tubercle has formed, corrosion with hydrogen depolarization continues inside the tubercle, and the tubercle collapses due to an increase in the hydrogen pressure. The source of hydrogen ions is bicarbonate ions, which determine the alkalinity of water. Table 2 shows the data on the chemical composition of the sediment forming the upper part of the tubercle, shown in Figure 6b.
