# Axial Vibration Analysis of Thrust Support of Vertical Hydrogenerator Unit

**Abstract**. Axial vibration is the main accident that affects the normal function of the vertical hydro-generator unit and endangers the use of the unit. There are many reasons for the axial vibration of the unit. This article only analyzes the mechanism of the axial vibration of the thrust bracket of the vertical unit caused by the connection of the thrust head and the mirror plate, and gives a real machine measurement example and treatment measures.

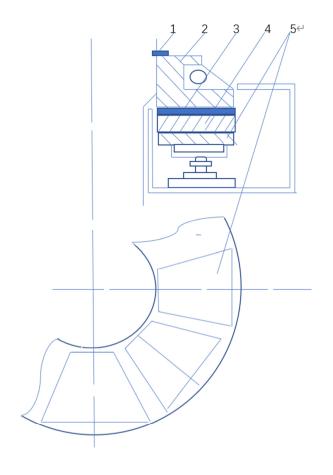
1-Snap ring 2-Thrust head 3-Insuiation pad↔ 4-Mirror plate 5-Thrust pad↔ Figure 1 Schematic diagram of thrust head structure↔

The weight and water thrust of the rotating part of the hydro-generator set act on the thrust bearing through the mirror plate connected by the thrust head. The thrust bearing is composed of several sector-shaped tiles with a certain gap between the tiles (Figure 1). Due to the unevenness of the insulating backing plate and the unevenness of the joint surface between the thrust head and the mirror plate, there is a gap between the thrust head and the mirror plate. When the gap is transferred to the thrust pad, the gap becomes smaller due to extrusion, the thrust pad is unloaded. When it turns to the thrust pad gap, it becomes larger due to slack, and the thrust pad is loaded at this time. This kind of loading and unloading alternately becomes an alternating force, and this alternating force causes the unit to produceaxial vibration. When the unevenness of the insulating backing plate is two steps, it will form an axial vibration with a frequency of twice the speed.

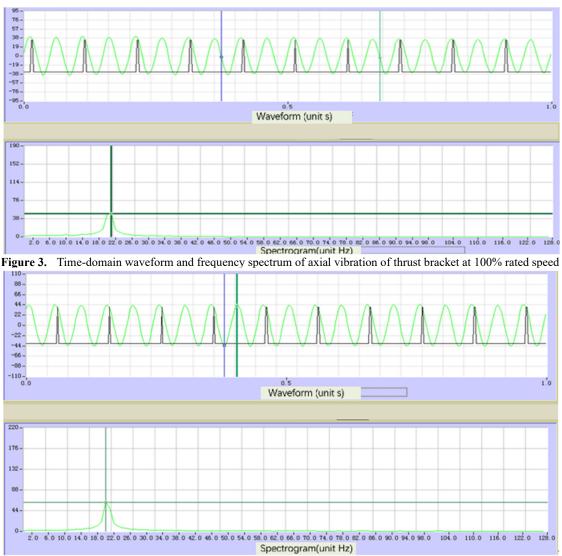
Figure 3 and Figure 4 show that the axial vibration frequency of the thrust bracket is 2 times the frequency of the unit in the idling and no-load conditions.

Experimental data and by waveform analysis, and exclude the pressure fluctuation generator axis adjusting unit caused by poor axial vibration. The main factor that causes the thrust bracket to vibrate at 2 times the rotational speed is caused by the level of the mirror plate or the defect of the insulating backing plate.

The unit was in a random parking position, and the No. 4 and No. 8 thrust bearings were found to be loose after inspection. After tightening the loose thrust bearing, rotate the rotating part of the unit 90 degrees and then check the thrust bearing. The results show that No. 2, No. 3, No. 6, and No. 7 thrust bearings are loose.

Figure 4. Time-domain waveform and frequency spectrum of axial vibration of thrust support under no-load conditions became thinner, forming a shape with high sides on both sides and low in the middle, resulting in uneven joints between the mirror plate and the thrust head.

- (1) Replace with a new insulating backing plate.
- (2) The friction surface of the mirror plate is processed smoothly, and the wave of the mirror plate is completely eliminated.
- (3) Finely adjust the axis of the unit to reduce the swing value of the shaft at the upper guide bearing.

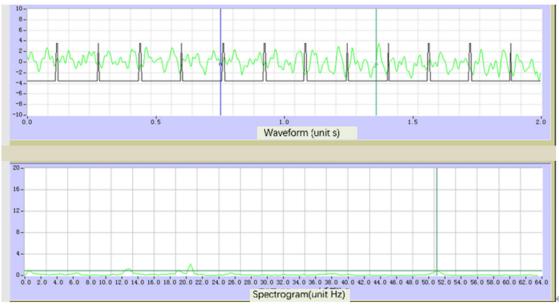
Figure 5. Time-domain waveform and frequency spectrum of axial vibration of thrust support under no-load conditions mechanical and electrical

The axial vibration of the unit during operation is reduced (Table 3), and the vibration frequency is a composite frequency of 1 rpm, 2 rpm and 8 rpm (Figure 5), and the treatment effect has reached the expected purpose.
