Surveillance of the banks of reservoirs on the Drava River in Slovenia after extensive floods

Pavel Žvanut*¹

¹Slovenian National Building and Civil Engineering Institute, Ljubljana, Slovenia

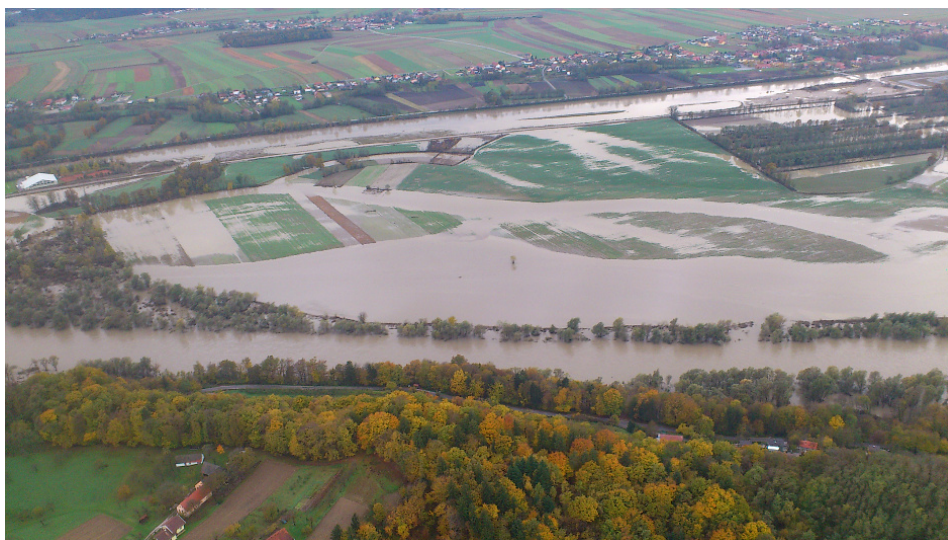
Fig. 6. Extensive floods of the Drava River in Hajdoše near Ptuj (downstream from Zlatoličje HPP) on the 6th November 2012 at 10:50 CET (Photo: Prlekija on net photo archive).

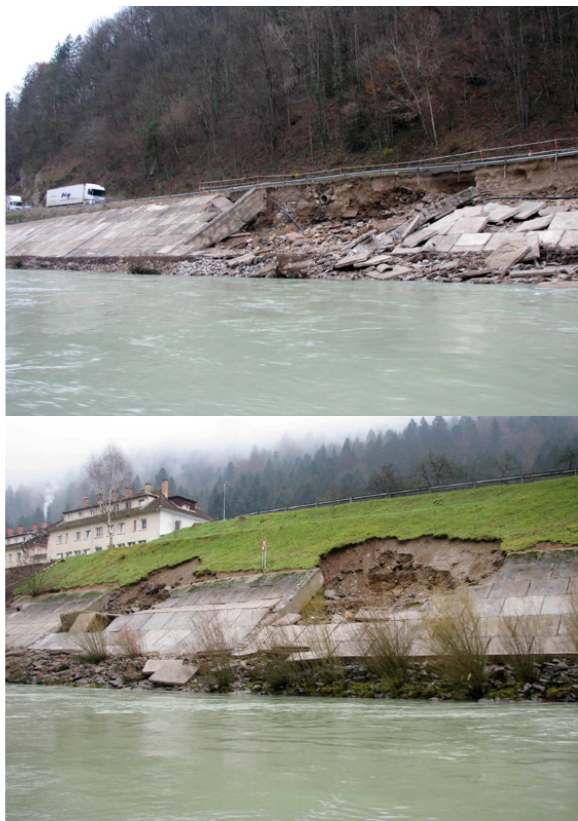
As a result of extraordinary visual inspections numerous landslides and landslips were identified, as well as damage due to erosion in the zone of water level fluctuations, damage to nearby buildings and retaining structures, and also damage and threat to nearby transport infrastructure (i.e. roads, railway lines, bicycle trails) (see Fig. 9). It was found out that the most damaged banks of reservoirs and levees of the derivation channels, as well as the damaged infrastructure, should be rehabilitated as soon as possible [12].

Fig. 9. Some examples of damaged banks of reservoirs on the Drava River after extensive floods (Photos: A. Geršak).

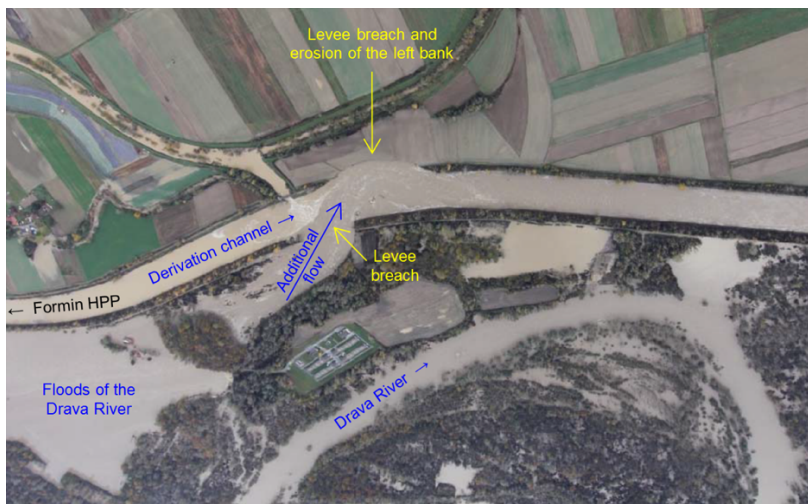
The most extensive damage was registered in the area of the derivation channel of the Drava River, about 1.5 km downstream of the Formin HPP (see Figs. 10 and 11), where the flood waters of the Drava River caused an additional river flow, which first broke through the right levee of the derivation channel and then also broke through the left levee of the derivation channel (see Figs. 12 and 13), where caused the erosion of the left bank of the derivation channel (see Fig. 14). Of course, the concrete diaphragm walls, installed in levees on both sides of the derivation channel, which prevented the drainage of groundwater into the derivation channel, were also demolished in this area (see Fig. 15). In addition, the flood waters of the Drava River transported large amounts of gravel into the derivation channel (see Fig. 14), which dammed water in the channel, with that caused rising of the water level in the channel and consequently flooding of the machine hall area of the upstream located Formin HPP [12-14]. Due to the high risk of additional damage and deterioration of the stability of the damaged banks of derivation channel, the main rehabilitation works began immediately after the detailed inventory of all noticeable damage was made, and they were completed quickly and successfully.

Fig. 12. The area with the greatest damage - during flooding (Photo: Mensuras photo archive).

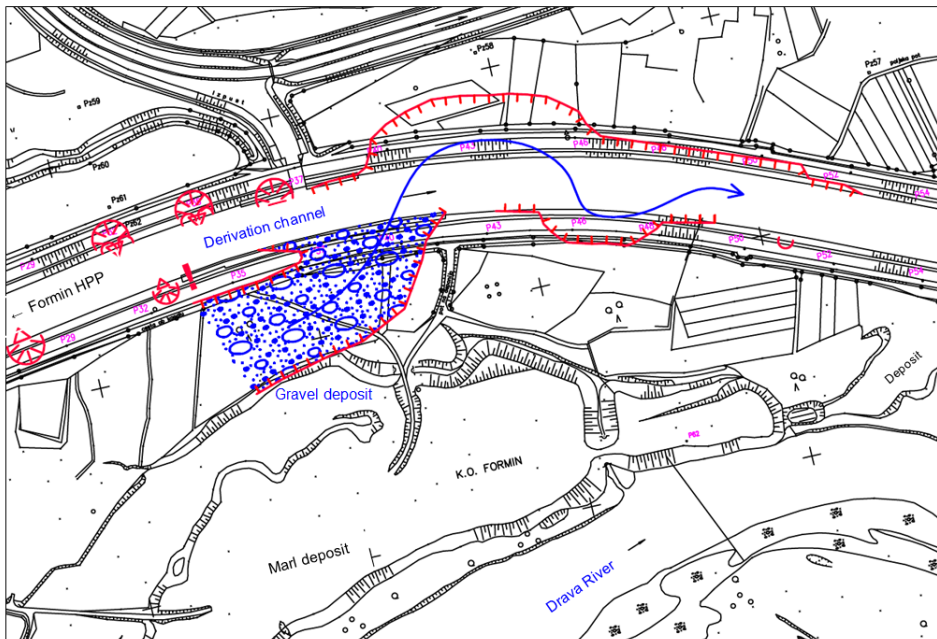
Fig. 13. Topographic map with registered damage at the area with the greatest damage.

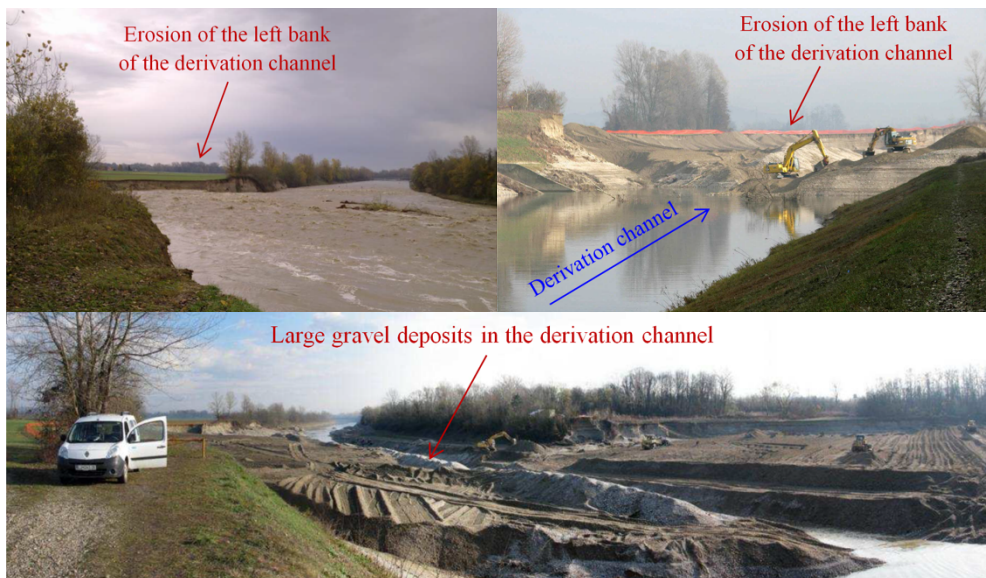
Fig. 14. Erosion of the left bank of the derivation channel and large gravel deposits in the derivation channel (Photos: DEM photo archive and A. Geršak).

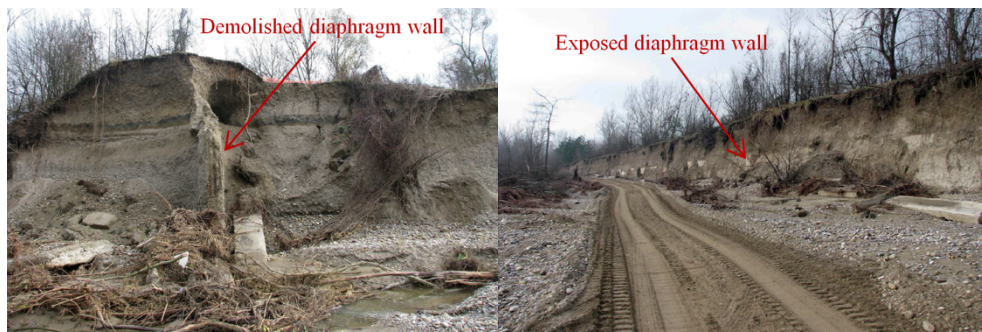
Fig. 15. Demolished and exposed diaphragm walls (Photos: A. Geršak).
