# Lessons learnt from dealing with climatic extreme events - A case of L. Victoria and the White Nile Cascade

*Wilberforce Manirakiza*<sup>\*1</sup>, *Emmanuel Tumwesigye*<sup>2</sup>, *Kevin Otim*<sup>3</sup>, *Mary Akurut*<sup>4</sup>, and *Harrison E. Mutikanga*<sup>5</sup>

<sup>1</sup>Dam Safety Engineer, Uganda Electricity Generation Co. Ltd (UEGCL), 75831 Kampala, Uganda

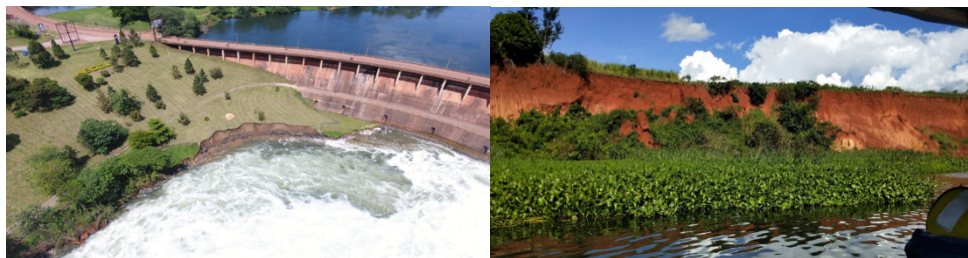
The effects on of the hydrological changes resulted into several dam safety issues and risks. Some of the loose soils closer to the power stations which did not have adequate rock cover or where restoration / flood wave protection works were not adequately done experienced some erosion and slope collapses due to a beaching effect from the higher wave action as shown in the Fig. 4.

**Fig. 4.** Excessive erosion and slope collapses.

High flows along the cascade led to increased reservoir levels creating an extra hydraulic loading against the cascade dams, excessive erosion of the riverbanks & several slope collapses of the reservoir rim. This necessitated modification in monitoring procedures to increase the frequency inspections and data collection (Fig. 5) for purposes of early detection of any dam safety incidents or progressions that could be detrimental to the dams [8].

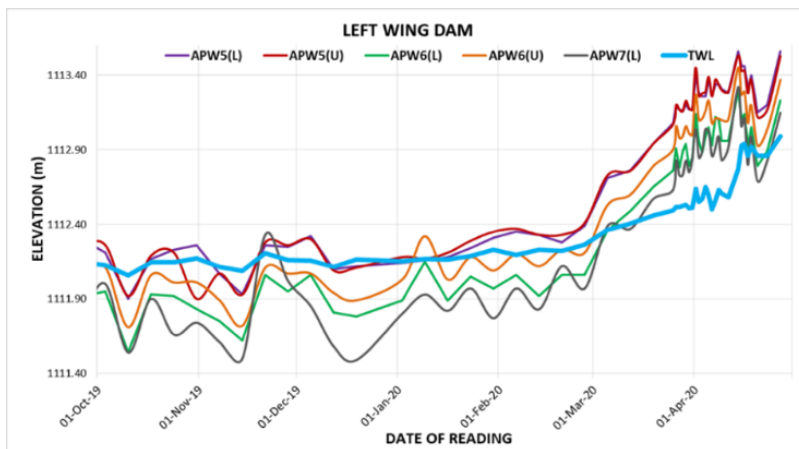
**Fig. 5.** Graph showing effect of rising tailwater pressures on piezometers at Kiira Dam.
