Unsaturated modelling, testing and monitoring towards the rehabilitation of a slope on National Route 3, KwaZulu-Natal, South Africa

Mario Schulz-Poblete^{1*}, Frans van der Merwe², and Fernando Pequenino¹

¹PeraGage, Johannesburg, South Africa

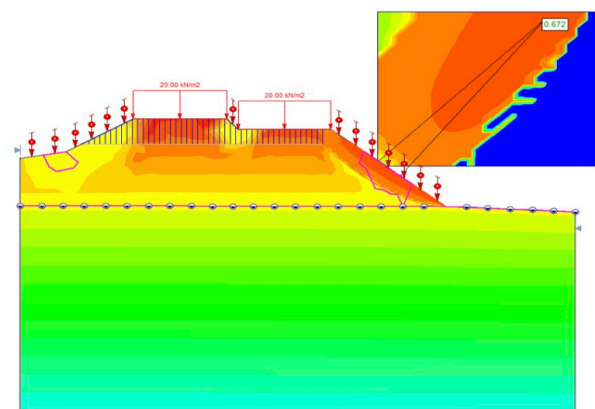
The slope had a FoS of 1.3 prior to the simulated rainfall event due to increased strength from matric suction. After the fourth day of rainfall the FoS over the crest reduced to below unity for all the failure planes showed in Figure 2. The negative pore pressures varied between 0 and -30kPa over the entire depth above the groundwater table. The model showed that the rainfall event had weakened the surficial layers which had previously been stable in their original conditions. While no such exceptional rainfall event occurred before the slope in question experienced translational failure, the net rainfall surplus area the slope is located in means that successive rainfall events will cause water to accumulate in the surficial areas of the slope without enough evaporation to remove infiltrated water. Over time this will lead to the same low suction conditions found by the model.

Fig. 2: Transient slope stability analysis simulating rainfall infiltration

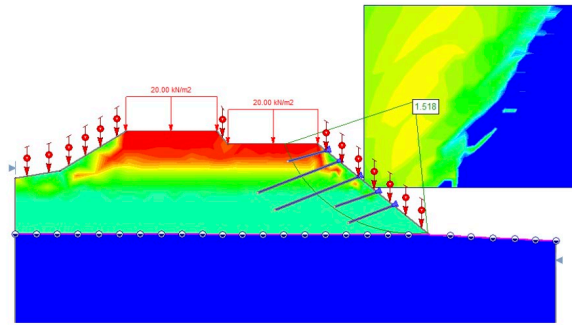
Fig. 3: Transient slope stability analysis simulating rainfall infiltration with slope stabilisation measures

The inclusion of passive soil nails to intercept the failure plane enhanced the sliding resistance. The model was therefore adjusted to include for passive soil nails until an FoS>1.5 was achieved after the simulated rainfall event. This is shown in Figure 3 below.

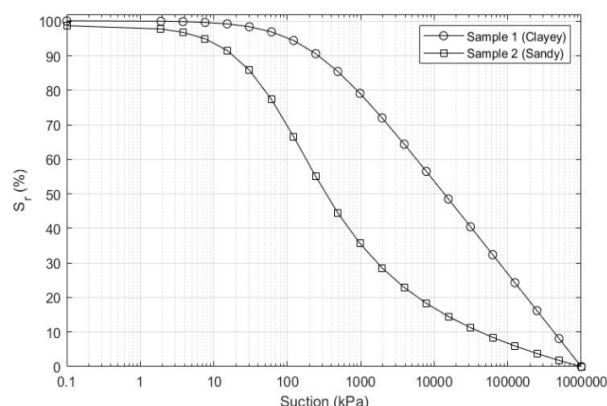
Fig. 6: SWRC's between 4.95 – 5.45m [7]

The difference in the two measured curves is likely due to the fact that the Shelby sample was retrieved at an interface between two different grades of fill (clayey sand above and silty clay below). The two samples tested were taken from the top and bottom of the Shelby sample respectively.

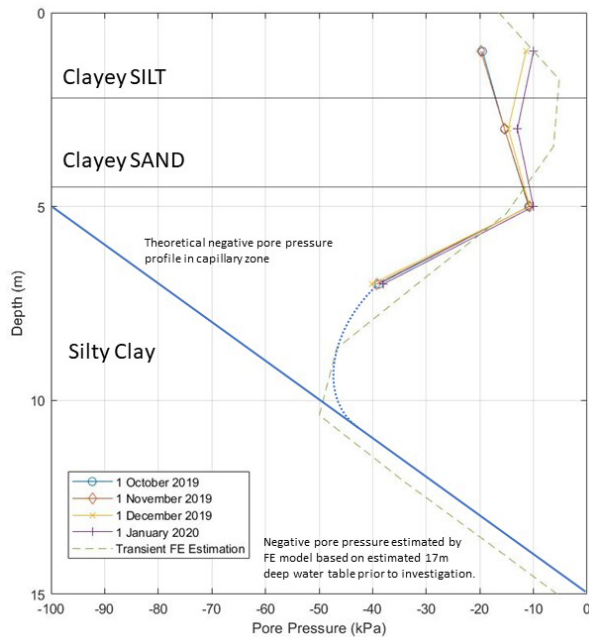
The estimated suction profiles match the measured data well, validating the use of the transient FE model in the emergency works design. In terms of infiltration influence with depth, the following observations can be made from Figure 7:

- The measured data shows seasonal suction fluctuations were mostly limited to the top 3m of profile, with some minor changes down to 6m.
- Minor suctions (<20 kPa) are present over the top 6m of the profile. This differs from the AS2870 [3] design suction depth of 3m.
- The net rainfall surplus has influenced suctions down to approximately 10m below the crest, after which the suctions from the water table's capillary zone become dominant.

Fig. 7: Measured suction profile with depth against profile estimated by FE transient analysis (adapted from [7])

It should be noted that 2019/2020 were moderately wet years, it is assumed that the suction over the top 6 to 7m can reduce even further during a more extreme rainfall event. It is also clear that the net surplus rainfall has in the past already influenced the slope's negative pore pressure regime over the upper crust, as the existing low suctions reflect substantial water infiltration down to the 4.5m interface with the clayey material.
