The Amazing Mechanism of the Standing for 700years of the Tall Masonry Stone Tower of 32m in height on Manmade Sandy High Mound by Shallow Direct Foundation, Bayon Temple, Angkor, Cambodia

Abstract. Soils and foundation of Bayon temple of Angkor Thom has been studied since 1994 by Japanese Government Team for Safeguarding Angkor (JSA). The main tower of Bayon of 32m in height from the base foundation mound consists of manmade fill of 14 m in thickness. The foundation was studied and found as a simple shallow direct foundation. This is just like a 10 story RC building standing upon thick manmade sand fill without such a deep foundation as piling. At present, such a structure based upon thick sandy fill shall lose the foundation stability in the dry season under the monsoon climate of South-eastern Asia. The amazing mechanism, standing for 700 years, has been identified as the unsaturated characteristics of well compacted silty sand.

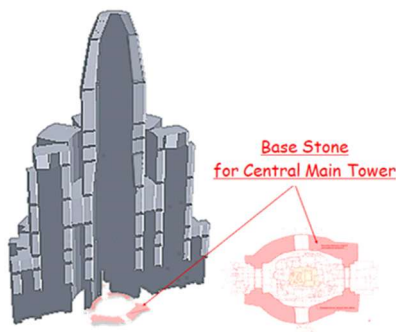
Fig.3 Direct shallow base stone Main Tower

Horizontal hand auger tests were carried out at 5 points and has resulted in finding no supporting stones, but only very dense sandy fill beneath the base stone support as shown in Fig.3. [2]

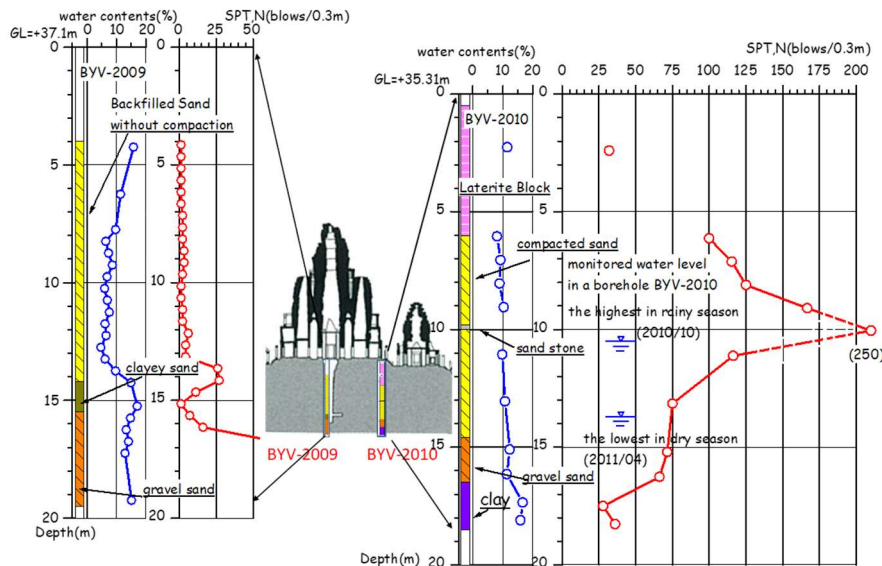
Fig.4 Borings at the vertical shaft and at top terrace

Geotechnical boring was performed at the backfilled vertical shaft and at the top terrace of the original manmade filled mound as shown in Fig. 4.

The back filled soil for BY09 was found in a very loose state of SPT, N-values $N < 4$ of BYV2009. Another

boring of BYV2010 at the top terrace shows the sandy fill lower than GL-6m of $N=100-150$, which is a very large value compared to the expected values of 20-40 for common filled sandy soil.[3,4]

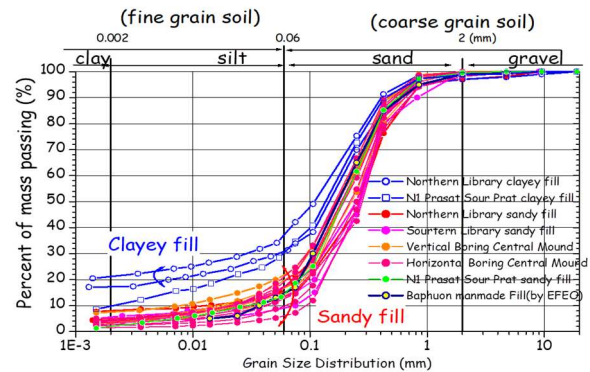
Fig.5 Grain size distribution of the soils of filled mound.

The grain size distributions of the sampled soil by the boring of BYV2010 and BYH2010-30 as well as other sites are shown in red and blue colour for sand and clay soils respectively in Figure 5. The sandy soil is filled soil and the entire samples of the filled soil show the same distribution, which implies very uniform fill material.

The silty/clayey fill was found at the boundary of such zone to prevent seepage as laterite block and sandy fill mound. The ancient engineers in Khmer clearly identify these two types of clayey fill and sandy fill.

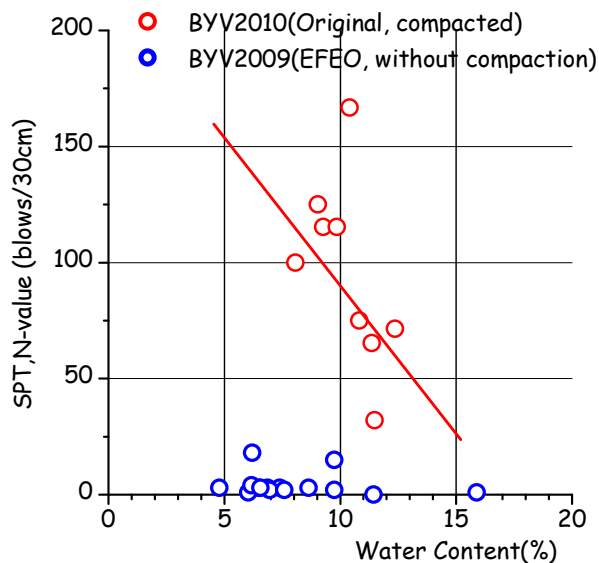
Fig.6 SPT-N-values vs. water contents

The obtained SPT, N-values are plotted against water contents of the sampled soils for both borings and shown in Fig. 6. No relationship is found for BV09 of the backfilled soil; however, the decrease of water is found to result in the increase of the SPT, N-values for boring BV10.

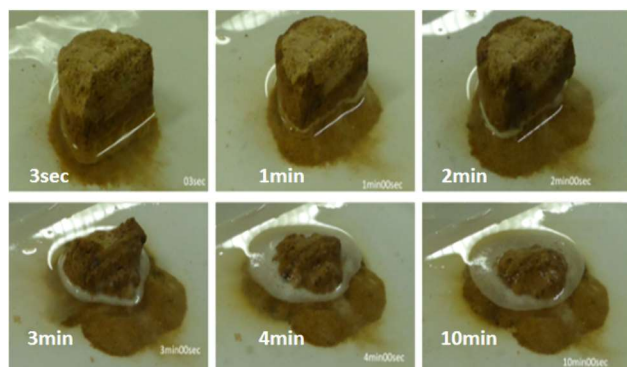
Fig.7 Collapse of the sampled sandy fill in water

Sampled soil of very high SPT-N-value for boring BYV2010 looks like soft sandstone as shown at the upper left position of Fig. 7. When the sampled soil was put into water, it sucked water, and finally collapsed within 10 minutes as shown in Fig. 7.

The sudden decrease of the strength with collapse as shown in **Fig. 7** is possible under free boundary conditions. In the field, the densely compacted soil with some confinements keeps its stability with the large frictional angle.

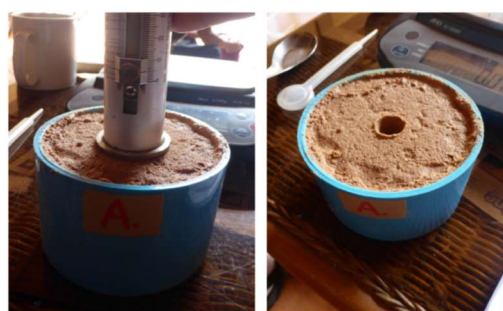
Fig.9 Yamanaka test for filled sand with samples of different water content by drying step

Yamanaka cone penetration tester was used to evaluate the bearing strength of the soils as shown in Fig. 9. The results are shown in Fig. 10 and It shows clearly an increase of strength more than 50 times due to the decrease of the water content.

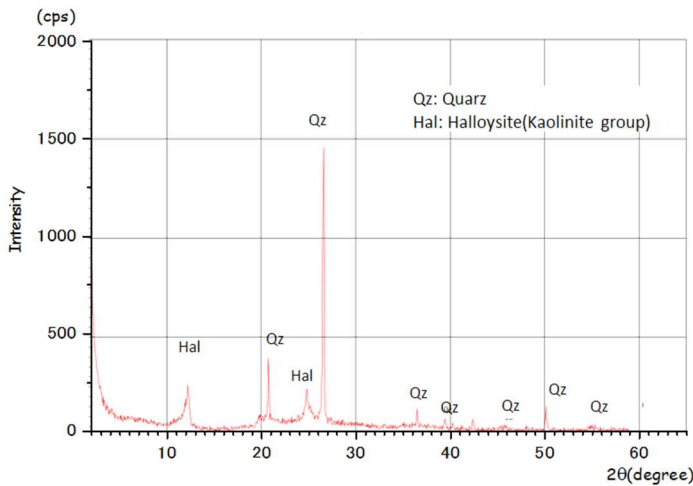
Fig.12 X-ray Refraction analysis for the filled soil

Micrograph of the section of the sample is shown in Fig. 11, where the round shape of sand is seen filled with clay material. X-ray diffraction analysis was applied to the fine particle of the foundation sand is shown in Fig. 12. In addition to quartz of sand, Halloysite (Kaolinite group) was detected as the clay component. Compared to other clay minerals, the power to absorb water is very

small and does not swell and the volumetric change is very small and stable compared to montmorillonite.

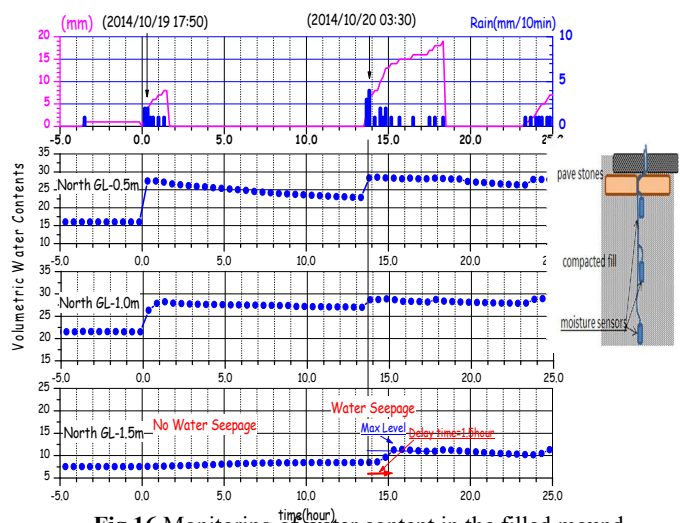
Fig.16 Monitoring of water content in the filled mound

In **Fig. 16**, the monitored results at S-point of two cases of rain events are shown. The earlier case shows the increase of the volume water content are found at the upper two depth points. The deepest point at GL-1.5 m, the volume water content keeps the constant value,

which means the infiltrated rainwater reached to the upper two sensors, but did not reach the bottom one. The amount of the rain was too small to provide enough rainwater in the earlier case. In the latter case, the sensor at the bottom of GL-1.5 m increases with a time delay of about 1.5 hours compared to the top sensor at the GL-0.5 m. The infiltration rate is about 1.0 m/1.5hours.

When the heavy rain stops the volume water content begins to decrease due to evaporation, and to some extent drainage. The present rain style is “Squall” which begins suddenly and continues for a few hours in heavy intensity and stops. In the squall type rain, rainwater penetrates from the surface to only a few meters, and did not cause fatal failure.

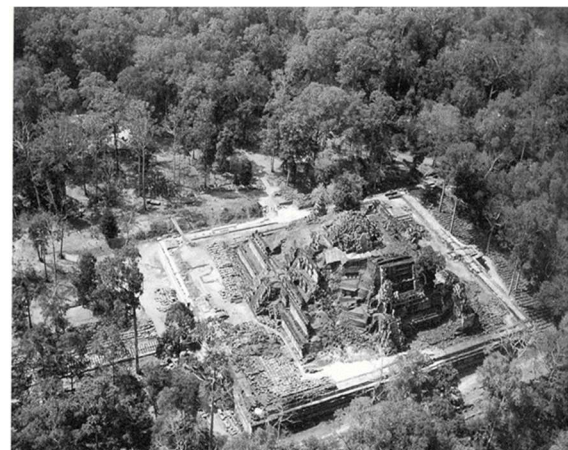
Fig.20 Failure of north-eastern side in 1943 [6]

The mound was very high at 30 m from the ground with very steep slopes of 45 to 60 degrees.

It is amazing fact such steep and high mound of manmade fill of natural sandy soil had been standing for 900 years, but failed in 1943 (Fig.20) [6].

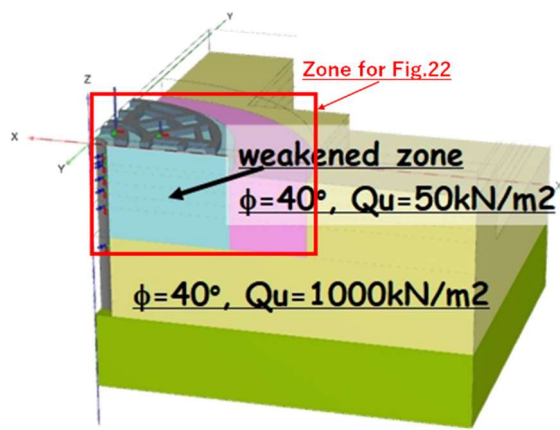
Fig.21 Weakened zone beneath the foundation.

Under the anticipated warm climate in the future, the rain type may change from squall to long and heavy rain. The strength of the filled sandy soil shall be weakened. Assuming the decrease of the strength of the foundation from $\phi=40^\circ$, $C=1000\text{kN/m}^2$ to $\phi=40^\circ$, $C=100\text{kN/m}^2$, a simulation result is shown in Figs. 21 and 22.

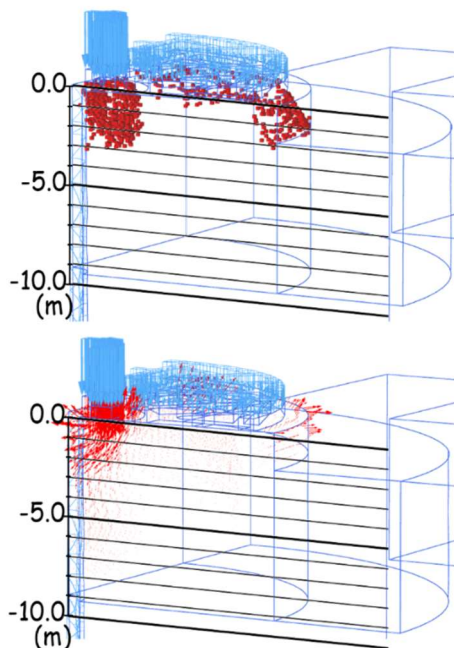
Fig.22 Plastic failure (upper) and displacement vector (lower) by the weakened soil.

Plastic failure points are concentrated into just beneath the Central Tower and the outer edge of the surrounding foundation step. zones. Direction of the displacements beneath the foundation is not only downwards but also inwards, which is caused by the very loose state of the sand. Direction of the displacement at the outer edge of the foundation mound is a horizontal outwards direction.

It is shown that the effects of the weakened filled soil by the long and heavy rain will cause the foundation failure and deformation of the outer edge of the mound.
