Deposit Characteristics of Diesel Engine Power Plant Fueled by Crude Palm Oil

Abstract. This study emphasizes the impact of using Crude Palm Oil (CPO) as fuel (Bio-oil) on the deposit characteristics formed in the diesel engine power plant. Before entering the engine, CPO was treated by heating, separation, and filtering to decrease its viscosity. Deposit composition and morphology were investigated using Scanning Electron Microscope (SEM) equipped with a spectrometer. The result showed that unburned fuel on the surface of the cylinder head and liner wall was found after the performance test. Furthermore, inspection after durability test shows that there are carbon deposits on the combustion chamber, hard deposits on the cylinder head edge, and scratches on the surfaces of the liner. Hard black deposits were also found in the fuel nozzle tip. These deposits can disrupt the fuel atomizing process and create an unbalance pressure between the chambers. The deposits formed were continuous and contained Calcium (Ca), Aluminium (Al), and Iron (Fe). The SEM and spectroscopy analysis showed that the deposit formed by using CPO as fuel for diesel engines contain complex substances and erod

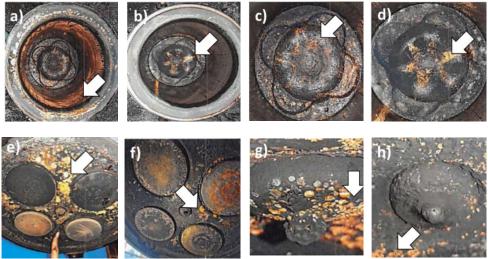
Visual examination after performance test is carried out on disassembled liner, cylinder head, the piston head, and fuel injector on cylinder number 5 and number 8. Indications of incomplete combustion can be seen in the combustion chamber. Trace of unburned CPO, which is orange, was found on the cylinder liner surface (Figure 2a-b), piston crown (Figure 2c-d), cylinder head (Figure 2e-f), and fuel injector (Figure 2g-h). One of the factors that cause incomplete combustion is the high viscosity of CPO due to a thermal boiler problem that had suddenly shut off during the performance test.

Fig. 2. Photograph of engine parts after the performance test. a) Cylinder liner no.5 b) Cylinder liner no.8 c) Piston crown no.5 d) Piston crown no.8 e) Cylinder head no.5 f) Cylinder head no.8 g) Fuel injector no.5 h) Fuel injector no.8.

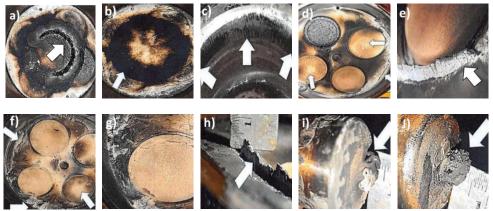
Visual examination showed that there was residual carbon in the combustion chamber and in the middle of the piston (Figure 3a-b), scratch on the liner surface (Figure 3c), irregular deposit formed on the tip of the cylinder head (Figure 3d-h), and black deposits covered the fuel injector nozzle (Figure 3i-j). Scratches on the surface of the liner above the cylinder head could happen due to rubbing between the deposits and cylinder head, piston, and liner. Comparison of fuel nozzle condition before and after the engine operates using CPO for 375 h and 58 min is shown in Figure 4.

Fig. 3. Photograph of engine parts after running test. a) Piston no.5 b) Piston no.8 c) Cylinder liner wall no.5 d) Cylinder head no.5 e) Cylinder head deposits no.5 f) Cylinder head no.8 g) Cylinder head deposits no.8 h) Enlarge view of (g) i) Fuel injector no.5 j) Fuel injector no.8.
