Adaptive Risk Management in Road Construction: Oyon-Ambo Highway Insights, El Niño 2019 Case Study

Victor Andre Ariza Flores^{1*}, and Rachel Salvador²

Abstract. This research provides an in-depth analysis of the challenges faced during the construction of the Oyon-Ambo highway in Peru, particularly during the extreme rainfall events associated with the 2019 El Niño phenomenon. Situated in the high Andean area of the Pasco region, this rigid pavement road project encountered significant disruptions due to the extraordinary weather conditions. The adjacent Chaupihuaranga River experienced increased flow rates, causing extensive damage to the road and necessitating substantial modifications to the engineering plans. Focusing on 14 critical sectors identified in the project's technical file as prone to instability, the study details the accelerated degradation and eventual destruction of these sectors due to the intense rainfall. Emphasizing the importance of adaptive risk management in road construction, especially in regions susceptible to natural phenomena like El Niño, the paper underscores the need for responsive reengineering approaches based on specific damage types. It also

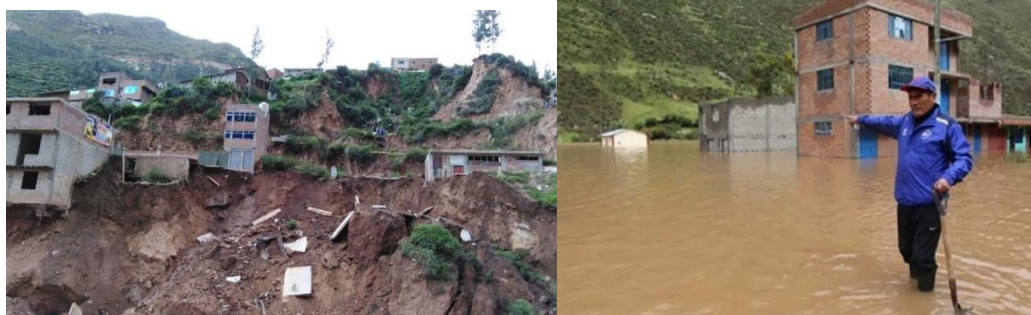
The Oyon Ambo Highway runs alongside the Chaupihuaranga River, which is a tributary of the Huallaga River. Originating from the peaks of the Raura and Huayhuash mountain ranges, the Chaupihuaranga River flows in a northeasterly direction until it joins the Huallaga River near the city of Ambo in Huánuco. Due to the high rainfall associated with this extreme natural event, the river experienced a significant increase in its flow. This surge caused considerable damage and necessitated alterations to the engineering design of the road project. Figure 2 provides an illustration of the 2019 El Niño's impact, showcasing examples of slope undermining and flooding in urban areas proximate to the road construction [14-15].

Fig. 2. Effects produced by El Niño 2019 in the construction zone of the Road

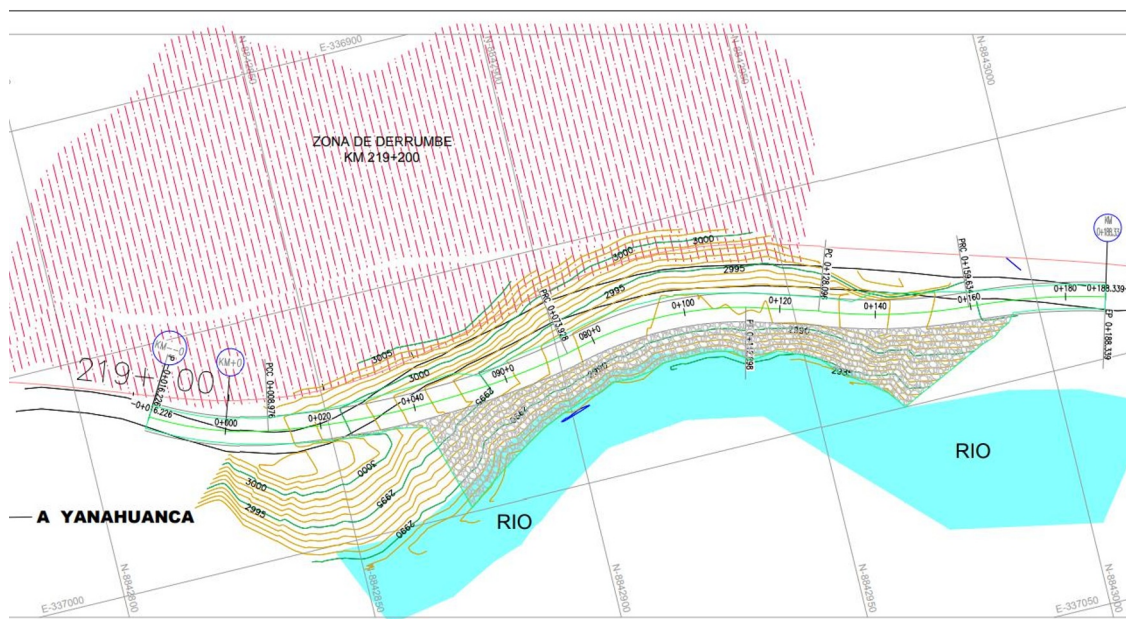
On the road project in question, it was deemed necessary to carry out only two emergency works: 1) in the San Juan Baños de Rabí sector, spanning from km 200 + 000 to km 201 + 700, and 2) in the sector with complete undermining of the platform, located between km 219 + 170 to km 219 + 260. For the first emergency work, measures included constructing a temporary speed bump, building a paved channel for the conduction of rainwater, and expanding the work platform. In the second case, a new support platform was constructed using a rock base to shield it from river undermining, as illustrated in Figure 5 and Figure 6. The total cost for these emergency works was estimated at USD 96,578.00.

Fig. 5. Floor plan of the emergency works of the sector from km 219+170 to km 219+260

The emergency additional works represent essential minimal interventions required to ensure vehicle movement and the safety of residents near the impacted zone. These tasks were carried out in April 2019.

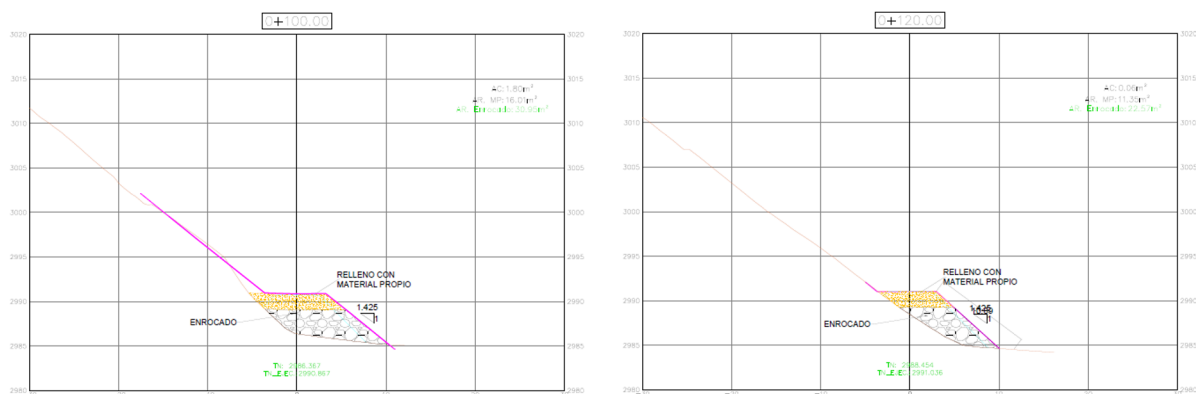
Fig. 6. Cross-sectional plan of emergency works in the sector from km 219+170 to km 219+260 (partial stakes 0+100 and 0+120)

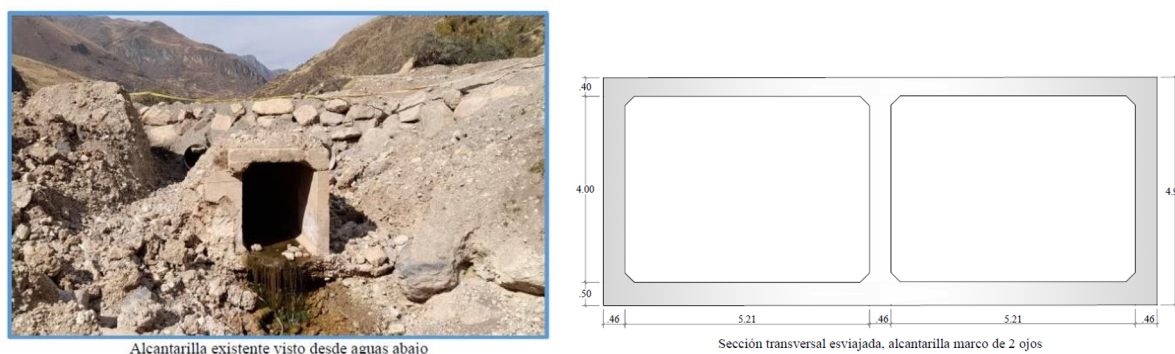
In the area with complete undermining of the platform situated between km 200+000 and km 201+700, it was proposed to construct two primary structures. The first is a two-eyed frame type culvert, with dimensions of 10.20m x 4.90m, as depicted in Figure 7. This culvert is designed to replace the current sewer, which has a 1.20m x 1.20m section, deemed

inadequate for the evacuation of rainwater and waters collected in the ravine of the San Juan Baños de Rabi peasant community.

Fig. 7. Two-eyed frame sewer solution approach

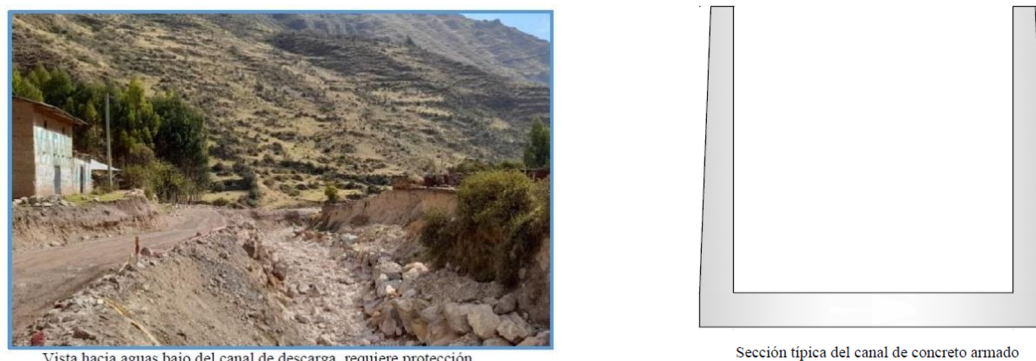
The second structure, as illustrated in Figure 8, is designed as a protective measure for the platform of the newly aligned projected road. Based on the fundamental study of hydrology and hydraulics, the construction of a reinforced concrete channel is recommended. This channel is to be built starting from the exit of the two-eyed frame sewer. The design of this structure was conducted in accordance with the AASHTO LRFD 2017 design specifications and the Bridge Manual issued by the Ministry of Transport and Communications. To ensure its structural integrity, it was confirmed that the sizing of each of the retaining walls adheres to stability criteria, including the pressures exerted on the foundation floor. Additionally, the reinforcement in the footings and walls was calculated to meet the limit states as per the design specifications. The total cost for the execution of all necessary structures in the sector between km 200+000 and km 201+700 has been estimated at USD 1,657,894.00.

Fig. 8. Platform protection structure solution approach
