# Failure Analysis and Protection of Oxygen Corrosion of Reheater Tube in a Power plant

A thermal power company found that the inner walls of the inlet pipes of the boiler's multiple wall reheaters

were corroded to varying degrees during maintenance. The material of the corroded reheater tube is 12Cr1MoVG, the design specification is  $\Phi$ 50×4 mm, the working temperature of the reheater inlet is 325°C, the working pressure is 3.8 MPa, and the cumulative operating time is 66,000 hours.

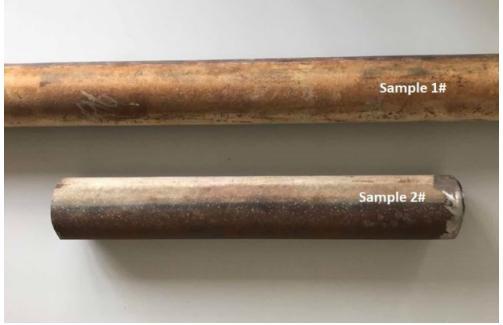
(a) The outer morphology of the tube

Figure 1 shows the macroscopic morphology of the failed reheater tube after sampling. Figure 1(a) is the macroscopic appearance of the outer wall of the two reheater tubes. The outer wall of the two reheater tubes has no obvious defects such as swelling or deformation, and the outer wall oxide scale is normal. Dissecting and observing the two pipes, it was found that there was no obvious oxide layer or scaling site on the inner walls of

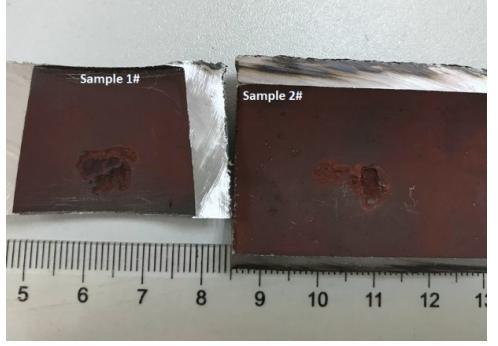
(b) The inner morphology of the tube

the two pipes, but several corrosion pits were observed on the inner walls of the two pipes, as shown in Figure 1(b). The macroscopic morphology of the corrosion pits on the inner wall of the root reheater tube.

It can be seen from the macroscopic appearance that the outer wall of the reheater tube submitted for inspection is relatively smooth, and there is no trace of oxidation or other loss, but the inner wall of the tube is corroded obviously, and there are many ulcer-like corrosion pits. The surface of the corrosion pit is covered with reddishbrown rust, and the inside of the corrosion product is relatively loose. Macroscopically, the corrosion is caused by the expansion of the inner wall of the tube to the outer wall, and the corrosion gradually penetrates the wall of the tube. The microscopic appearance of the two reheater tubes is similar, and the generation mechanism should be the same. The energy spectrum analysis of the tube matrix shows that the material of the reheater tube is 12Cr1MoV, which meets the requirements of the standard. Observation of the morphology of the reheater tube showed that the metallographic structure of the matrix before the corrosion pit was not abnormal. However, there are discontinuous pits in the corrosion front, and a small amount of corrosion products can be seen inside the pits. In addition, there were no other defects such as decarburized layer or microcracks in the bottom structure. The test results of corrosive substances are mainly Fe and O. Based on the above test results, the corrosion characteristics of the failure of the reheater tube are consistent with the oxygen corrosion characteristics<sup>[4,6]</sup>.

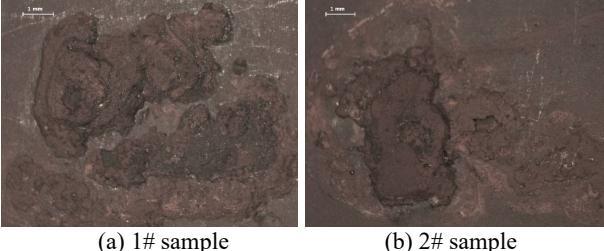
Figure 2. Macro corrosion morphology of reheater tube

In order to facilitate the observation of the internal morphology and characteristics of the corrosion pits, the two reheater tube corrosion pits were observed with a solid microscope. The morphology is shown in Figure 2. The morphology showed that the corrosion pit of a reheater tube was a stepped ulcer. The corroded surface was covered with reddish brown rust, with a small amount of corrosion products at the bottom, and the texture was relatively loose. The inner wall of the noncorrosive pit is reddish brown and smooth.

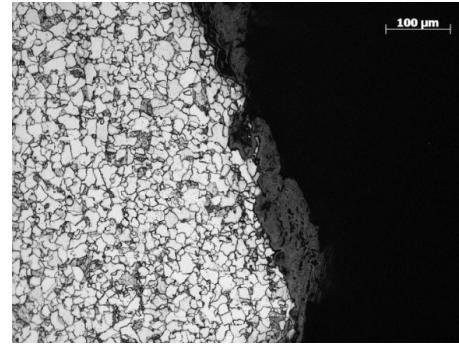
(a) The corrosion morphology at the edge

The metallographic examination was carried out on the cross-sections near the corrosion pits on the inner wall of the 1# and 2# samples, as shown in Figure 3-4. The comparison of the metallographic structure of the two reheater tubes reveals that the pits of the two tubes have similar corrosion morphologies, and there is a layer of visible corrosion products at the bottom of the pits. There were no inter-granular or transgranular microcracks, no obvious decarburization layer and aging, as shown in Figure 3(a) and Figure 4(a).

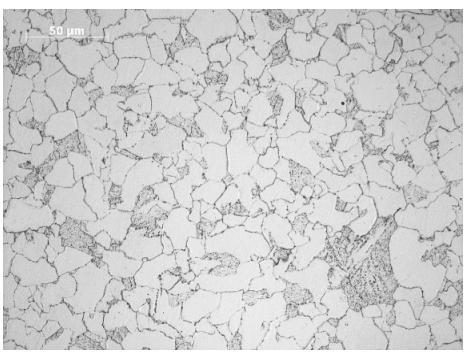
(b) Metallographic structure of matrix

In addition, there is no obvious difference between the metallographic structure near the corrosion pit of the reheater tube and the metallographic structure of the matrix, both of which are ferrite and pearlite, with an aging level of 2.5, as shown in Figure 3(b) and Figure 4(b).

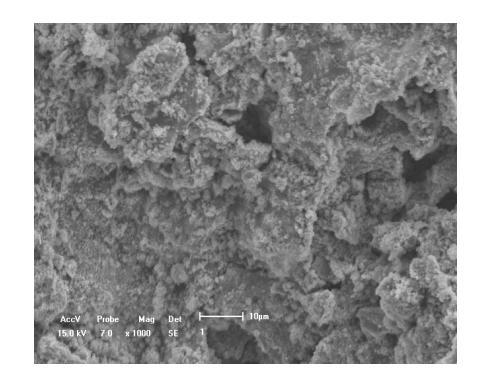
Figure 5 SEM morphology of reheater tube 1# sample

Figure 5 is the scanning electron microscope (SEM) morphology of the corrosion products at the bottom of the pit of 1# sample. The topography shows that the oxide structure is loose, with holes, and the surface layer is in the form of fine powder. Except for this, no other foreign matter is seen.

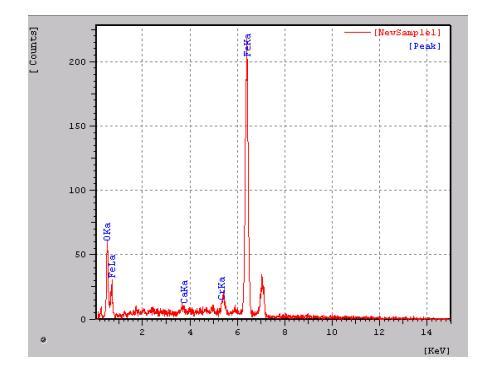
Figure 6. EDS spectrum diagram of reheater tube 1# sample

Figure 6 is the energy spectrum of the corrosion product of sample 1#. According to the peak value, the main elements in the corrosion product are Fe and O. Comprehensive SEM morphology and EDS results show that the corrosion product of the reheater tube is  $Fe_2O_3$ .
