# Experimental stand for investigation of fluid flow in heat exchangers with cross-flow arrangement

**Abstract.** The operation analysis of high-performance heat exchanger with tubes elliptical indicated that the heat exchangers can be subject to damage. The reason for this is probably improper distribution of working fluid in tubular space of heat exchanger. Therefore, a part of the tubes may be improperly cooled and subject to compressible stresses. The paper presents an experimental stand allowing to confirm the given assumption. The experimental investigation enables to examine the mass flow rate in heat exchanger tubes. Also, it is possible to assess the impact of the construction of inlet, intermediate and outlet chambers on the flow distribution within the heat exchanger tubes.

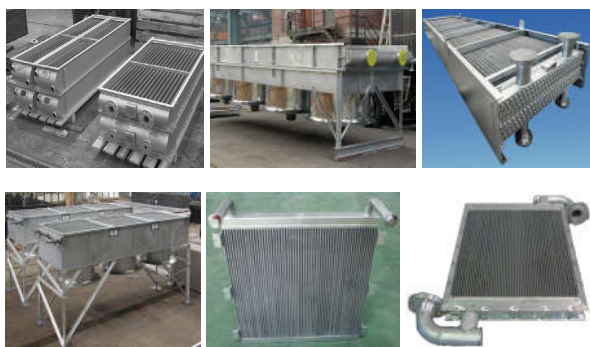
Fig. 1. Examples of construction of high-performance heat exchangers heater/cooler

The operation of the high-performance heat exchanger with finned elliptical tubes in cross-flow working fluid arrangement (e.g. flue gas-water), indicates a possibility of failure. This situation occurs mainly in the case when a large difference between the working fluid temperatures exists. The failure can be seen as a certain deformation of tubes in the form of buckling, or as a tube rupture. Examples of the construction of heat exchangers which are mentioned here, often refer to high-performance heat exchangers are shown in Fig. 1 [1, 2]. Figure 2 shows a structure (the basic elements) and the principle of operation.

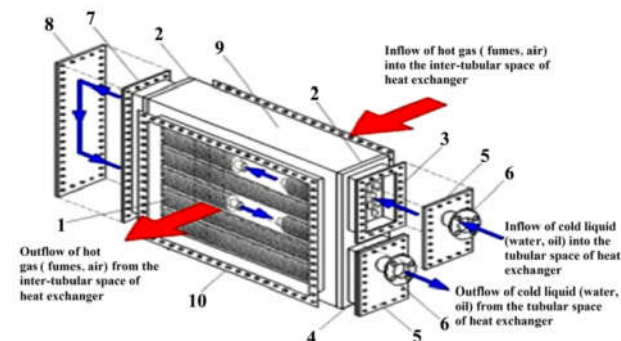
Fig. 2. High-performance heat exchanger with finned tubes: 1 – finned elliptical tubes, 2 – sieve plate, 3 – inlet chamber, 4 – outlet chamber, 5, 8 – chamber cover, 6 – inlet/outlet nozzle, 7 – intermediate chamber, 9 – shell, 10 – flange connecting heat exchanger with channel (e.g. air, flue-gas flow)

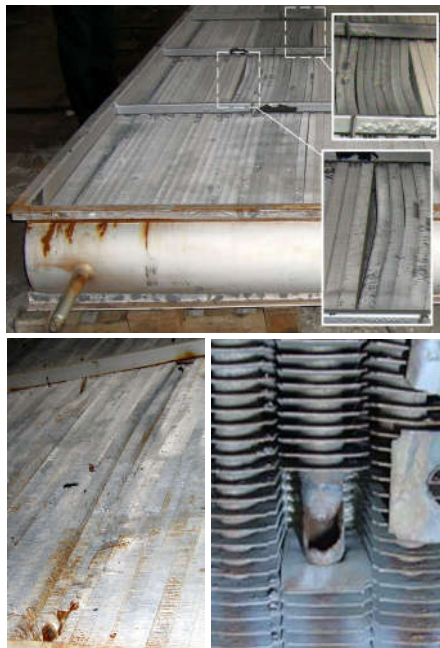
Fig. 3. Buckling and fracture of heat exchanger tubes

evident, but it is often problematic to find a reason of the failure, which usually requires a thorough analysis of many factors including the flow and heat transfer, as well as the distributions of stress and deformation of the structure [8-12]. Moreover, these issues are gaining importance in cases of repeated operational problems, especially damage [7, 12]. Examples of heat exchanger failures (with the cross-flow arrangement of flue gas and water), are shown in Fig. 3. By the local inspection, the nature of the damage was found. The buckling of several tubes (in both heat exchanger passes) and fractured tube nearby the sieve plate, shows that the compressible stresses were the reason of failure.

Figure 3 presents damages on a heat exchanger; that is structurally similar to the one shown in Fig. 2, but vertically disposed and had a profiled chamber: inlet, intermediate, and outlet. The chambers are formed from the large pipes Fig. 4). The heat exchanger operated in one of the heat recovery units in Poland. The problems already appeared after three months from the date of heat exchanger launch. It should be noted that a new device (which was inserted in place of the previous) also suffered a failure, after eight months of operation and both the location of damage, as well as their nature was similar [7, 11].

stresses, which can contribute significantly to the heat exchanger failure. It should be noted that the previously described damage underwent the tubes corresponding to the unfavorable conditions of the heat exchanger (tubes no. 11-13 in the first pass, tube no. 22 in the second pass). The observed improper flow distribution in cross-flow heat exchanger (Fig. 6) leads to the significant temperature differences in the tubes located in both passes. As it can be seen in Fig. 7, in the tubes with the reverse-flow, the water temperature is significantly higher compared to other tubes. Maximum reach approx. 158 ° C (this corresponds to a saturation temperature at a pressure of 6 bars, for which calculations were performed [12]) and the lowest is approx. 112 ° C. Those differences significantly affect the temperature of the tube wall and result in the thermal stresses. Due to a considerable stiffness of sieve plates, the tubes with the lower temperature exhibit tensile stresses, while those with the higher the compressible stresses [10, 11].

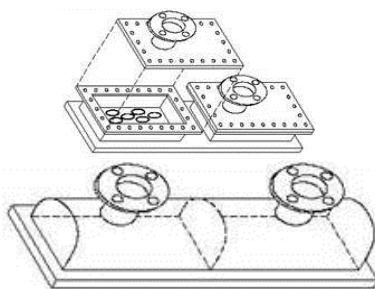
Fig. 4. The shape of heat exchanger headers used in cross-flow heat exchangers

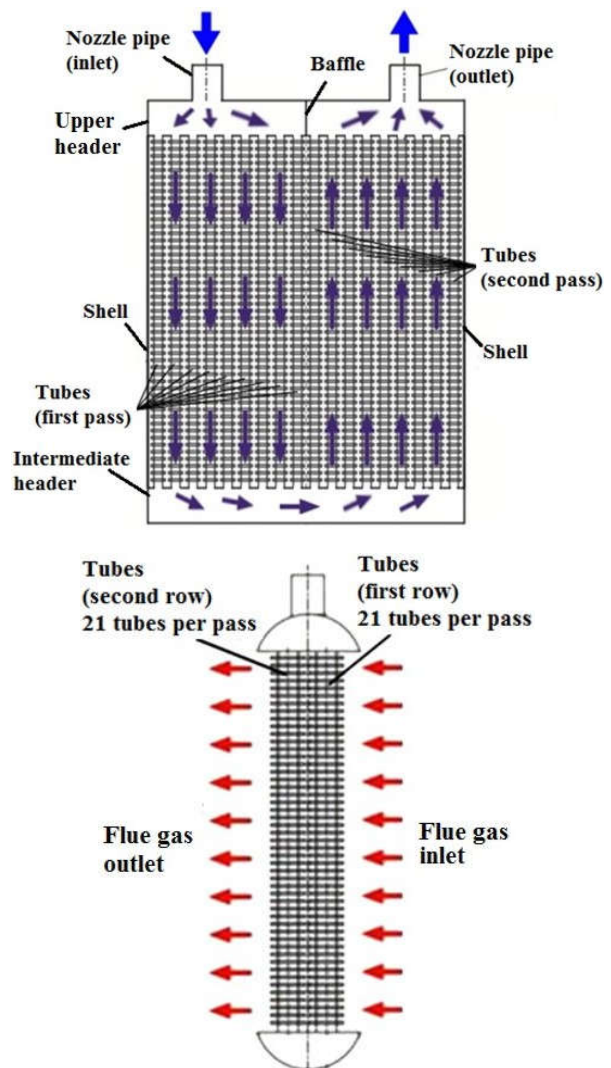
Fig. 5. Scheme of the two-pass cross-flow heat exchanger

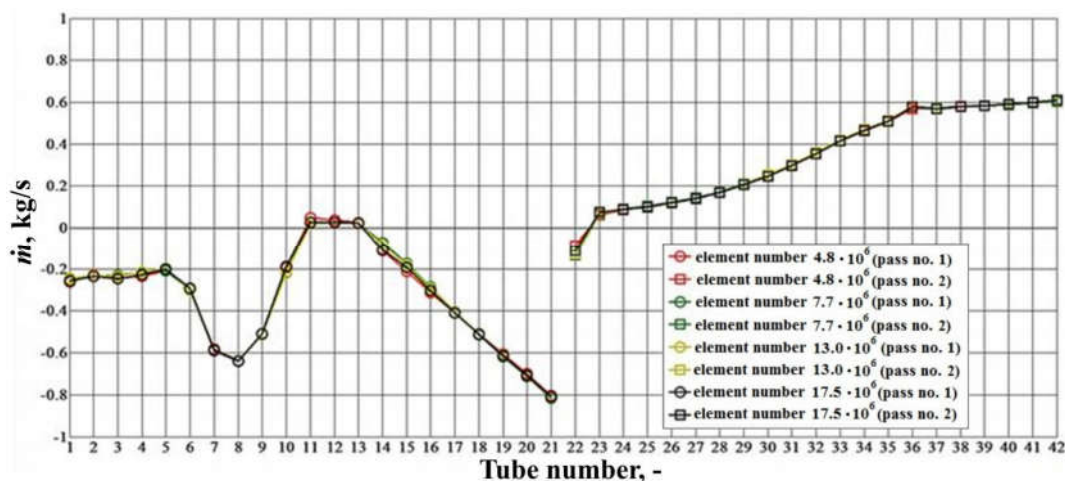
Fig. 6. Water mass flow rate in elliptical tubes of the heat exchanger of the first pass – tubes no. 1÷21, of the second pass – tubes no. 22÷42 (the legend shows number of finite element used)

The analysis of Fig. 6 reveals that the flow of coolant (in this case water) in the heat exchanger tubes is very diverse, with the largest value is approx. 0.8 kg / s (for tube 21) and the smallest, approx. 0, 02 kg / s (tube 11, 12 and 13). In both cases, the differences exist in the tubes of the first pass. In the second pass, the highest value of flow rate is approx. 0.6 kg / s, and applies to tubes 36 ÷ 42, and the lowest, approx. 0.1 kg / s, to the tube 22. From Fig. 6 one can observe the different sign of mass flow rate in tubes no. 11 to 13 of first pass and tube no 22 of the second pass (compared to adjacent tubes). This situation indicated the reverse flow of water. This situation leads to a significant increase in water temperature (may cause the flow boiling [17, 18] in the case of low flow rate) since the path of the flow is repeated several times. Figure 6 shows that the water flow rate in the pipes is very low. The flow rate is one of the most important factors affecting the intensity of the heat transfer process. Hence, the conditions of heat removal in the individual pipes are different. In this regard very unfavorable conditions apply to the tubes with low flow rates of water, especially characterized by backflow. In this case, one can expect high thermal

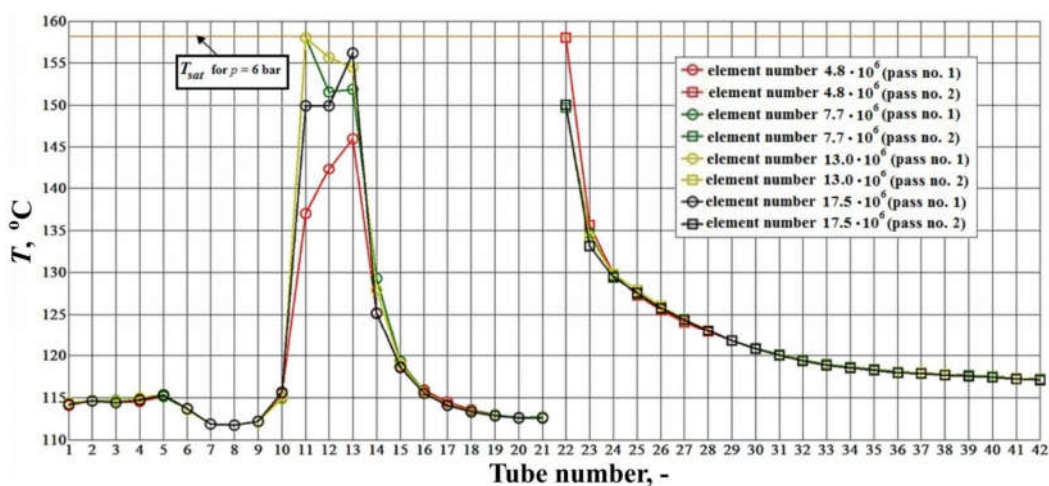
Fig. 7. Average water temperature in elliptical tubes of the heat exchanger of the first pass – tubes no. 1÷21, of the second pass – tubes no. 22÷42 (the legend shows number of finite element used)

The considerable variations in the water flow rate result in increased temperature of water in heat exchanger tubes (Fig. 7). Figure 7 reveals that the water temperature differences are up to 45 °C and the saturation temperature is reached in tubes no 10 (first pass of the heat exchanger) and 22 (second pass of the heat exchanger).

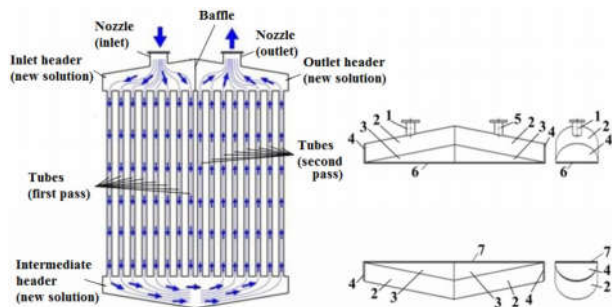
Fig. 8. A scheme of the two-row/two-pass high performance heat exchanger (of water/flue gas type) with the new shape of headers: 1 – inlet nozzle, 2, 3 – header combined from the tube sector (2) and two wedges (3), 4 – bottom, 5 – outlet nozzle, 6 – sieve plate (connected with outlet and inlet headers separated by the baffle), 7 – sieve plate (connected with intermediate header)

The possible solution to improve the working conditions of the analyzed heat exchanger is the change the shape of headers. The new solution (the patent procedure is in progress) is shown in Fig. 8.

Because a new inlet, intermediate and outlet headers with increased flow space are proposed, a uniform flow distribution to heat exchanger tubes is expected. However, to confirm the expectation, the extensive experimental investigations are needed.

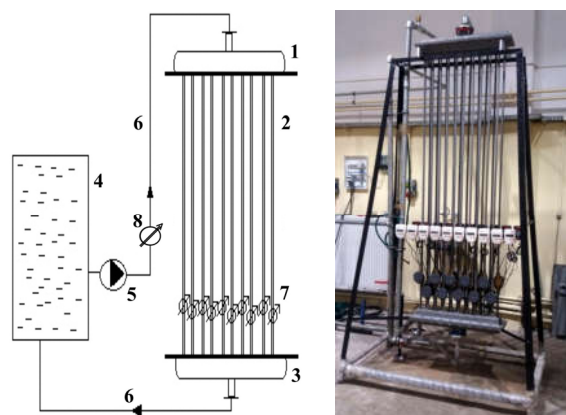
Fig. 9. Schematic of the stand for investigation of flow distribution in heat exchanger with elliptical tubes: 1 – inlet header with nozzle pipe, 2 – tubular space of heat exchanger (elliptical tubes), 3 – outlet header with nozzle pipe, 4 – water tank, 5 – feed pump, 6 – connections, 7 – flowmeters located in each tube, 8 – flow meter of total flow rate of working fluid

Figure 9 presents a schematic and general view of the test stand (for investigation of flow distribution in the heat exchanger with elliptical tubes). Various interchangeable inlet and outlet chambers are depicted in Figs. 10 and 11.

The Sontex Superstatic 749 flowmeters are used for the measurement of the instantaneous flow rate in individual heat exchanger tubes [19]. The another flowmeter is installed before the heat exchanger to control the total flow rate and the indications of the flowmeters located within the tubes.
