Materials, used in historical buildings, analysis methods and solutions proposals

M.Sami Döndüren¹, and Ozlem Şişik¹

¹Department of Civil Engineering, Selcuk University, 42060 Konya, Turkey

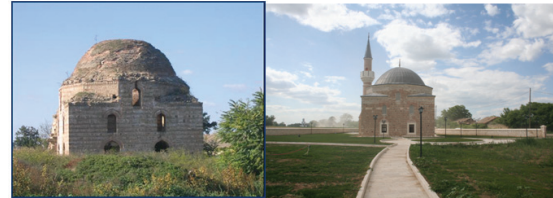
Fig. 1. Photographs before and after restoration of the Timurtaş(Demirtaş) Mosque (2007-2008).

In this section informations given was taken from the restoration,pre- restoration and restoration reports prepared for the Timurtaş (Demirtaş) Mosque of Edirne foundation general in 2007 prior to restoration of the building. Figs. 1-3 show the pictures of the tomb before and after repair.

The material decrement on the groud form walls have been completed according to the original material and mesh system. Filling the capillary cracks in the structure with epoxy plaster, 4 cm wide cracks are stitched with iron plates and they are filled with epoxy again. For cracks larger than 4 cm, it is recommended that the perimeter be disinfected and filled in accordance with the original material and mesh system. Except base of the minaret, the mosque was destroyed. Since the old photo about the minaret could not be found, it was completed with the guidance of periodical analyzes. As a suggested at the restitutions projects, the rostrum with alternated had been built of bricks. Transition from the ground form to the base was made with triangles. As a result of the periodical analyzes, this decision was made (Saruca Pasha

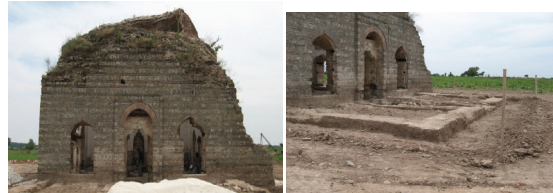
Fig. 2. Photographs before and after restoration of the Timurtaş(Demirtaş) Mosque (2007).

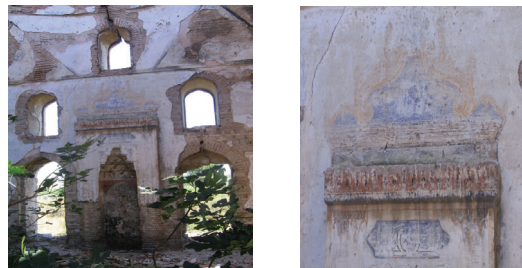
Fig. 3. Photographs before and after restoration of the Timurtaş(Demirtaş) Mosque (2007).

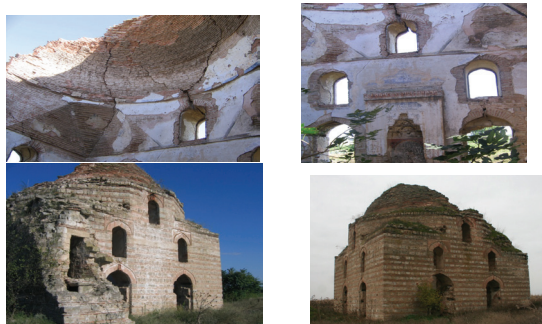
As a results under G force when the effects of structural analysis are examined, on the carrier walls of the structure. In the Turkish Earthquake Regulation, it has been observed that the compression tension and dislocation stress values proposed for masonry structures are exceeded. As a matter of fact, the size of the dome of the structure and the cracks formed is an indication that the structure is not stable (Fig. 9).

Fig. 9. Timurtaş (Demirtaş) Mosque prior to the restoration of damaged photos.
