As- built inventory of the office building with the use of terrestrial laser scanning

Abstract. Terrestrial Laser Scanning (TLS) is an efficient tool for building inventories. Based on the red-laser beam technology it is possible to provide the high accuracy data with complete spatial information about a scanned object. In this article, authors present the solution of use a TLS in as-built inventory of the office building. Based on the provided data, it is possible to evaluate the correctness of built details of a building and provide information for further construction works, for example an area needed for Styrofoam installation. The biggest problem in this research is that an error which equals over 1cm could generate costs, which could be a problem to cover by a constructor. Based on a complicated place of the construction works (centre of a city) it was a challenge to maintain the accuracy.

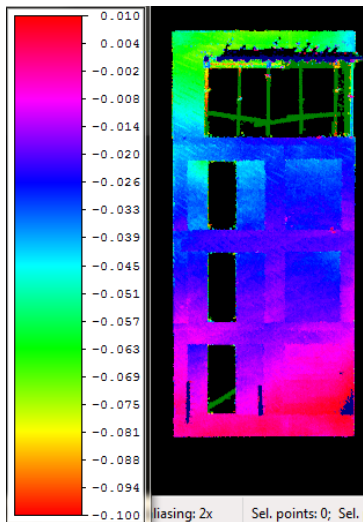
measurement accuracy was up to 1 cm, the plane matching error has to be estimated. It was computed as standard deviation values for points distances which was taken into consideration and belonging to that plane. With that process, the standard deviation value equals approximately 5 mm. Angular deviations for each wall are presented in Fig. 10 for North, Fig. 11 for South, Fig. 12 for West and Fig. 13 for East. Values are presented in meters.

Fig. 12. Angular deviations for West wall in meters.
