Effective Dispersion of Carbon Nanotube in Epoxy Grout for Structural Rehabilitation

Abstract. The industry nowadays is incorporating the composite repair system for repairing pipelines rather than the conventional steel repair. The mechanism of this repair method usually consists of three components which are the composite wrapping, infill material and the adhesive. However, there has been very little research on the function of the infill in the repair mechanism. This work is concerning the enhancement of the performance or the strength properties of the infill material in pipeline repair by reinforcing the putty with carbon nanotubes (CNT). The enhancement of the performance of the infill has been carried out by dispersing the CNT into epoxy resin with a three roll mill. In the mechanical properties testing, it is found that the CNT is an effective material to improve the tensile strength of the epoxy grout. However, the CNT-modified samples in the compressive property test show a contrast to the tensile test. All the CNT-modified samples exhibit a lower compressive strength than the control sample and the milled down sample. In conclusion, CNT shows the potential to be a very

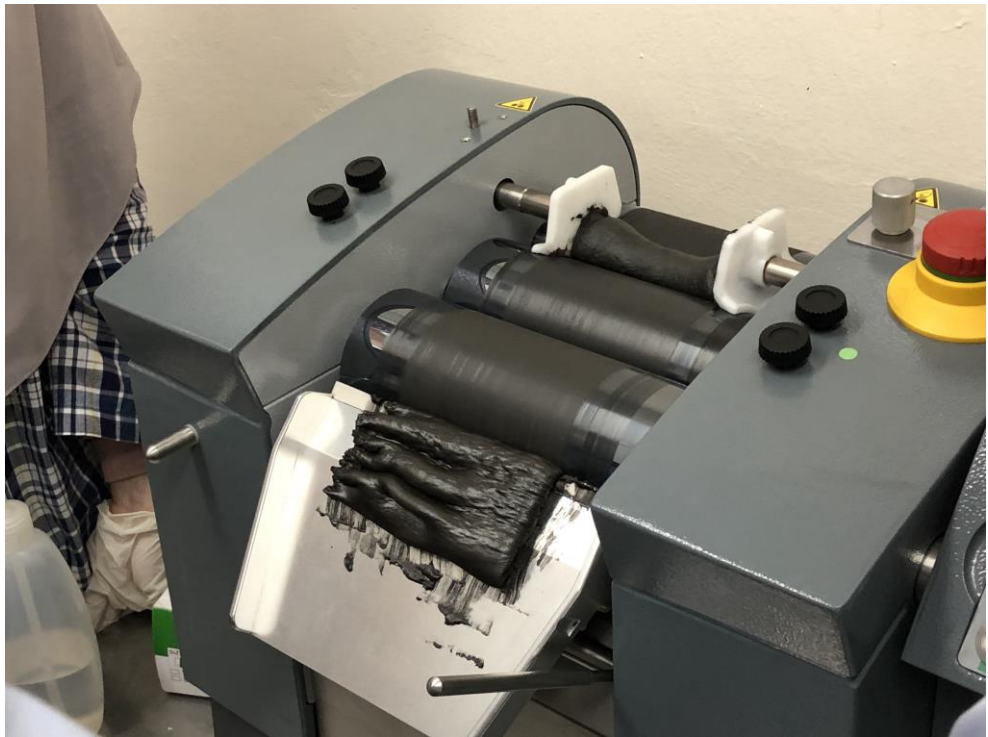
Fig. 2. Calendaring process of CNT-resin mixture.

Table 1. Three roll mill configuration.

No of passes	Gap 1 (μm)	Gap 2 (μm)	Roller Speed (rpm)
1	100	60	200
2	60	30	200
3	45	15	350

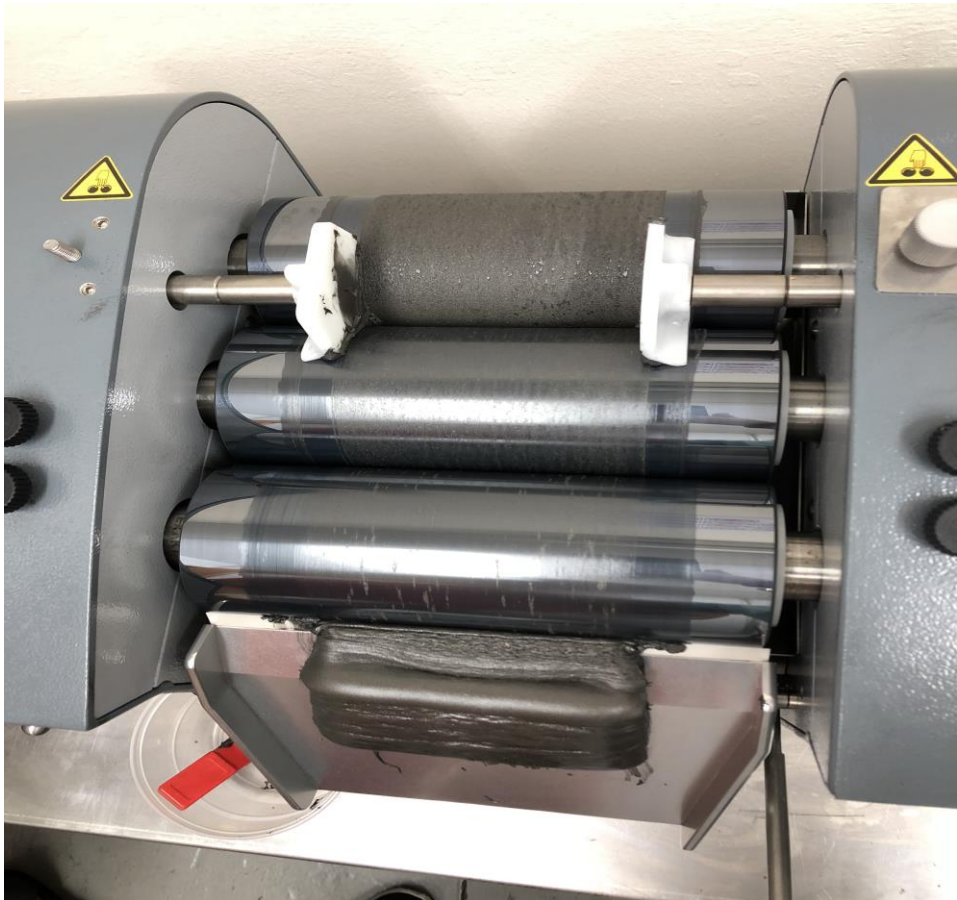
Fig. 3. Phase separation of the existing filler on the three roll mill.

In both the mechanical properties test, the result of the milled down sample differ from the other. This situation is most likely caused by the phase separation of the existing epoxy grout filler in the resin from the resin by the three roll mill (refer Fig. 3). The sizes of the

existing filler in the resin are too big to go through the designated gap of the three roll mill. The milled down sample has the highest compressive strength but the lowest tensile strength. The existing steel filler in the resin are suspected to act as the main tensile strength contributor in the unmodified matrix of the epoxy grout. Hence, with the steel filler which is the tensile strength contributor in the matrix separated from the resin in the milled down sample, the tensile strength drops dramatically from the control sample to the milled down sample. On the other hand, with the tensile strength contributor separated, the compressive strength of the matrix can be improved because the matrix will be denser and without any filler.
