Experimental Study on the Effect of Heel Plate Length on the Structural Integrity of Cold-formed Steel Roof Trusses

Abstract. Applications of Cold-Formed Steel (CFS) are widely used in buildings, machinery and etc. Many researchers began the research of CFS as a roof truss system. It is required to increase the knowledge of the configurations of CFS roof trusses due to the uncertainty of the structural failures regarding the materials and rigidity of joints. The objective of this research is to investigate the effect of heel plate length to the ultimate load capacity of CFS roof truss system. Three different lengths of heel plate specimens were fabricated and subjected to concentrated loads until failure. The highest ultimate capacity for the experiment was 30 kN. The results showed that the increment of the length of the heel plate had slightly increased the ultimate capacity and strain. The increment of the length of the heel plate had increased the deflection of the bottom chords but decreased the deflection of the top chords. Local buckling of top chords adjacent to the heel plate was the primary failure mode for all the heel plate specimens.

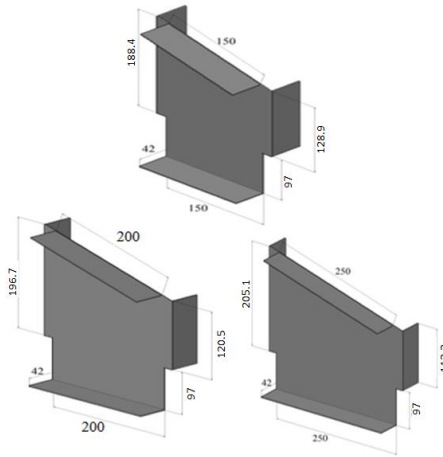
Fig. 1. Dimensions and configurations of heel plates.

All the members were supported by using a heel plate, additional plate, and ridge plate as shown in Fig. 1, Fig. 2 and Fig. 3 respectively. All the members were connected by M5 hexagonal head bolt and nut. The lengths of the heel plates used consisted of 150 mm, 200 mm and 250 mm. Fig. 4 shows the dimensions of the heel plate truss specimen. Fig. 5 and Fig. 6 show the configurations of a typical test setup for the heel plate truss specimen and conventional roof truss with intermediate members respectively. The conventional roof truss was fabricated to compare the ultimate capacity with the heel plate truss specimen.

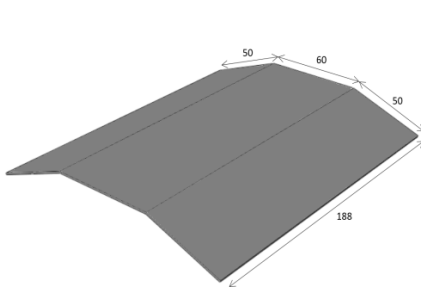
Fig. 2. Additional plate.

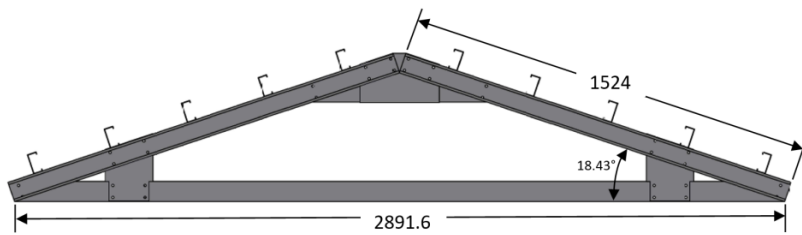
Fig. 4. Dimensions for heel plate CFS truss specimen.

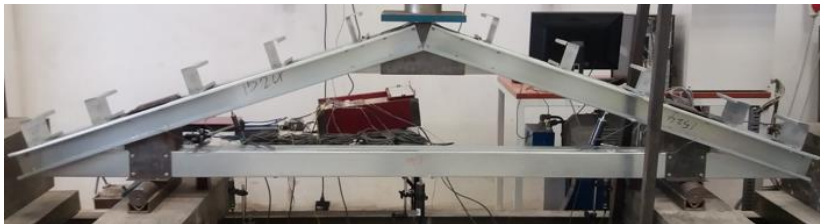
Fig. 5. Typical test setup for the heel plate CFS truss specimen.

The ultimate capacity and failure mode for all the specimens were determined by using 300 kN structural reaction frame subjected to an area load at the ridge [7]. Load capacity, deflection, strain and failure mode of the specimens were analyzed and the load was plotted against deflection and strain.

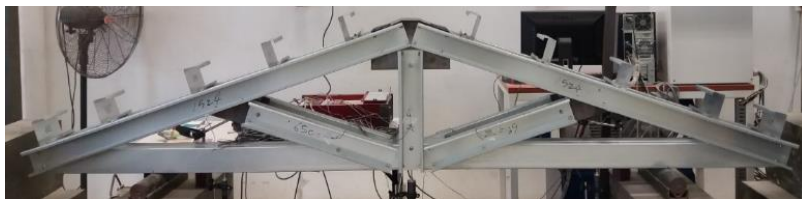
Fig. 6. Conventional CFS roof truss specimen.

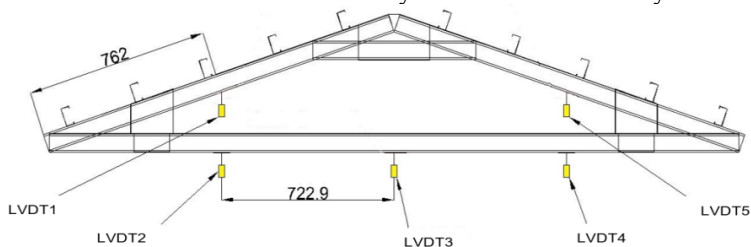
The positions of LVDTs were referred to Mohammad, Tahir, Tan & Shek [10] as shown in Fig. 7. LVDTs 1 and 5 were placed at the midspan of the top chord to determine the vertical deflection of top chords. Besides, LVDT 3 was positioned at the middle of the bottom chord to identify the maximum vertical deflection of the bottom chord. Whereas, LVDTs 2 and 4 were installed with a distance of 722.9 mm away from LVDT 3 to verify the load balancing.

Fig. 7. Positions of LVDTs.

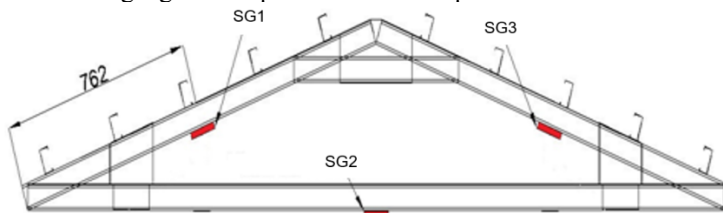
Strain gauges were used to measure the strain. Fig. 8 shows the location of the strain gauges. All of the strain gauges were placed in the midspan of the chord member.

Fig. 8. Positions of the strain gauge.

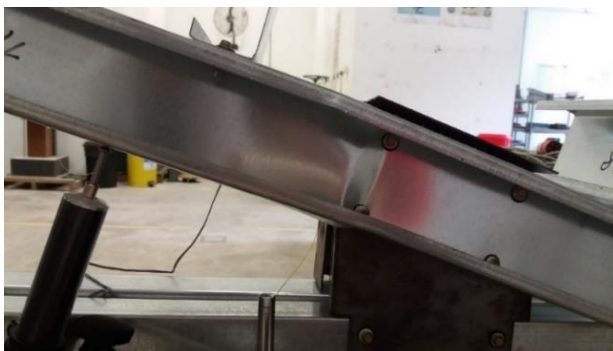
Based on Table 3, the ultimate capacity for heel plate truss specimens was in between from 28 to 30 kN. Buckling waves were formed at the top chord webs adjacent to the heel plate when the load applied around 18 to 20 kN. The failure mode for all the heel plate truss specimens was local buckling of top chords adjacent to the heel plates at all of the four top chords as shown in Fig. 9. Harper, LaBoube, and Yu [5] stated that removing the intermediate member of the truss will occur the failure of local buckling of top chords. As for conventional roof truss, the failure mode was local buckling of bottom chords at the support and distortional buckling of top chords at the ridge as shown in Figs. 10(a) and 10(b).

Fig. 9. Local buckling of top chord for heel plate truss specimen.

The experimental results were analyzed and discussed on three small-scale CFS roof truss specimens were fabricated with different lengths of the heel plate. The major failure mode for all of the heel plate specimens was local buckling of top chords adjacent to the heel plate. Whereas, the failure mode for conventional roof truss was distortional buckling of top chords at the ridge and local buckling of bottom chords at the support. The ultimate load capacity, ultimate deflection for bottom chords and ultimate strain for top chords slightly increased with the increment of the length of the heel plate. Whereas, the ultimate deflection for the top chord slightly decreased when the length of the heel plate increased. All the deflection mode for the heel plate truss specimens were sagging deflection at top chords and sagging hogging sagging deflection at bottom chords. As for conventional truss specimen, all of the chord members were in sagging deflection.

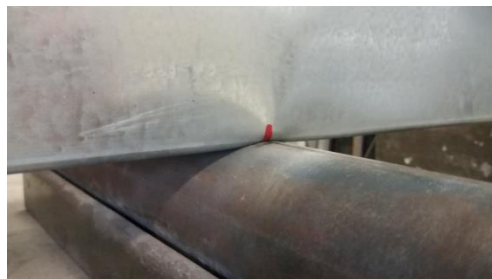
Fig. 10(a). Local buckling of bottom chord for conventional truss specimen.

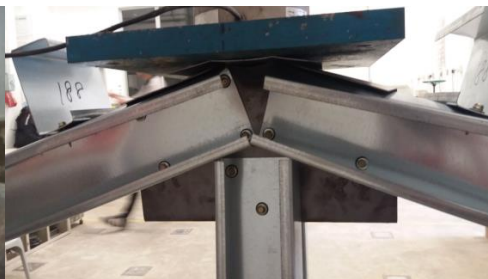
Fig. 10(b). Distortional buckling of top chord for conventional truss specimen.

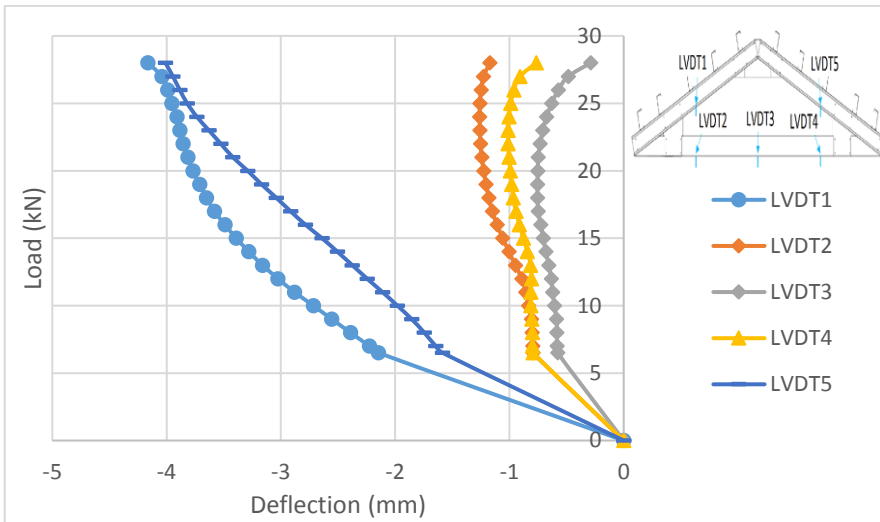
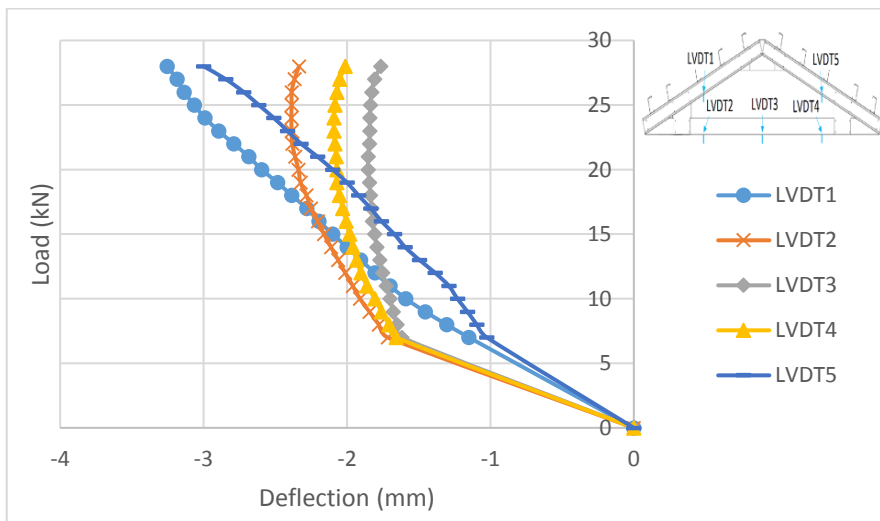
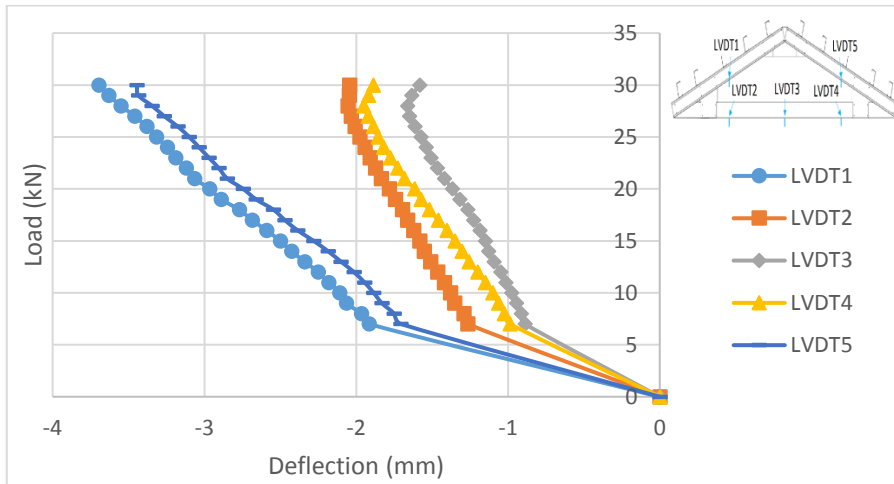
Fig. 11. Load versus deflection for T3L150 specimen.

Fig. 12. Load versus deflection for T3L200 specimen.

Fig. 13. Load versus deflection for T3L250 specimen.

All the data were plotted with load against deflection and strain as shown in Fig. 11 to 16. The data from Table 3 showed that both sides of the top chords were in negative deflection, which was sagging deflection. LVDT3 for heel plate truss specimens were in hogging deflection. Whereas, both LVDTs 2 and 4 were in sagging deflection for heel plate

Generally, the ultimate load capacity increased as the length of the heel plate increased from 150 mm to 250 mm. As for maximum deflection, the top chords for T3L150 specimen had the highest deflection followed by T3L250 and T3L200 specimens. These might be due to the effective length of the top chords for T3L150 specimen was longer than other specimens. Whereas, the bottom chords for T3L150 specimen had the lowest deflection followed by T3L250 and T3L200 specimens. These might due to the top chords for T3L150 specimen had absorbed almost all the energy and transferred the lesser load to the bottom chord. As the heel plate goes longer, the heel plates went closer towards the applied load,

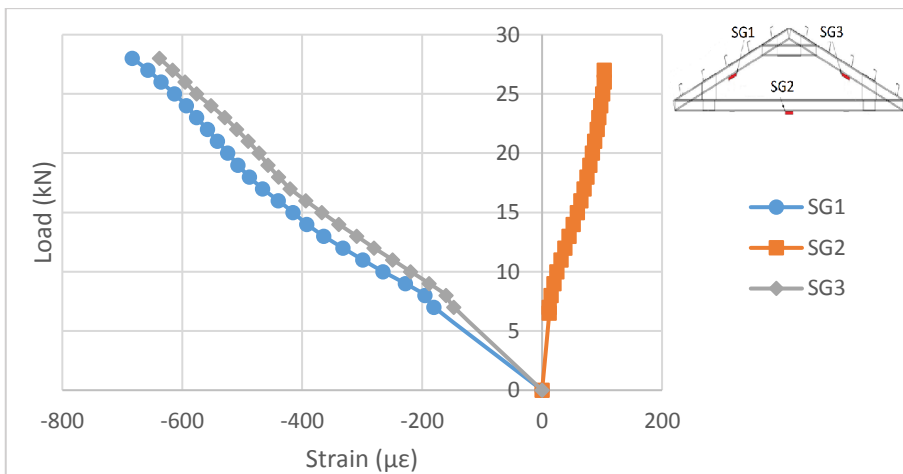
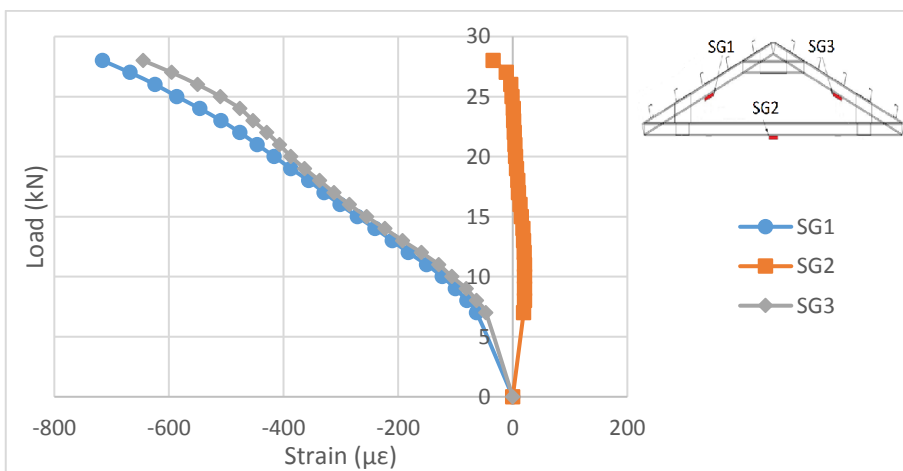
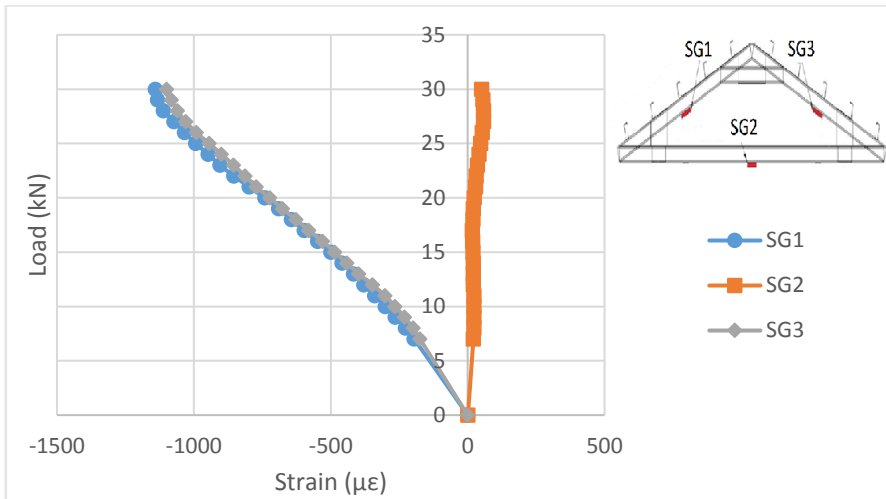
Fig. 14. Load versus strain for T3L150 specimen.

Fig. 15. Load versus strain for T3L200 specimen.

Fig. 16. Load versus strain for T3L250 specimen.

truss specimens. LVDT3 for heel plate truss specimens were hogging deflection even though it was negative deflection. These were due to both LVDTs 2 and 4 were higher negative deflection compare to LVDT3. On the other hand, the bottom chords for conventional truss were in sagging deflection. Fig. 17 to 19 show the illustration of the top chords and bottom chords deflections for heel plate truss specimen. Figs. 20, 21 and 22 show the load against deflection, load against strain and the phenomena of the top chords and bottom chords deflections for conventional truss specimen respectively. According to the strain data from Table 3, all the top chords for the heel plate specimens had a negative strain, which was in compression. Whereas, all the bottom chords for the heel plate specimens had a positive strain, which was in tension except for T3L200 specimen. While all the chord members for conventional roof truss were in positive strain as shown in Table 3.

The ultimate strain for the top chords increased simultaneously with the length of the heel plate. These were due to the edge of the heel plate became closer to the position of strain gauge as the length of the heel plate increases, where the local buckling failure happened at the edge of the heel plate. Besides that, the strain of bottom chords for T3L150 specimen had the highest strain followed by T3L250 and T3L200 specimens. These might due to the deflection of the bottom chords, where the difference between LVDTs 2 and 4 with LVDT3 became higher along the order, a higher difference of the deflection affect the strain changed from tension to compression. However, the ultimate strain for bottom chords of the conventional truss was a high positive strain, because the middle of the intermediate member carried the load directly from the ridge to the bottom chords of the truss. Both side of the top chords for conventional truss was in a tension state. These might due to both sides of the intermediate members pulled down the top chords as the bottom chords went downward with the increment of the load capacity.

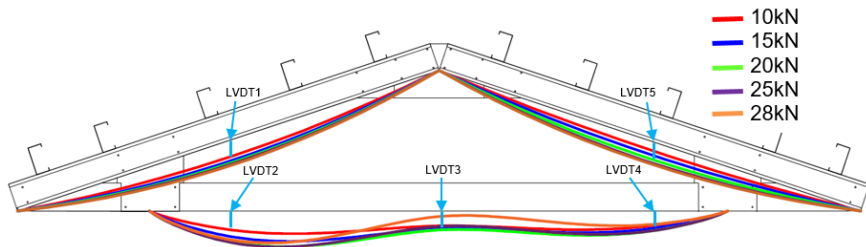
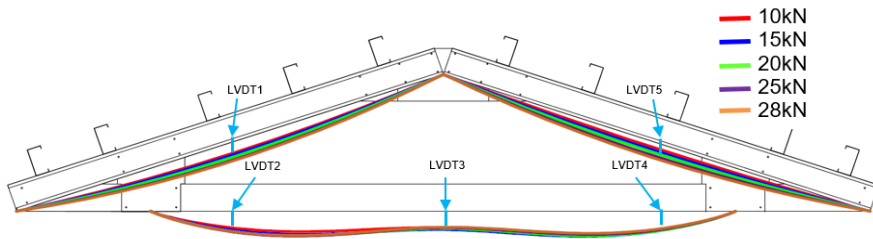
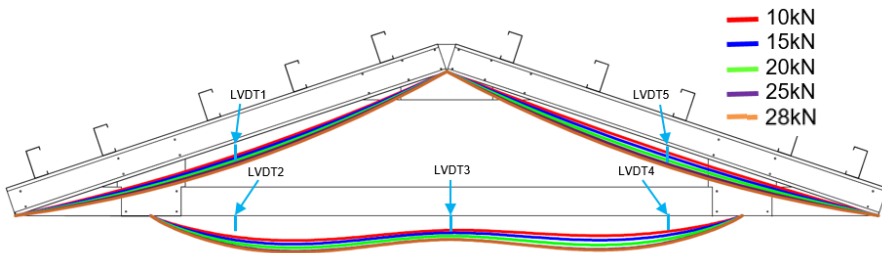
Fig. 17. Deflection for T3L150 specimen.

Fig. 18. Deflection for T3L200 specimen.

Fig. 19. Deflection for T3L250 specimen.

which resulting the load from the top chords transferred faster to the bottom chords than shorter heel plate specimen. However, all the data for T3L250 specimen were in the middle for both top and bottom chords. All the chord members for the conventional roof truss specimen had higher midspan deflection compared to all of the heel plate truss specimens. However, the ultimate load for the conventional truss specimen was lower than that of the heel plate truss specimens.

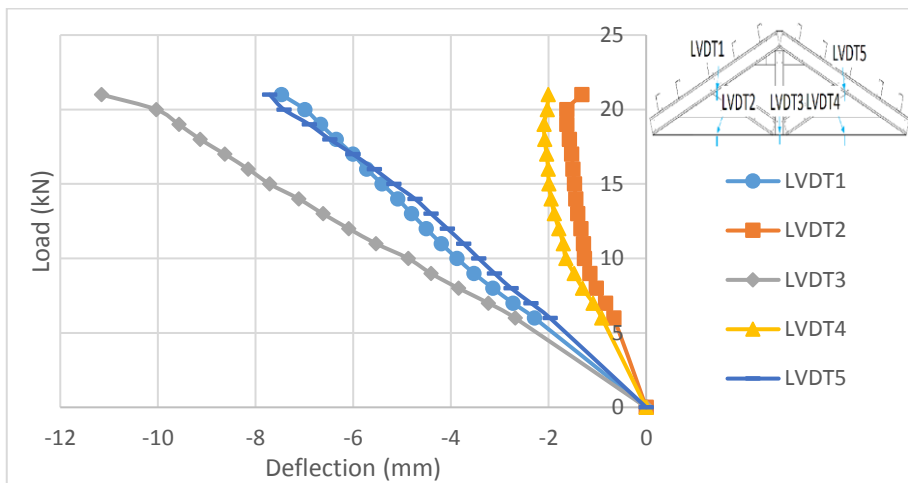
Fig. 20. Load versus deflection for conventional roof truss specimen.

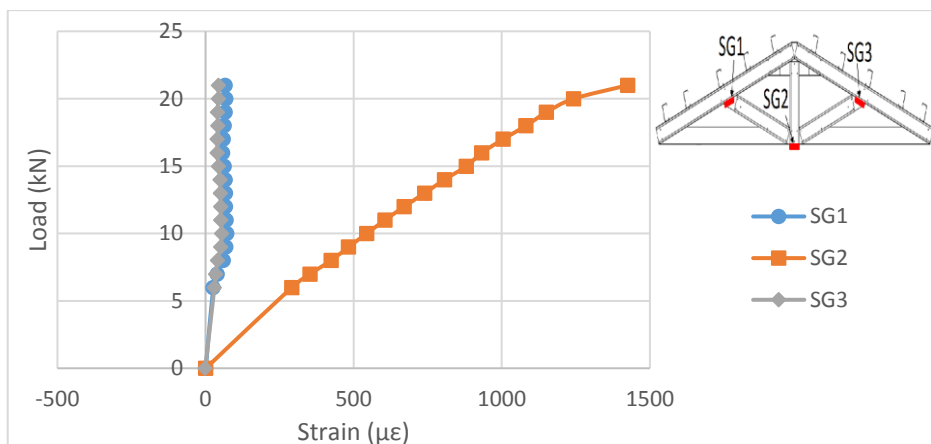
Fig. 21. Load versus strain for conventional roof truss specimen.

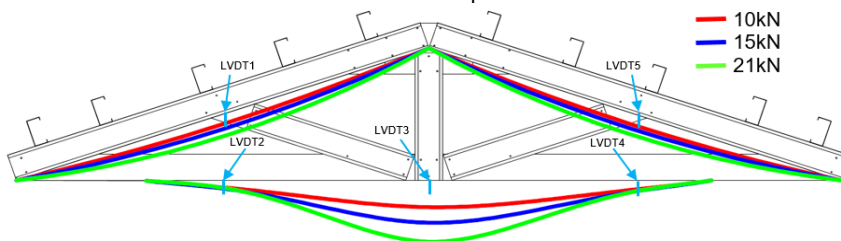
Fig. 22. Deflection for conventional truss specimen.
