Stability analysis of the Kosciuszko Mound using terrestrial laser scanner and numerical modelling

*Elżbieta Pilecka**, and *Karolina Tomaszekiewicz*

Cracow University of Technology, Faculty of Civil Engineering, Cracow, Poland

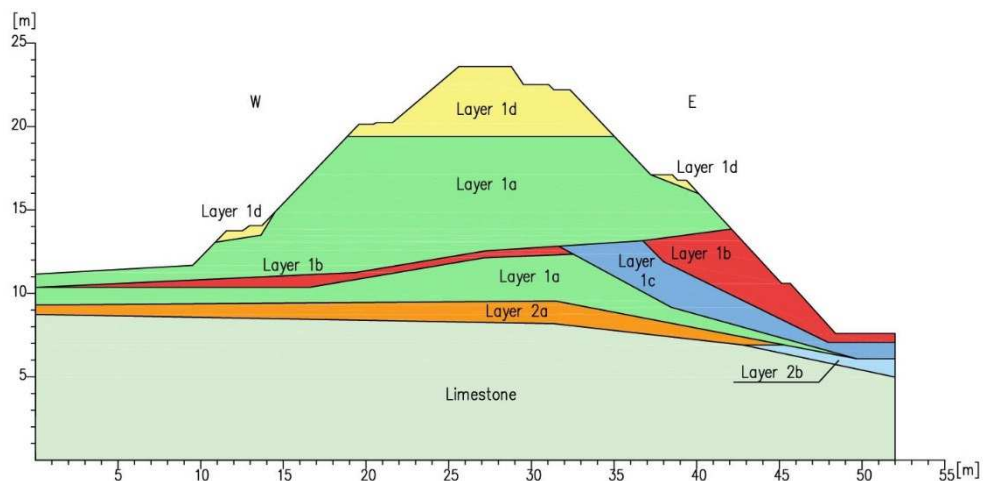
Fig. 5. Layout of W-E cross-sections adopted for the numerical model.

The width of the model is 52 m, and the height of 23.5 m (at the highest point). The layers marked 1a-1d are anthropogenic soils and layers 2a and 2b are original soils. The upper part of the Mound is made of non-cohesive soils in the form of medium sand, medium sand with gravel, medium or fine sand with dust, sand with dust and gravel, gravel with sand and dust, gravel with sand. The lower part of the embankment is made of cohesive soils in the form of dusts, dusts with loams, clay with dust and sand, dust with clay and sand. The whole structure is based on limestone.
