# Remote sensing of Carpathian flysch landslides with the use of terrestrial laser scanner

**Abstract.** Terrestrial laser scanning helps us to detect unstable subsurface behaviour, assessing the slope stability and potential landslide failure modes. If the slopes are regularly observed, the risk of slope movement and subsequent consequences may be considerably reduced. This allows for optimum land use conditions that are economically justified. Landslides in the Carpathian flysch have a peculiar susceptibility to activation due to the region's geological structure. This work addresses the problem of monitoring and analysing the effects of landslides associated with the operation of routes (roads and railway lines) running through the slopes of the Carpathian flysch. The terrestrial laser scanner enables site remote sensing in a simple and automated manner. Regular measurements with multiple scanner positions may be used for long term slope monitoring. A detailed geological structural model allows for risk assessment with regards to failure modes, and it allows for a slope stability assessment. The model, along with the substrate parameters, introduced into the Finite Element Anal

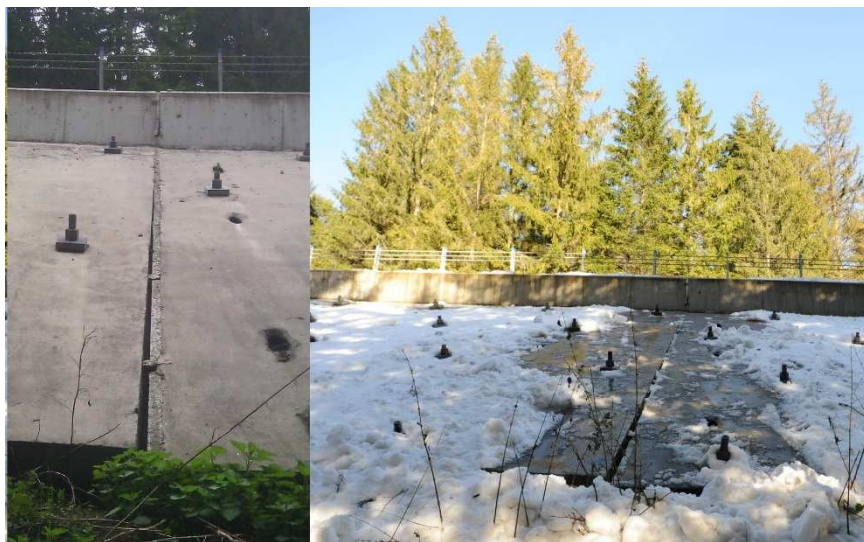
**Fig. 3.** Retaining structure with the damaged slab section (photo by authors).

The research area is located in the active part of the landslide #1 [7]. Therefore, the section of the provincial road located along this area is at risk. The as-built inventory shows that the sections of the retaining structure have been visibly dislocated. The displacement is clearly visible in the upper part of the plate and measures 8 cm horizontally and 3 cm vertically. Figure 3 presents a picture of the damaged slab section of the anchored retaining structure from different perspectives, taken during the summer and winter measurement campaigns.

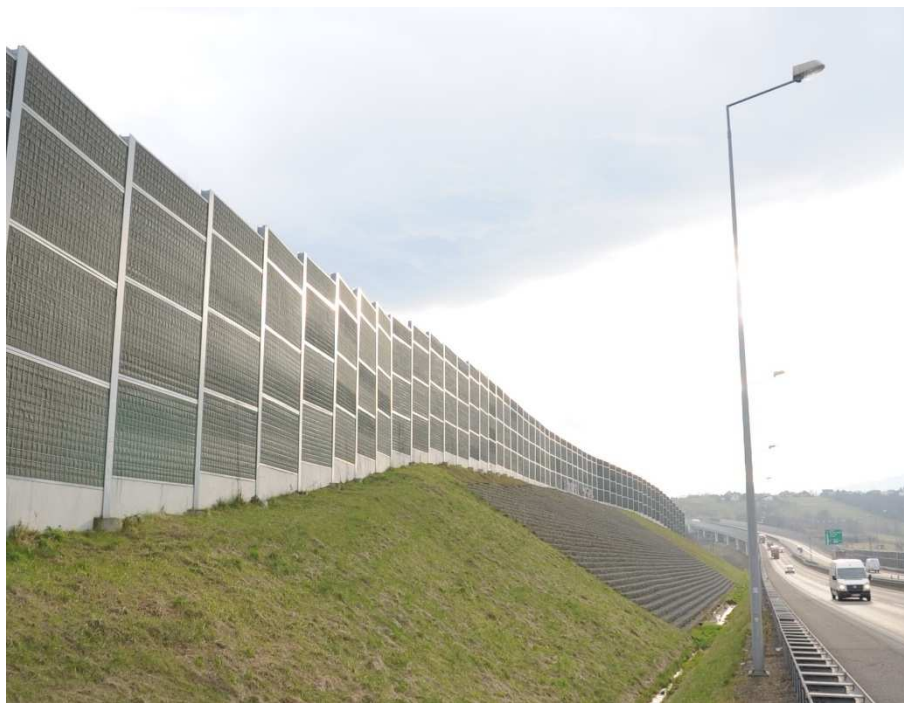
In the vicinity of the slope, a dual expressway was planned and built, along with a noise barrier located within the traffic lane. Therefore, earthworks were carried out involving the removal of the overburden soil and the construction of the escarpment. Figure 9 presents the overview of the slope with the retaining structure and noise barriers. The results of the analysis indicate the impact of the road excavations on reducing the stability of the built-up slope. Numerical calculations showed that the slope stability factor with the excavation made is about 15% smaller than the slope stability factor without excavation. The results concern only the dry slope. An additional destabilizing factor may be the groundwater table rise. The groundwater reduces the stability factor by about 20% [11]. This means that an excavation of the road and raising the groundwater level increases the threat to the road infrastructure.

**Fig. 9.** Overview of the slope with retaining structure and the noise barriers (photo by authors).
