Effect of Near-Wave Field Mining Tremors on the Rock Bolt Support Behaviour within Stress Domain

Abstract. One of the most serious hazard in the underground copper mining in Poland is the roof fall hazard. The scale and intensity of this type of events depends on several factors. Due to seismic activity, weaker roof strata can loosen and deform, generating additional load on the rock bolt support. The type of load depends strictly on the course of stratum deformation as well as on the intensity of the dynamic effect in the form of a seismic wave. Continuous monitoring is then necessary to determine the risk level of stability loss within existing excavations in order to minimize the probability of serious accidents. The following study analyses the impact of tremors recorded within the near-wave field upon the stress change in the instrumented rock bolts.

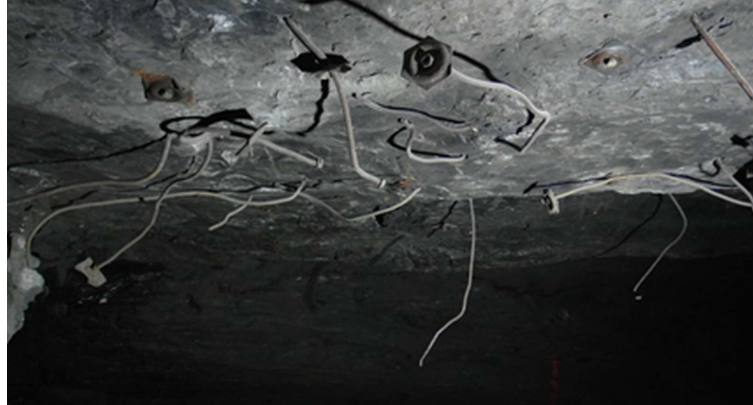
Based on many years of experience, it should be stated that the methods applied do not fully meet the expectations regarding early warnings of instability occurrences [14], which therefore results in a relatively high number of roof falls. Example of stability loss within the direct roof is shown in Fig. 1.

Fig. 1. Result of roof instability occurrence.

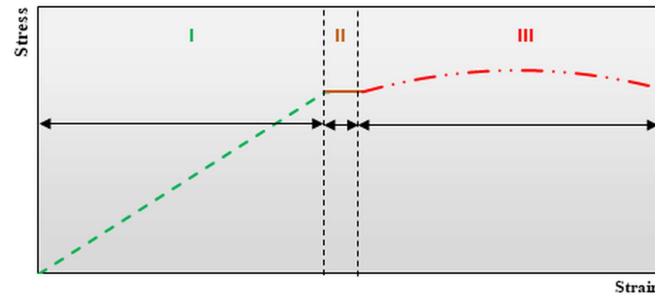
When the elastic limit of the rod is exceeded, the tension stabilizes temporarily and changes from elastic to plastic behaviour (Stage II in Fig. 3). In this state the stresses are determined by the following relation:

After exceeding the lower yield point, step III introduces, in which the nonlinear deformation begins. It may be described by the following relation:

Fig. 3. A typical stress-strain curve of steel used to rock bolt manufacture.

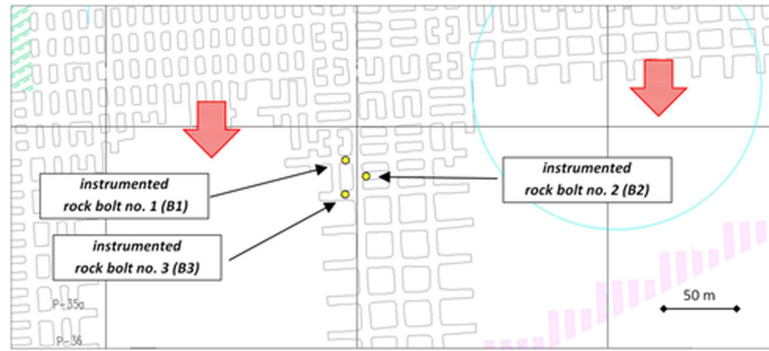
Fig. 4. Location of instrumented rock bolts (state of excavations on the day of installation).

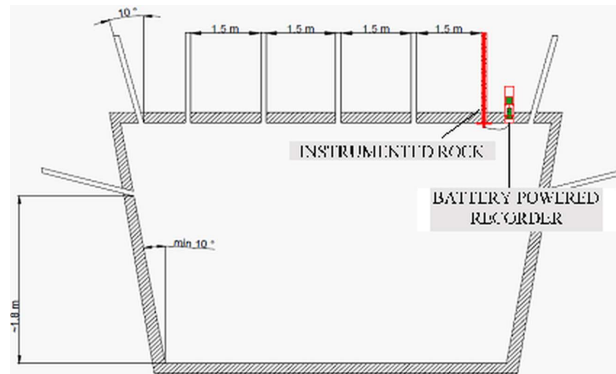
The rock bolts were installed close to walls within the roof of the excavations. It allows to prevent their possible damage by any mining machines (Fig. 5). The rod of the measuring bolts had same external dimensions as the dimensions of standard rock bolts used to support the drifts, thus their installation was carried out in accordance with the procedure adopted.

Fig. 5. Location of the instrumented bolts in the section of the drift.

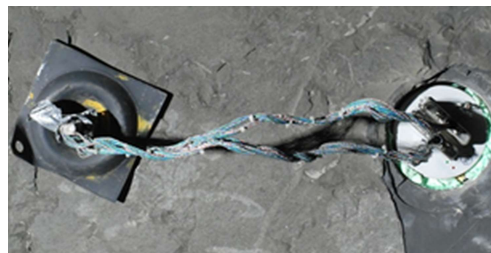
The recorder was placed in a bore located approximately 30 cm from the measuring bolt (Fig. 6). The measuring system was equipped with power supply unit in the form of a Ni-Cd battery and internal memory. The sampling frequency of 1 Hz allowed for the precise mapping of forces acting on the bolt rod.

Fig. 6. View of the measuring system installed in the direct roof.

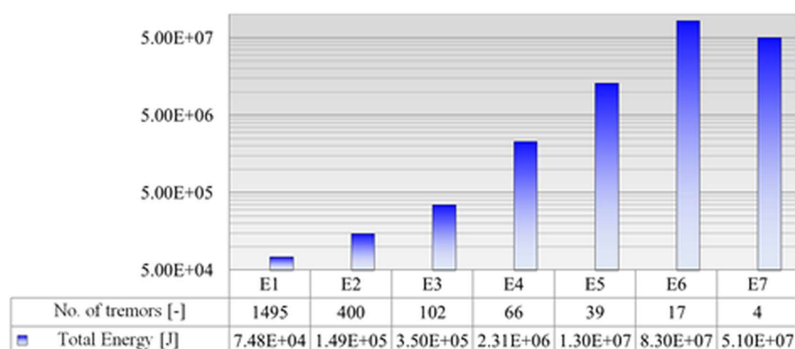
During the measurement period, from 17 May 2016 to 10 December 2016, seismic activity remained at a high level. The energy distribution of seismic tremors in the analyzed panel is presented in Figure 7.

Fig. 7. Energy distribution of seismic events within the analysed period.

The total number of tremors in the abovementioned period amounted to 2123 with a total energy emission of 1.5×10^8 J. Data of all events that caused a visible change in the stress in the bolts rods were considered.

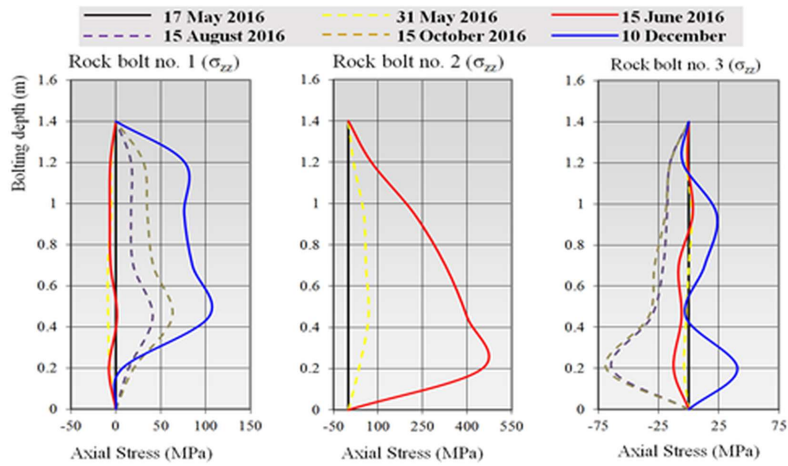
Despite close distance between the individual bolts, the obtained values of axial stresses on subsequent bolts differ significantly. In the bolt no. 2, axial forces exceeded the value of 450 MPa, which indicates that the bolt rod reached already a plastic state. Continuous recording allowed to register a sudden increase in axial stresses, as a result of which, 7 days before the roof collapse, the roof fall hazard was determined. On 15 June 2016, the roof was scaled due to the serious hazard of roof fall. Therefore, in the following testing period, i.e. from 16 June 2016 to 10 December 2016, the measurements were carried out using two other bolts. From figure 10 on may conclude, that on the final day of the measurements, the axial stresses in bolt no. 1 slightly exceeded the level of 100 MPa while in the bolt no. 3 - 40 MPa.

Fig. 8. Measured values of axial stresses within the direct roof.

Records obtained from the measurements were analysed and correlated with the observed seismic activity within the considered mining panel in order to determine their impact on the roof condition. The recorded values of shear and axial stresses are presented in Figures 8-10.

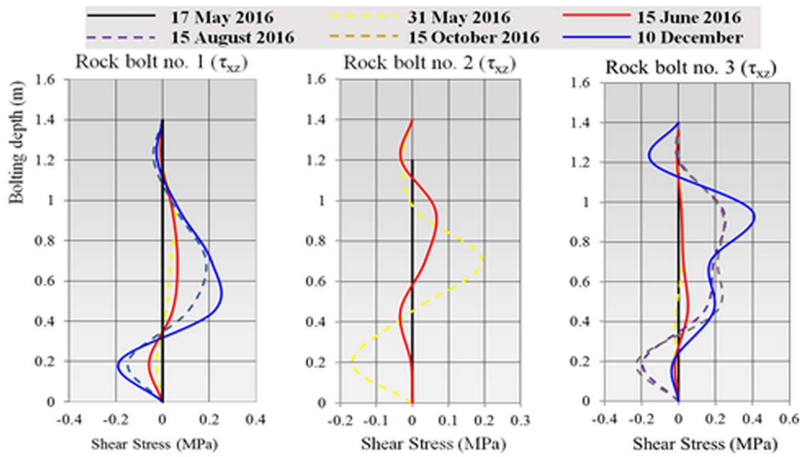
The four-way system allowed to determine the shear stresses at each measurement level. As shown in Figures 11 and 12, the largest values of shear forces towards the x and y components varies between 0 and 1.2 MPa. It proves almost no shearing in the surrounding roof.

Fig. 9. Measured shear stresses τ_{xz} in the roof strata.

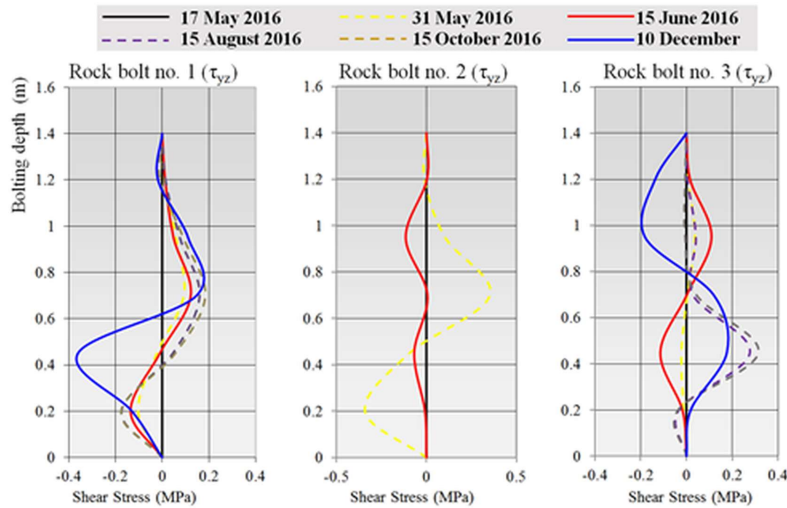
Fig. 10. Shear stresses τ_{yz} in the roof strata.

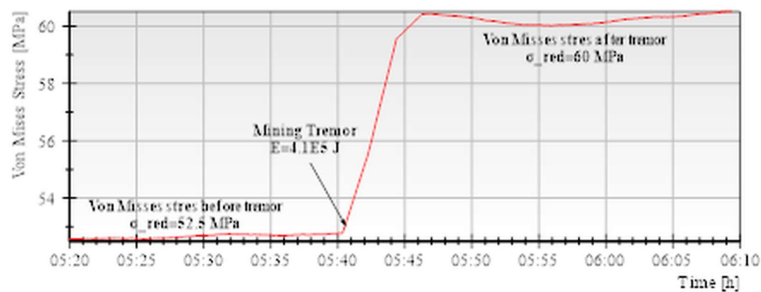
This enables to compare the measured values with the basic material constants. Reduced stress values were calculated for 103 events, including 60 high-energy events, for bolt no. 1 and no. 3 and 23 for bolt no. 2. Then, the results of the recorded stresses before and after the tremor were compared, allowing to verify the extent to which events of individual energy classes impacted the local roof stability (Fig. 11). Thus, all tremors which led to a visible change in the bolt stress were taken into account.

Fig. 11. Methodology for determining changes in axial stresses due to tremor.

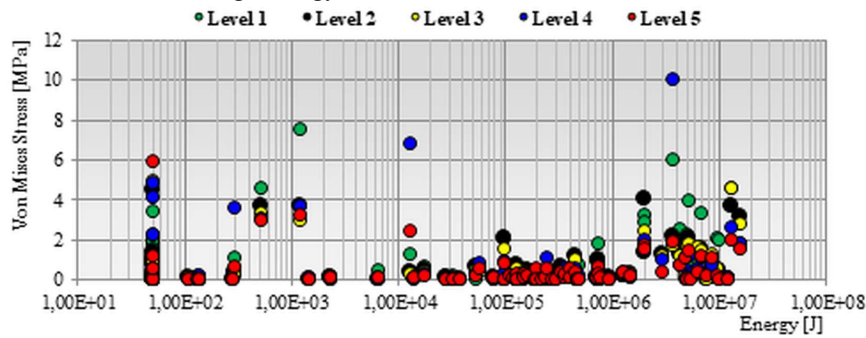
In the bolt rod no. 1 on the experimental completion day, the maximum value of recorded axial stresses amounted to 103.78 MPa. The biggest change occurred after the tremor with the seismic energy of 3.7×10^6 J and amounted to 10.02 MPa. In addition, four events with the energy smaller than 1×10^5 J led to a significant change in stresses, i.e. 1.2×10^3 J (+7.53 MPa); 5.0×10^3 J (+ 5.92 MPa); 1.3×10^4 J (+6.83 MPa) and 5.0×10^2 J (+ 4.92 MPa). The point cloud formed from the remaining 98 events did not reveal a clear correlation between their energy and the stress change within the roof strata. Figure 12

shows that in many cases tremors with relatively low energies have a greater impact on the roof fall hazard than the high energy events.

Fig. 12. Reduced stresses change due to dynamic event for bolt no. 1.

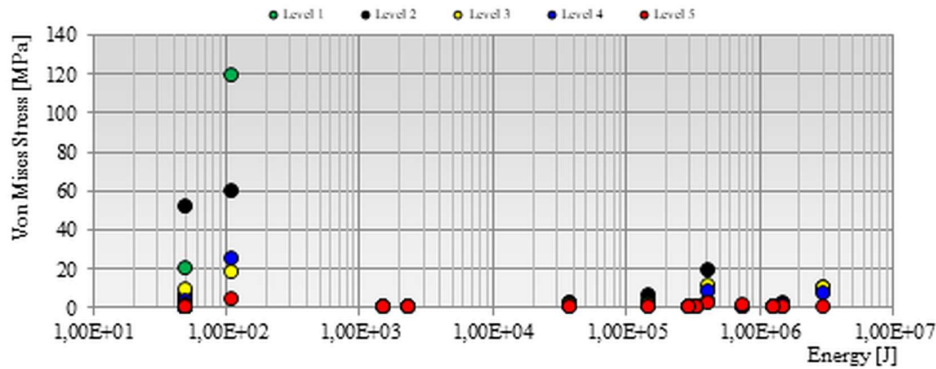
In the case of rock bolt no. 2 (Fig. 14), the maximum increase in the reduced stresses correlates with the occurrence of low-energy events. The highest stress increase was caused by a low-energy tremor of 1.1×10^2 J. Additionally, a significant increase in stress (52 MPa) was observed right after the seismic event with the energy of 5.0×10^1 J. Simultaneously, the negligible impact of high-energy events on the stress changes in the vicinity of the bolt no. 2 has been proven. This confirms the thesis that the roof fall safety is closely related to the location of tremors, even if they represent the lowest energy classes.

Fig. 13. Reduced stresses change due to dynamic event for bolt no. 2.

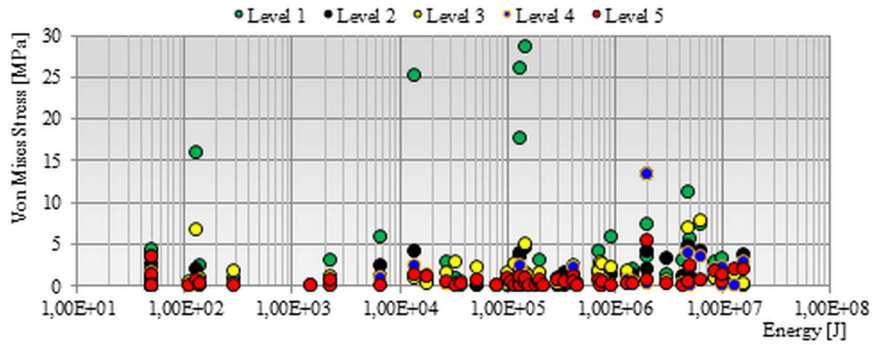
In the roof strata in the vicinity of rock bolt no. 3, the maximum stresses reduced based on von Mises criterion on the measurement completion day amounted to 40 MPa. Considering the impact of individual events on stress changes within the direct roof, it was concluded, that the greatest stress changes were caused by tremors of energy of 10^4 J and 10^5 J, i.e. 1.5×10^5 J (+29 MPa), 1.4×10^4 J (+26 MPa) and 1.3×10^5 J (-27 MPa). Events of E7 energy class did not cause any major stress changes in the roof strata in the vicinity of bolt no. 3. From figure 15 one may conclude, that the largest increase in stresses were recorded on the first measurement level, i.e. in the stratum located directly above the roof of the excavation.

Fig. 14. Stresses change as a result of dynamic event for bolt no. 3.

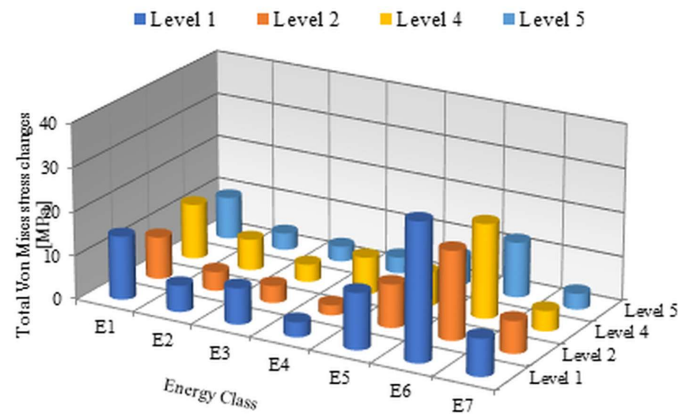
Changes of the stresses before and after the considered events were summed in order to determine the impact of events of particular energy classes on the stability of the roof. The obtained values are presented in spatial charts that enabled graphical interpretation of the obtained results. The largest total change in the stresses was caused by seismic events with energy of 1×10^6 J in the vicinity of bolt no. 1. Tremors of this type have a negative effect on the bolt rod along its entire length. Low-energy events had a significant effect on the stability of the roof as well (Fig. 15).

Fig. 15. Total changes of reduced stresses in bolt rod no. 1.

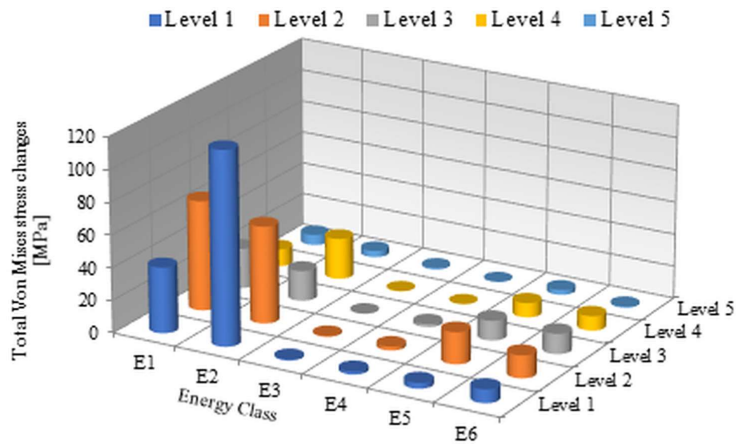
The largest stresses in bolt no. 2 were recorded at the first and second measurement level (Fig. 16). Changes of forces acting in the roof strata were triggered by events with low energy, i.e. E1 and E2 classes. It can therefore be assumed that such a high impact of tremors representing low energy classes is related to their genesis. Sudden increase of stresses in the area of measuring points after low-energy tremors indicates that they could have been caused by cracking or sudden spalling of rock stratum located directly above the immediate roof level. This confirms the increase in stresses at the first two measurement levels. Cracked rock layers, due to their low thickness, do not release energy great enough to determine their exact location during cracking. However, after partial detachment, they hang on the roof support generating high axial stresses.

Fig. 16. Total changes of reduced stresses in bolt rod no. 2.

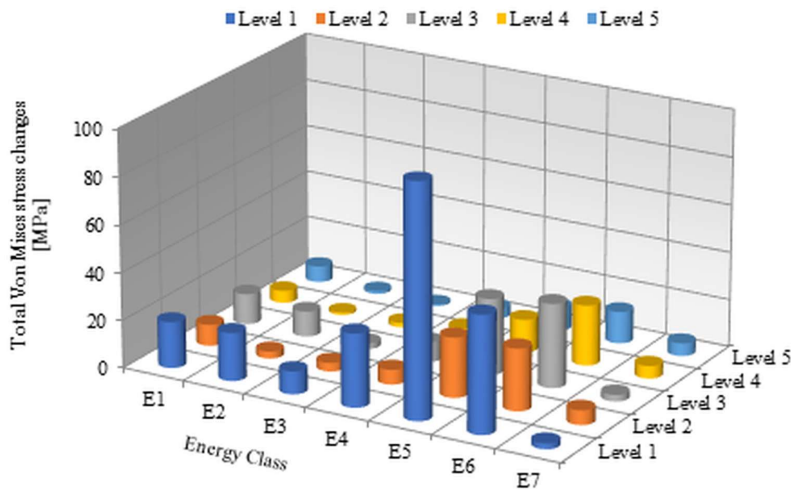
Measurements in the rock bolt no. 3 were characterized by relatively small changes in stresses. As shown in Figure 17, many tremors resulted in a decrease in the stress acting on the bolt rod. Similarly as in the case of the other two measuring bolts, dynamic changes of reduced stresses were recorded at the first and second measurement level, i.e. directly above the bottom of immediate roof strata. However in this case, the greatest destructive impacts were associated with the high-energy tremors.

Fig. 17. Total changes in reduced stresses in the bolt no. 3.
