# Landslide formation modelling and surveying of the slope in unsaturated and saturated ground conditions

**Abstract.** The terrestrial laser scanner enables site remote sensing of the slopes in a simple and automated manner. Regular measurements with multiple scanner positioning might be applied in long term landslide monitoring. A detailed geological structural model allows for hazard assessment, and then for a slope stability assessment. Numerical model, along with the subsoil parameters, introduced into the Finite Element Method (FEM) software enables an estimation of landslide susceptibility and the possible displacements of the terrain in longer period of time, as well as, due to different loading cases. In this paper the formation of landslides and stability of the slope after the retaining structure establishment is analysed. Two analysed landslides have different origin and may be a threat even after stabilization works already maintained.

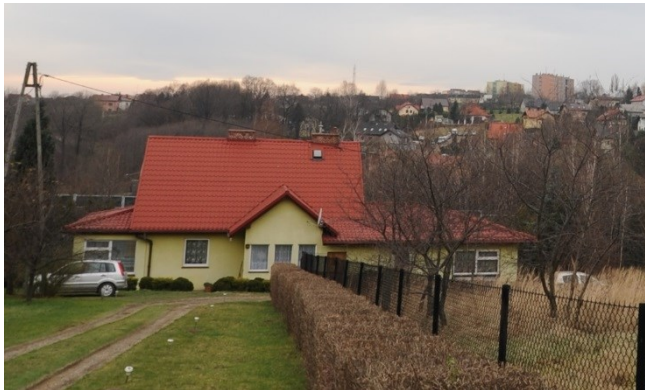
**Fig. 7.** The house located on the slope in the analysed case (photo by authors).

Figure 7 shows a house located on the slope in the analysed case. A terrestrial laser scan of the house is displayed in Figure 8. In fact, it is a differential model of the house prepared using the RiScan PRO software package using two consecutive scans [11-14]. The image obtained here, in the form of a cloud of points, proves that the ground movements below have almost no influence on the house located on the hill. The range of vertical deformations of the house do not exceed 2cm. The site is still under the investigation and the results of two consecutive scans visible in Figure 8 were performed within 12 months.

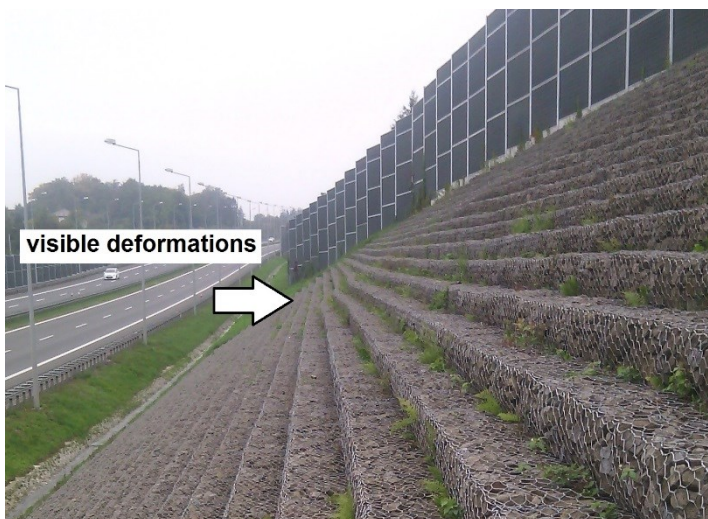
**Fig. 9.** Overview of the slope with retaining structure and the noise barriers (photo by authors).

In the vicinity of the slope, a dual expressway was planned and built, along with a noise barrier located over the traffic lane. Therefore, earthworks were carried out involving the removal of the overburden soil and the construction of a new escarpment. Figure 9 presents the overview of the slope with the retaining structure and noise barriers. From Figure 9 one may notice that there are significant deformations of the gabion wall boxes visible. Unfortunately, gabion boxes have been filled with unstable materials, which have probably originated from the demolition of surrounding objects being in collision with the road, and these are destroyed due to poor quality - e.g. crushed remains of old concrete construction elements, which were in poor state, and due to weather conditions disintegrate. That is the reason why it is impossible to analyse the displacements of the retaining structure basing only on the laser scanning.

Figure 12 displays the horizontal strains of  $E_{xx}$  in a direction perpendicular to the escarpment reflecting the manner of loss of stability. We may clearly see here the problems occurring in securing the slope with gabions, shown earlier in Figure 9, and subsequently the disintegration of the aggregate in gabions. The next figure confirms that, the slope has been stabilized. It may be visible in Figure 13 that, the retaining structure balances the forces destabilizing the escarpment. It shows horizontal displacements perpendicular to the slope calculated for the existing retaining structure on the slope after the accomplishment of the
