Identification of liquefaction disaster in Jondul Rawang, Padang City West Sumatra

Abstract. Liquefaction is a condition of continuous soil mass deformation at residual stress due to increasing pore water pressure that results in effective stress reduced. This study was conducted to identify the potential hazards of liquefaction in the Jondul Rawang area in Padang City. This study is to observe the soil contour and characteristics. Primary data obtained by observing the soil contour, soil characteristics, and the form of buildings, etc. Whilst, secondary data obtained from the related documents as supporting data. The results concluded that the Jondul Rawang area is potentially liquefaction area where the soil contours and characteristics could be classified as peat soil and lied in the swamps. Furthermore, if the rainfall intensity increase then flooding occurred. Then as consequences, there were many residential houses and other buildings around the area turning into tilted and drowned due to the degradation of soil bearing capacity. Therefore, requiring disaster management efforts against the threat of liquefaction in that area, both in terms of the drainage system due to flood

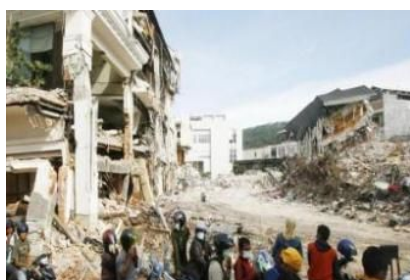
Fig. 1. Buildings collapse due to the Mentawai Earthquake in 2009 [3].

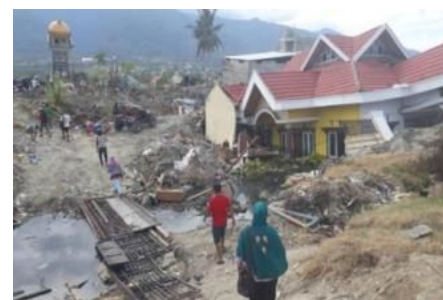
Fig.2. Sinking house in Bolora Housing due to earthquake resulting liquefaction 2018 [6].

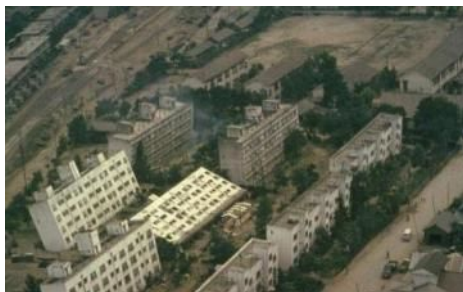
Fig.3.The liquefaction due to the Nigata earthquake in 1964 with 6,4 RS magnitude [7].

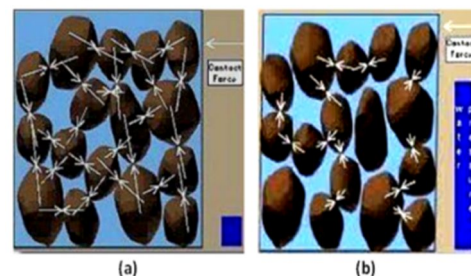
Fig.4. (a) Soil particles-liquefaction, (b) Soil particles after liquefaction [10].

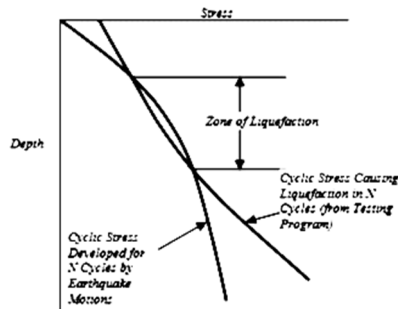
2. Determining the amount of cyclic stress using a loading test in a laboratory by an untroubled sample through a predetermined free pressure variation or tolerating properties with characteristics in the field.
3. Comparing shear stresses caused by earthquakes with things that can cause liquefaction to determine whether land deposits are in the liquefaction zone or not. As shown in Fig. 5.

Fig.5. Evaluation method for soil liquefaction potential [11].

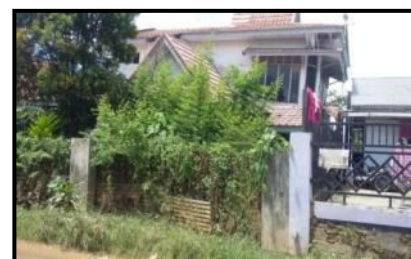
Following observation in the field, the type of soil at that location is peat soil. Peat soil is formed from the accumulation of residues from plants that are half-rotted or undergoing incomplete decomposition [15]. The type of soil in the observation location also has a lot of water content, as indicated in the Jondul Rawang Housing is a swampland that heaped up by the developer for the construction of housing (based on the interviews with the residents). The location under these conditions is very susceptible to the risk of liquefaction during an earthquake in Padang city.

Fig.7. The degradation of soil bearing capacity

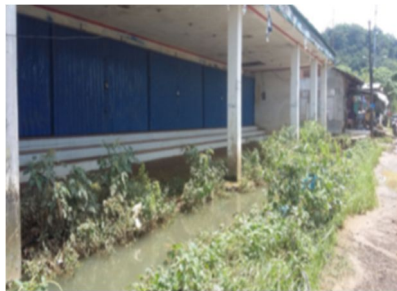
The description of the buildings in the Jondul Rawang Housing is the group of buildings that have several supermarkets or minimarkets owned by people. Fig. 8 shows the supermarket due to the changes of land subsidence in the study area. It shows the abandoned supermarket with a puddle of water due to the lack of water shrinkage in the location. The plants that grow in this location are needle grass, indicating that soil type is grainy.

Fig.8. The condition of supermarket due to land subsidence

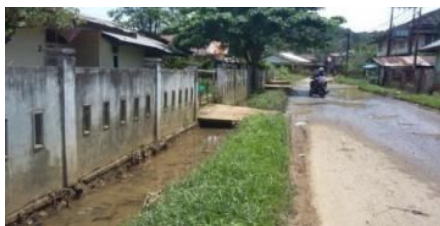
Besides soil degradation caused by the soil bearing capacity, the other causes are also caused by substandard drainage conditions in the housing (Fig. 9). In the picture, this below can be shown that the drainage system in the housing, which it's quite unworthy and the elevation of the drainage slope. It is caused by the process of land subsidence yearly. If the intensity of the rainfall is very high, it will enable the area to be very susceptible to flood disasters.

Fig.9. The degradation of the drainage canal

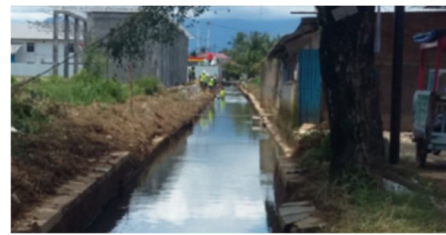
Fig.10. The refinement of the drainage canal

As for substandard drainage system issues, it is necessary to have a good process of improvement and drainage planning. As the authors visited the study area found that there was a process of renovation on the drainage system. These repairs aimed to control water capacity during heavy rainfall and can prevent flooding in the future (Fig. 10).
