# Repair and retrofitting of buildings post earthquake

**Abstract.** This paper discusses the damage types, repair methods and retrofitting of buildings post an earthquake. Data were taken by conducting surveys and assessment of buildings directly, both engineered and non-engineered buildings affected by the West Sumatra earthquake in 2009. Some causes of damage, among them is the detailing of reinforcement that do not follow the existing standard, soft-story effect, foundation failure, low material quality and does not meet the requirements, design and implementation of the construction do not follow the rules and technical provisions of the building earthquake resistant. Improvement and buildings retrofitting can be done after the buildings damage types or its components/parts and the quality of the building materials used were known. The structural analysis was done in order to know the cause of the building elements damaged and if the results of analysis with the latest regulations earthquake load, the building structures is able to withstand the earthquake loads and a repair is not required, but if not, the retrofitting is required.

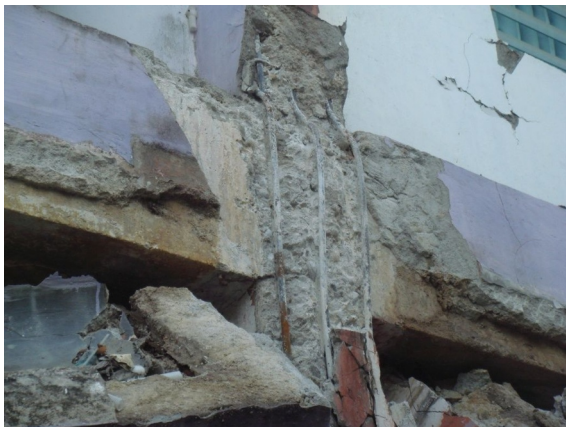
- a. Reinforcement detailing does not follow the standard include on the beam-column joints. Fig 1 and Fig 2 show the detailing do not meet the standards.

Fig. 1. Bad reinforcement detailing of beam-column joint

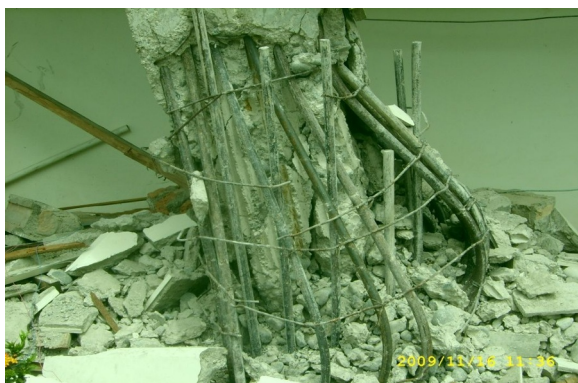
Fig 2. Reinforcement detailing do not meet a standards

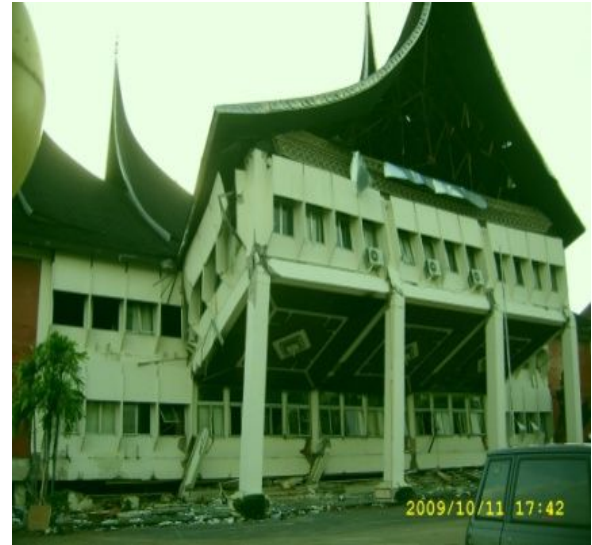
- b. Soft-story effects followed by the collapse of the beam-column joint as shown in the following Fig 3.

Fig 3. Soft-story effect on buildings

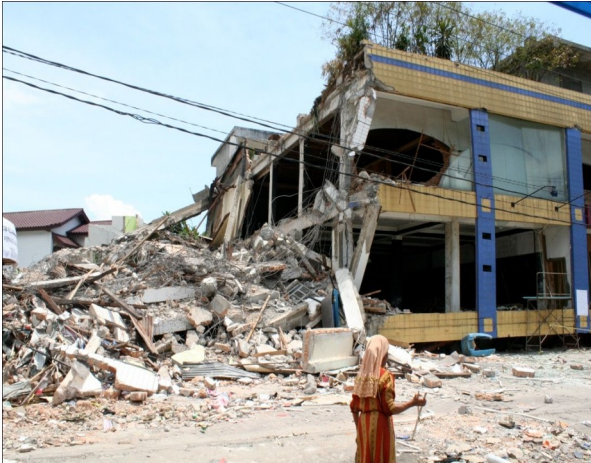
- d. The poor quality of materials and do not meet the requirements, both strength and its quality, as shown in Fig 5.

**Fig 5.** Building collapsed due to material quality do not meet the standards

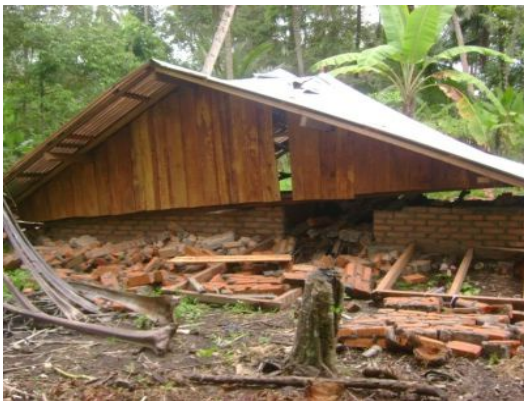
Fig 6, 7 and 8 show some types of collapse that occur in non-engineered buildings.

**Fig 6.** Brick walls collapsed

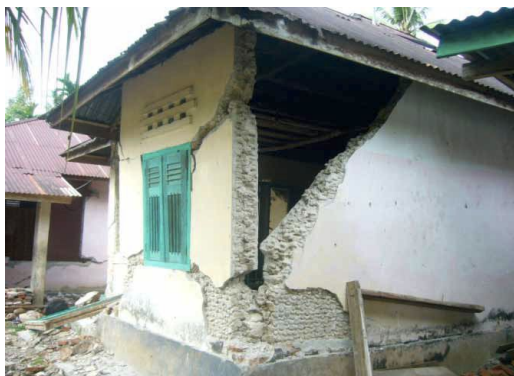
**Fig 7.** Wall separation of URM

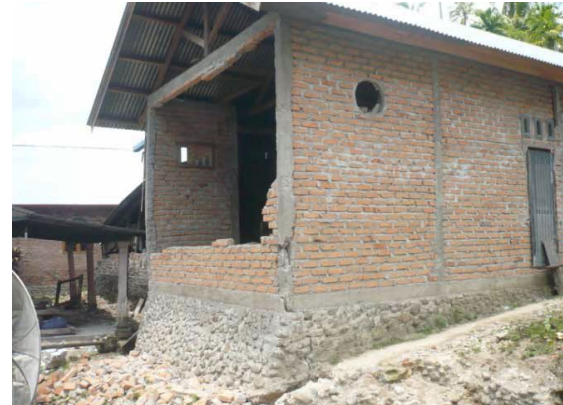
**Fig 8.** Some brick walls are collapsed

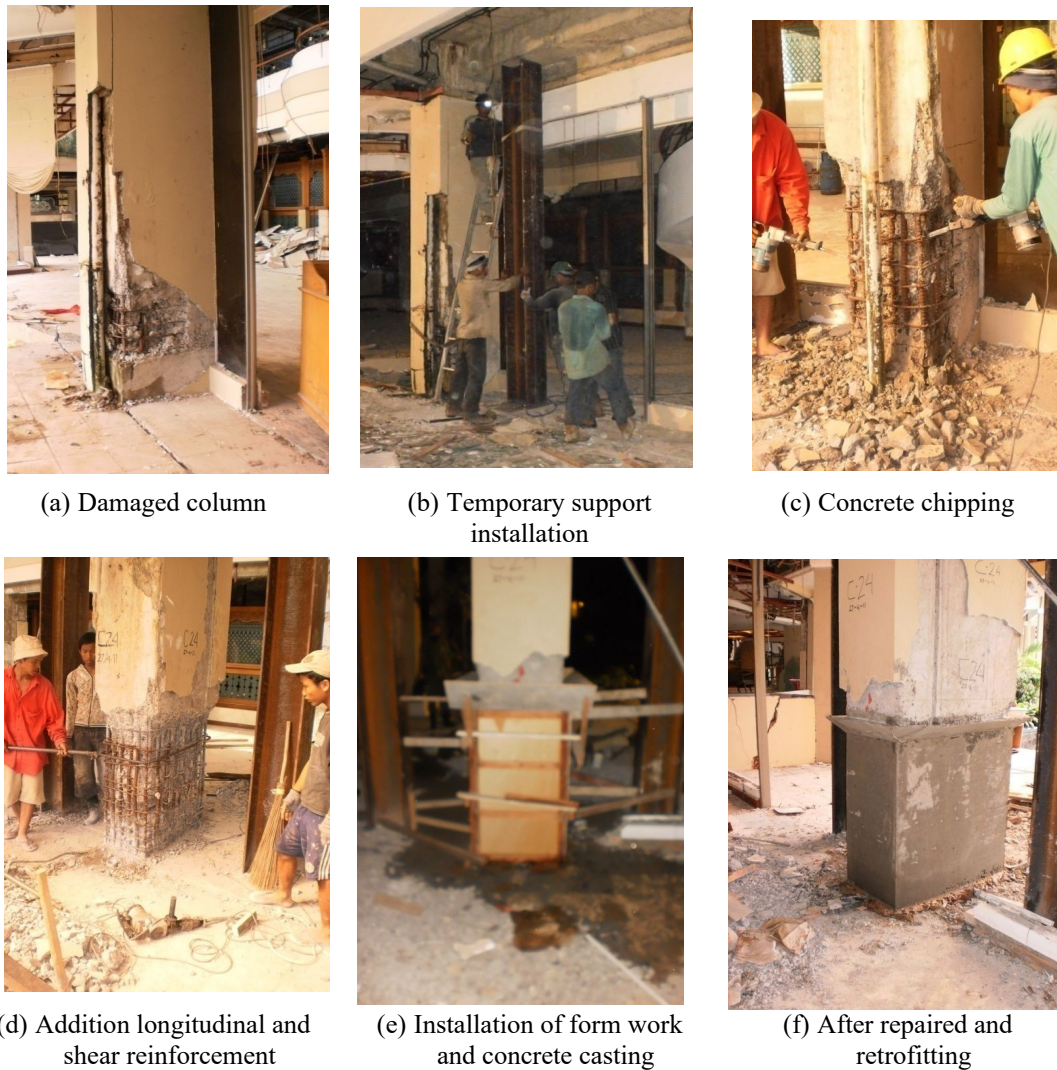
**Fig. 9.** Repair and retrofitting process of damaged column at the bottom.

Fig. 1 shows the repair process of column damaged at the bottom. The damaged column at the bottom (1. a). Installation of the temporary support (1.b), then done concrete chipping (1.c) addition of longitudinal and

shear reinforcement (1.d). Then installation of form work and concrete casting (1. e), and the final result on (1. f)

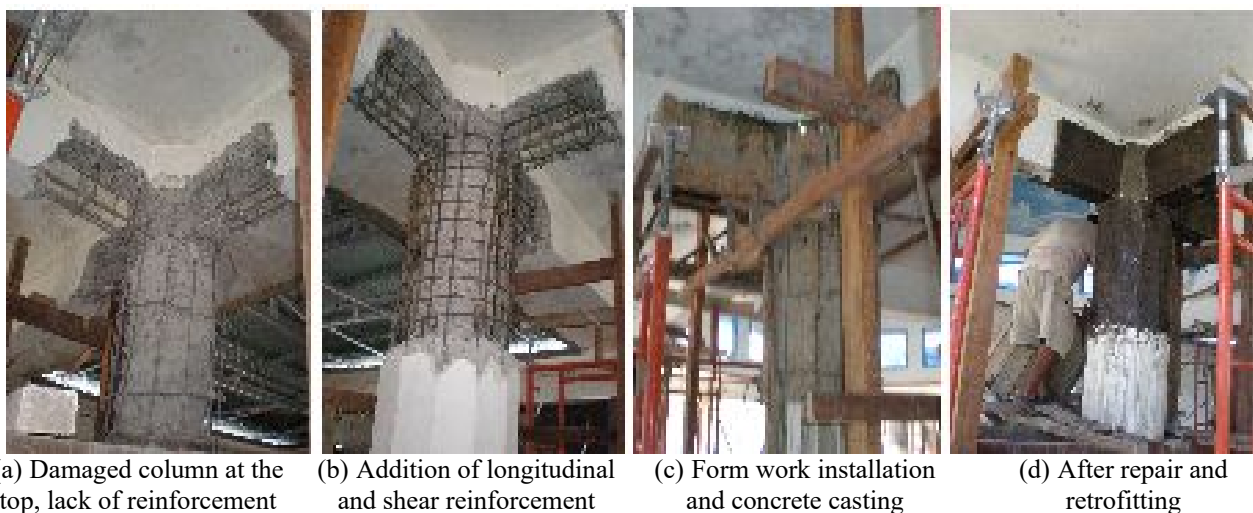
**Fig. 10.** Repair and retrofitting process of damaged column at the top.

The repair process and the retrofitting of the damaged columns at the top were shown in Fig. 2. The damaged column at the top with lack longitudinal and shear reinforcement (2.a), addition of shear and longitudinal reinforcement (2.b). installation of the form work and concrete casting (2.c), and the final result as in (2. d).

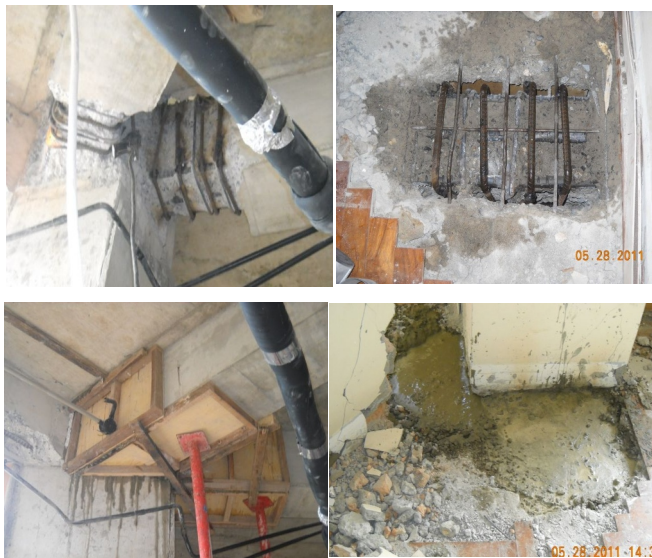
**Fig. 11.** Repair and retrofitting process of damaged beams

Fig. 3 shows a repair process of the damaged beam as follows. Repair and retrofitting were done by adding a shear reinforcement on the beam, and done the concrete grouting.

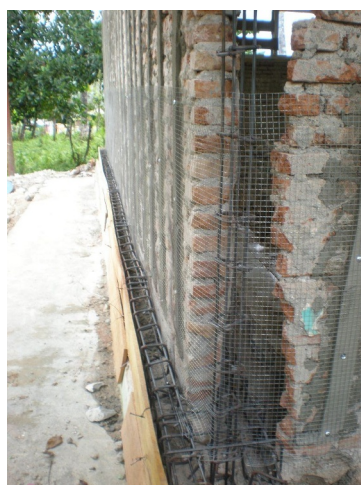
**Fig. 12.** Repair and retrofitting of *non-engineered* building by adding the reinforcement of tie beams, columns and link-beam

Non-engineered building repairs and retrofitting were shown in Fig 9 below. The building without reinforcement (Unreinforced Masonry, URM) was added with the reinforcement of the tie beams, columns and link beams. The brick wall were retrofitted with the wire mesh.
