An assessment of the sewer tunnel stress-strain behavior during the reconstruction of an object of cultural heritage

Abstract. The article offers an information about the work carried out on technical monitoring of the city sewerage system tunnel in the framework of the actual problem of recreating the objects of cultural heritage of St. Petersburg, which fall into the protected zone of underground engineering networks. The purpose of the study is to identify values of the stress-strain state of the tunnel lining at various stages of construction of a cultural heritage object located on the earth's surface in the immediate nearness. For formation of a base of the analyzed values was undertaken geolocation of ground massive, conducted geodetic measurements, defined the deformation of the soil by inclinometer boreholes, was obtained graphs of precipitation the soil massive, developed by setup technology for strain gauge sensors linear displacement inside the tunnel, worked out the mathematical model in the specialized software. Analysis of the obtained results allowed us to associate values of the stress-strain state of the collector tunnel effect from the buildings under constructi

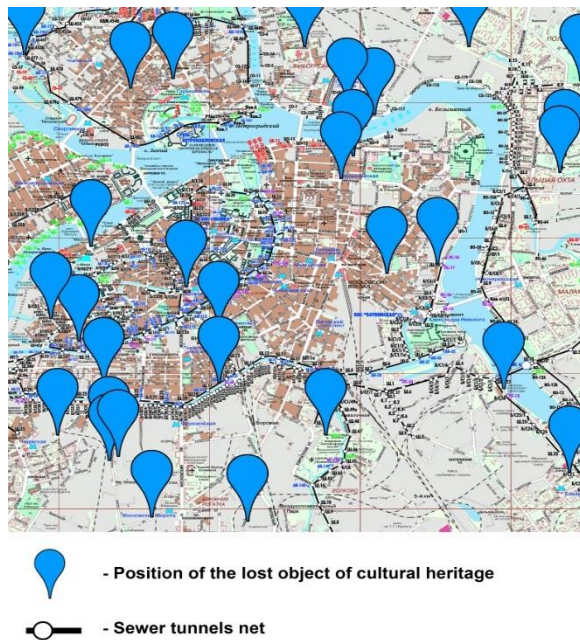
Fig. 1. St. Petersburg city center plan showing the lost objects of cultural heritage overlaying the scheme of tunnel-like water sewage networks

The analysis carried out helped to detect 38 city locations where there is a future probability of re-erection of lost objects of cultural heritage. The major part of them accrues to the city center and adjacent districts of St. Petersburg (Fig. 1). The analysis showed that not less than 30% of the objects, which might be re-erected in the mid or long-term period, could have an effect on the existing sewer tunnels. In such cases a special individual approach is needed for reconstruction of cultural heritage objects. This approach should be capable of preserving the available genuine fragments of the lost buildings, ensuring safety of construction works, and minimizing the influence of construction on the technical condition of the sewer tunnels. The general industrial approaches to this kind of challenges are well-known. Nevertheless, the particular cases characterized by individual engineering and technical features present a great interest.

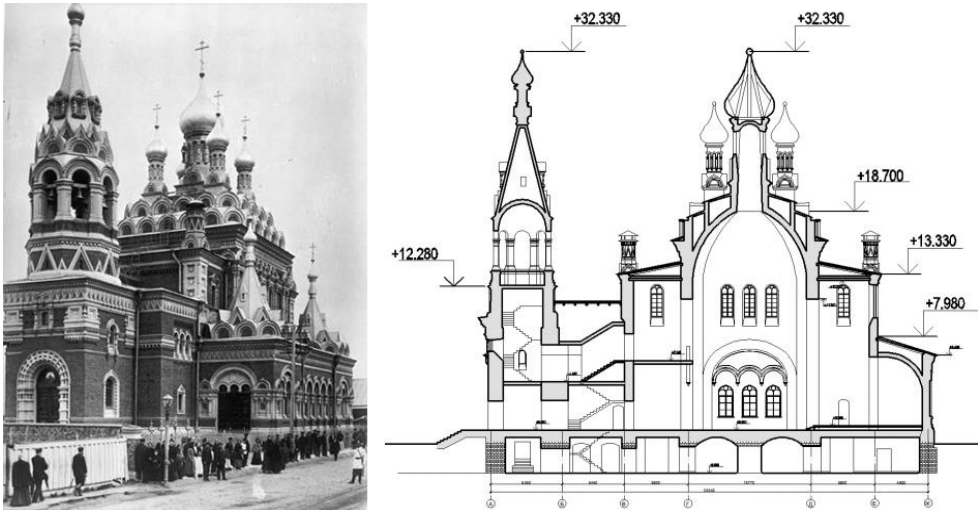
Fig. 2. The general view and the cross-section of the Church of Our Lady Joy of All Who Sorrow before demolition

An example of modern approach to optimization of sewer tunnels performance while constructing surface buildings was shown by re-erecting of an object of cultural heritage – the Church of Our Lady Joy of All Who Sorrow, located at: 22–24, Obukhovskoy Oborony ave., Nevsky District, St. Petersburg (Fig. 2). The original building in the Russian Revival style was constructed in 1894–1898 to the project of architects A.I. von Hogen and A.V. Ivanov. In November 1932 the church was closed and later demolished. Once the archeological excavations were finished, the foundation of the lost church was declared a significant site of local relevance. In 2015 the re-erection work was begun. Working on the project solutions for re-erection of the cultural heritage building the specialists established that the church was located above the mainline sewer tunnel carrying waste water collected from the most part of the Nevsky District of St. Petersburg.

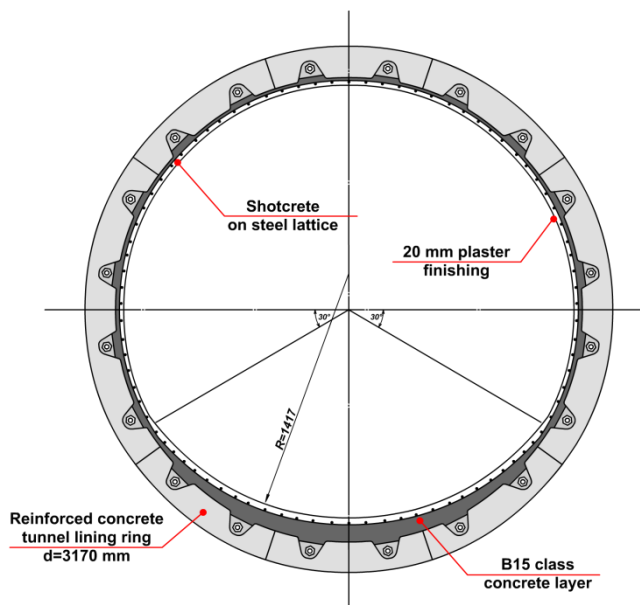
Fig. 3. TKK23 sewer tunnel lining cross-section affected by the re-erection of the object of cultural heritage

In 1966 a need appeared in arranging waste water sewage system, which was caused by the active development of the left-bank part of the Nevsky District of Leningrad. So, a TKK23 sewer tunnel was constructed partly crossing the foundation of the church disassembled in 1933. The sewer tunnel structure consists of prefabricated reinforced concrete lining of circular cross-section having the diameter of 3,230 mm, equipped with reinforced concrete jacket and made up by shotcrete on steel lattice (Fig. 3). The part of the sewer tunnel affected by the church in the interval between shafts #1/27 and #18 is located at the depth of -4.80 m to -4.64 m and lies predominantly within weak quaternary deposits, which required applying special methods of work using caisson technology (tunneling with compressed air)[4].

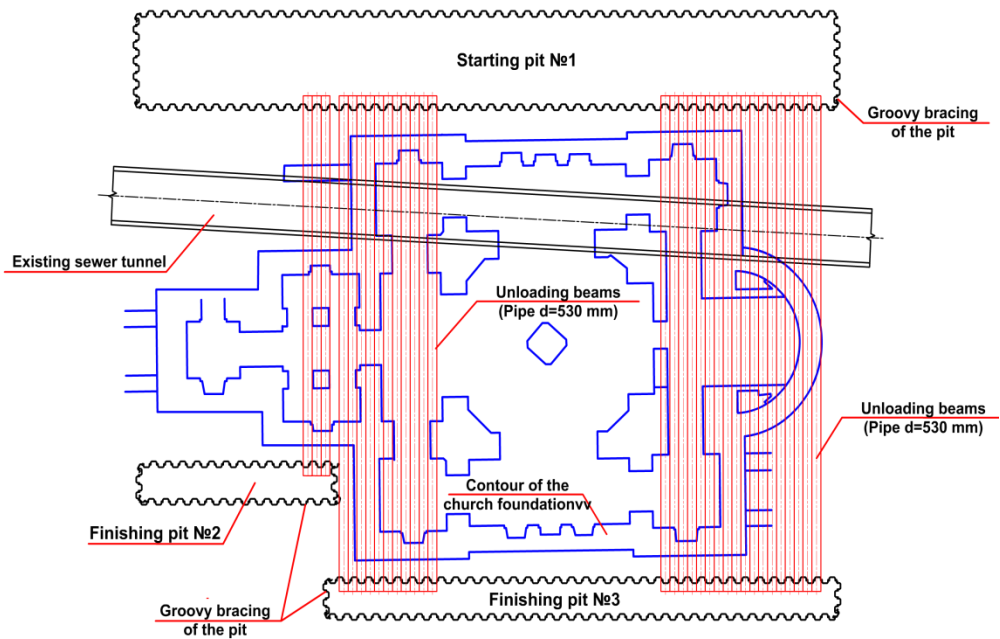
Fig. 4. Layout of reinforcement girders under the church foundation

The problem might have been solved by developing and implementing compensational stress relieving systems above the existing sewer tunnel, which were designed to minimize the impact of the newly-constructed building weight and to ensure safety of construction works. Thus, in the process of re-erecting the Church of Our Lady Joy of All Who Sorrow it was proposed to establish a bridging made of tubular girders with 530 mm in diameter that should have been installed within the rock pillar between the preserved foundation of the church and the existing sewer lining. Moreover, to decrease the load acting upon the sewer some reinforced concrete piles with casing pipes (800 mm in diameter) were sunk to the depth of 30 m. These had to withstand the admissible tunnel deformations by transferring the load from the church to the low-compressible bottom soil under the sewer [5, 6].

It was impossible to excavate the daylight surface in order to install a protection screen. Therefore, it was decided to apply closed tunneling technology, which implied jacking tubular sections through the ground with a hydraulic jack. For this purpose starting and

finishing pits with grooved bracing were arranged on the sides of western and eastern facades of the re-erected building (Fig. 4).

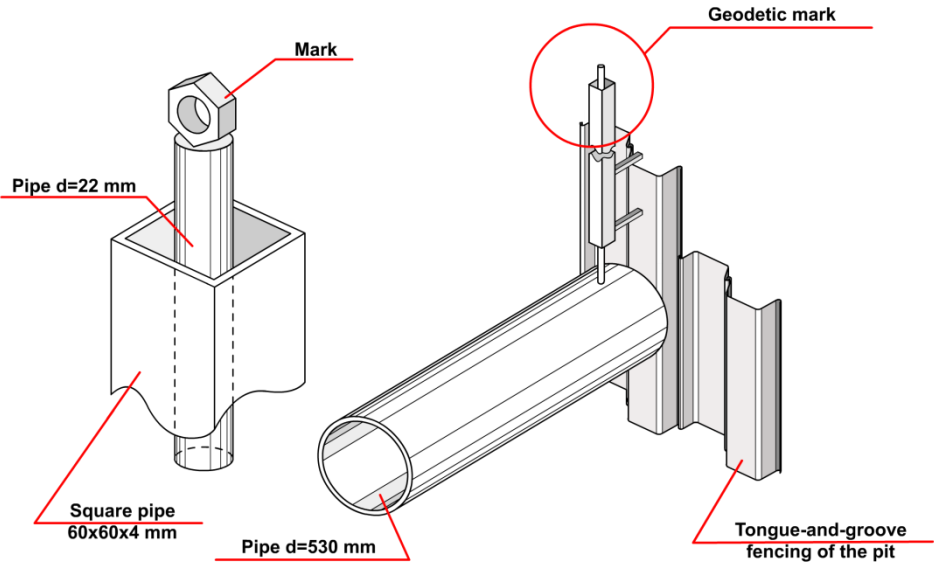
Fig. 5. A geodetic mark scheme

The further step included in-situ assessment of the sewer tunnel condition; at this stage geodetic marks were installed to provide monitoring of the ground and the church

foundation settlements. For this purpose the engineers developed a system of geodetic benchmarks that were attached to the reinforcement tubular girders jacked through the soil under the church foundation (Fig. 5);

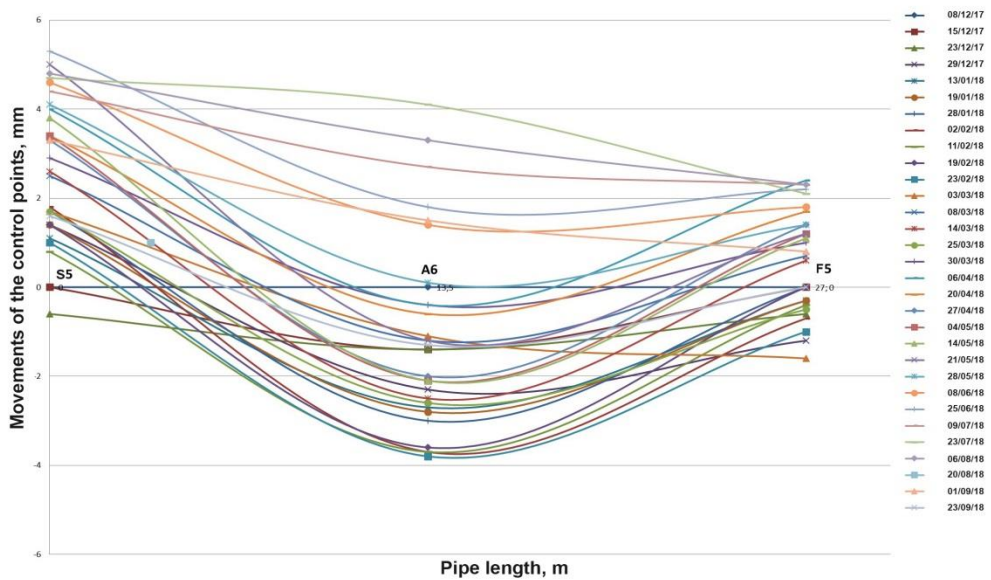
Fig. 6. A diagram of movements of geodetic marks control points

The analysis of data obtained while observing the geodetic marks resulted in the diagrams of the ground and the church foundation settlements (Fig. 6).

Thus, the monitoring performed from December 2017 to December 2019 showed that ground settlements within the project area occurred in two stages, which was explained by the technology applied for arranging pile foundation of the re-erected church. The

maximum benchmark settlements in the starting and finishing pits were -19.5 mm, whereas in the altar area of the church the settlement was -32.4 mm.

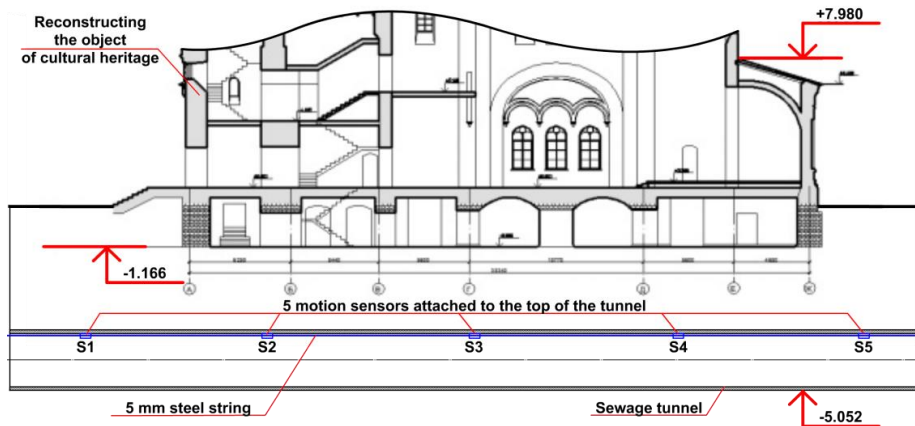
Fig. 7.

Installation layout of motion sensors within the sewer tunnel

Further works were focused at ultrasonic tomographic identification of cavities beyond the lining and at installation of a system of strain-gauge motion sensors in the arch area of the tunnel, which could help to monitor the properties of the lining and to transfer the obtained data to the surface (Fig. 7). However, due to unstable ventilation within the actively used sewer tunnel installation of sensors appeared non-feasible.

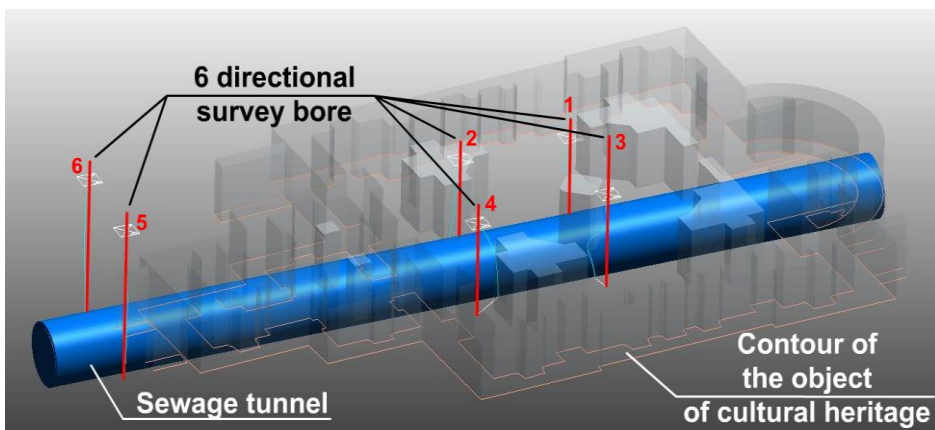
Fig. 8. Layout of survey bore sensors

For the purpose of real-time detection of deformations six survey bores were made around the sewer at the distance of 1 m from the tunnel lining, including four bores in the altar area of the church.

To collect objective and evident data on deformations the survey measurement bores were paired along the sewer axis and placed close to the church columns where the highest load was expected (Fig. 8).

In the course of study the maximum movements were detected at the survey bore #4, which accounted 3 mm at the 5–6 m depth along the sewer X-axis and 4 mm at the 5–6 m depth along the sewer Y-axis.

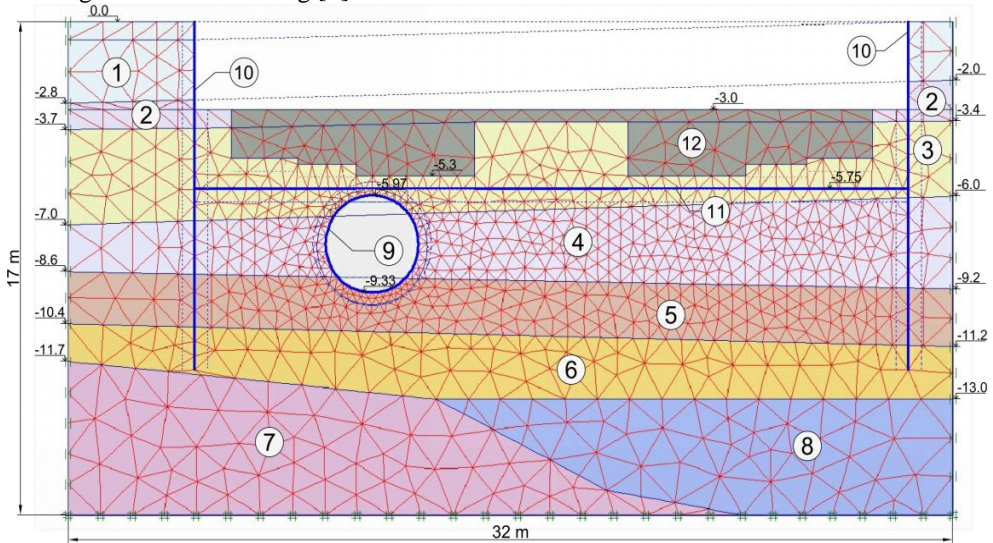
Fig. 9. The accepted analytic model: 1 – fill-up ground: soft sandy loam; 2 – silty sand; 3 – very soft loam; 4 – banded sluffing soft loam; 5 – banded sluffing soft loam; 6 – very soft laminated loam; 7 – soft sandy loam; 8 – semi-solid soft loam; 9 – sewer lining; 10 – grooved bracing; 11 – pipe, Ø530 mm; 12 – existing foundation of the church.

In order to perform real-time analysis of the sewer lining stress-strain behavior and basing on the survey data and geodetic marks the specialists undertook mathematical simulation with Plaxis software. The task was being solved in two-dimensional formulation by means of finite elements (FE) method (Fig. 9).

With the area of construction process influence on the sewer tunnel having been considered, a fragment of soil was selected for calculation aimed at determining dependencies between the deflections of tubes with benchmarks and the strains in the lining. These helped to obtain a strain figure of the soil and the lining (Fig. 10) and to formulate evaluation criteria for the construction works undertaken in the process of re-erecting the surface building [8].

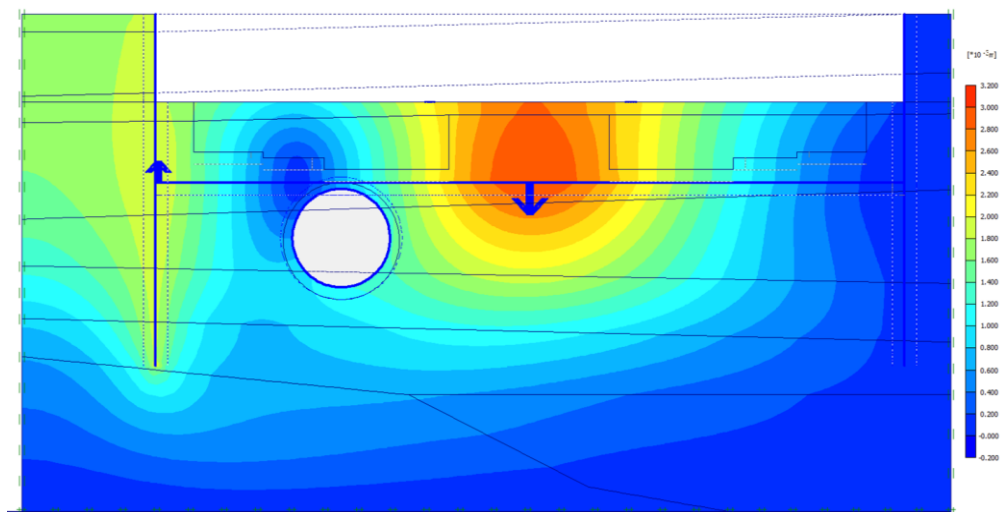
Fig. 10. Strain figure according to the results of geodetic monitoring.
