Channel processes of a small river heavily modified by human activities

Abstract. Widely-spread small rivers are very poorly studied in relation to channel processes. The influence of local factors, high sensitivity to human impact, close connection with basin processes, and relatively low rates of channel changes distinguish them from medium and large ones and make it necessary to form a special approach to studies. Based on collection of long-term maps and local residents' interviews, we reconstructed the transformation of channels in the Kudma River basin (the Volga Upland) for the last 200 years. Based on the bank erosion monitoring during 2011-2019 the modern rates of channel changes were revealed. We found that significant human impact is associated with the artificial channels cutoffs and draining of ponds which led to channel incision of the Kudma and Ozerka Rivers in the middle reaches and the transformation of floodplain into terrace. Agriculture development caused siltation of the upper reaches of rivers. The rivers of the forested part of the basin experienced the least human changes. From 2011 to 2019 the maximum rates of bank erosion were found to be within range of

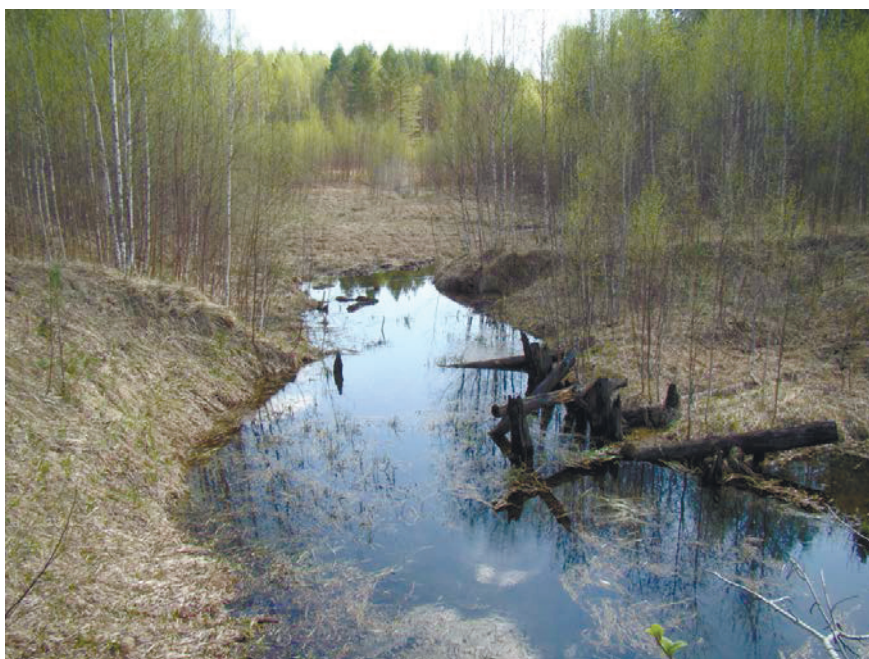
Fig. 1. Remains of a dam in the upper Kudma basin.

channel incision and sediment accumulation. However, these dams did not lead to significant channel changes: by the 1930s most of the old dams in the forest part of the basin were destroyed; now we observe the remains of dams and canals on floodplains overgrown with woody vegetation (Fig. 1). Fire and fishing ponds are preserved mainly in the plowed part of the river basin.

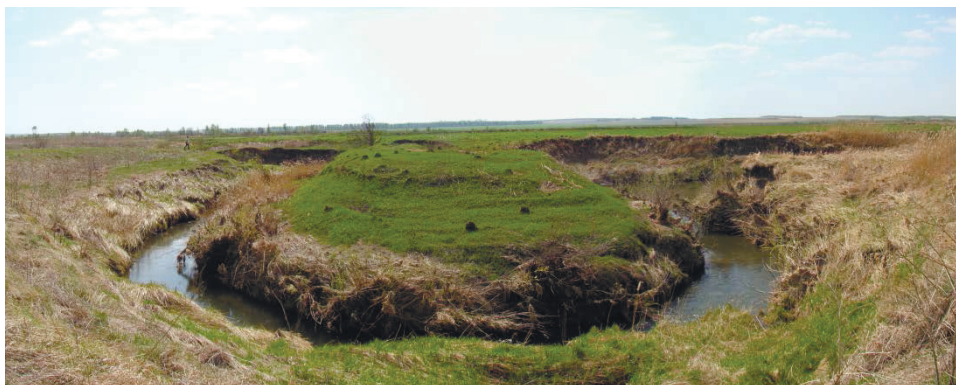
Fig. 2. Incised channel in the middle course of the Ozerka River.

The processes of river incision increased due to the descent of the remaining ponds in the post-Soviet period, when there was a decline in agricultural use of floodplains, no new dams were built. As a result, the channels of the Kudma and Ozerka Rivers incised for 1.5 m (the average rate was about 1.5–2 cm per year), which led to its transformation into a low

terrace (Fig.2). At the same time the channel, with the exception of the straightened reaches, retained its original sinuous shape. On the Ozerka River near the village Belozerovo this led to the appearance of whirlpool zones specific increase of channel width at the tops of bends; in the other areas – to reduction of the length of bank erosion front, general stabilization of the channel.

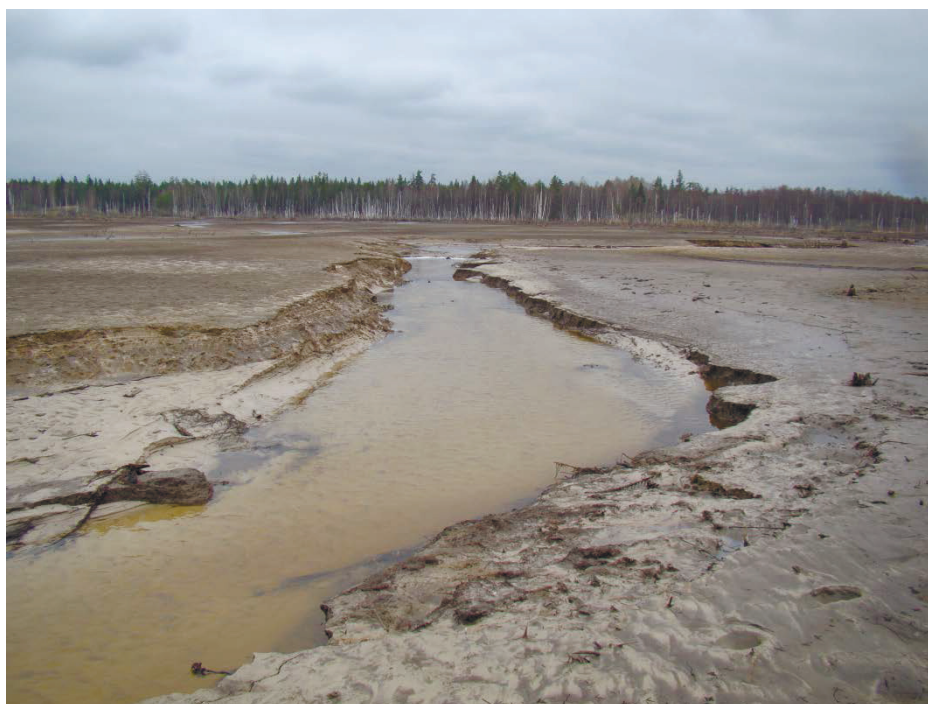
Fig. 3. A new channel forming on a silt field in the place of former pond.

Since 2010, construction of low-pressure reclamation dams, fishery and fire ponds (the upper Kudma River and its tributary the Setchuga River) has resumed. Most of them were built without research and project development; accounting for these facilities is missing. The descent of such ponds in case of dams destruction during flood periods leads to the violent removal of sediments downstream, their deposition in the form of sand ridges, formation of huge silt fields in place of the former ponds where new channels form (Fig. 3).
