Foreign and domestic expertise in strengthening concrete structures with carbon fiber

Dmitriy Topchiy^{1,*}, and *Egor Safenkov*¹

¹Moscow State University of Civil Engineering, Yaroslavskoe shosse, 26, 129337, Moscow, Russia

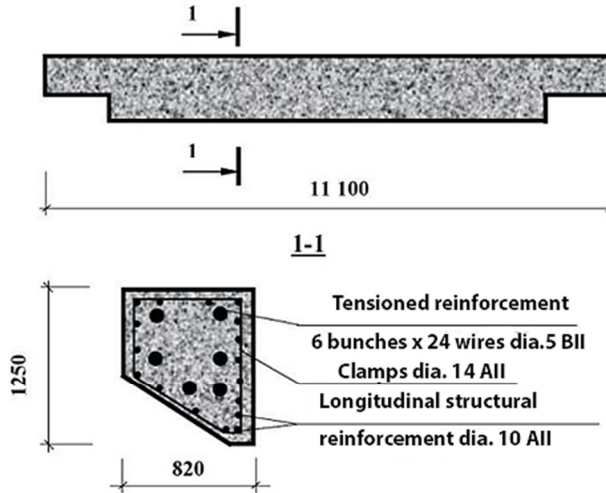
Fig. 1. Edge beam of temperature insert.

The edge beam (Figure 1) is a pretensioned structure 12 meters long. 6 bunches of high-duty wire diameter 5 mm class B11 are used as pretension reinforcement material. Each bunch consists of 24 wires. The transverse structural reinforcement is made of rods 14 mm AII. The longitudinal reinforcement is made of rods 10 mm AII.

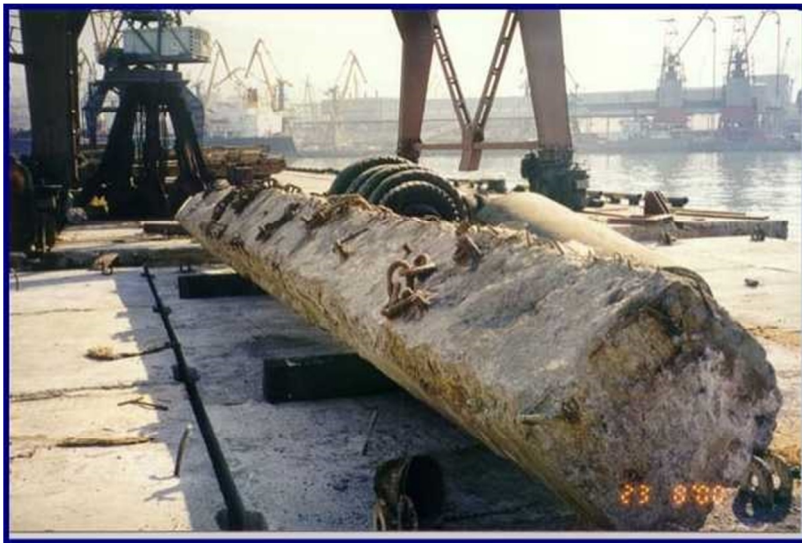
Fig. 2. Edge beam before the repair.

The examination found numerous detachments of concrete up to 8 cm in depth on the surface of the beam with stripping of longitudinal and transverse structural reinforcement (Figure 2). The expert estimation registered the 40% loss in cross section of structural reinforcement due to corrosion, no damage of pretensioned reinforcement was detected.

To compensate for the loss of structural reinforcement it was decided to stick domestic-produced carbon stripes LU-300-2.

Before adhering the stripes, repair and recovery works on the beam section were performed including the following:

1. Cleaning of concrete surface, removal of regions with damaged structure,
2. Cleaning of stripped reinforcement from rust, its treatment with rust solvent,
3. Concrete surface treatment with corrosion inhibitor,
4. Concrete surface repair using special high-duty quick-hardening compositions (indent and cavities patching, surface leveling).

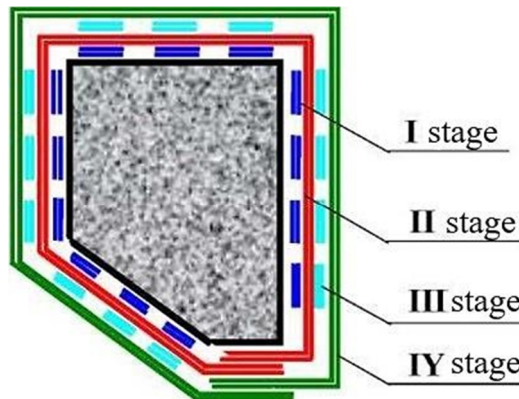
Fig. 3. Carbon stripes adhesion pattern.

As per the estimates done, stripes 150 mm wide with stepd 150[^]200 mm from 4 layers of carbon stripe are required to be adhered in longitudinal and transverse direction to compensate the loss in structural reinforcement [2].

Since carbon stripes LU-300-2 are 300mm wide, they were folding in two when being adhered. At stage 1, 2 layers of longitudinal strips were adhered, at stage 2, it was 2 layers of transverse strips. The operations were repeated at stages 3 and 4. The ambient temperature during the adhering was 20-22°C, while epoxide polymerization process was being finished on the following day. After adhesion was completed, the stripes surface was finished with a protective epoxide composition with powdering small-scale quartz sand over the freshly-prepared surface. Figure 4 shows the edge beam during the carbon stripes adhering process. After being repaired and strengthened, the edge beam was mounted to the structure of the bearth. Operation within several months showed that the repair was satisfactory since neither damages in the repairing layer nor stripping-off of the carbon fiber strips occurred.

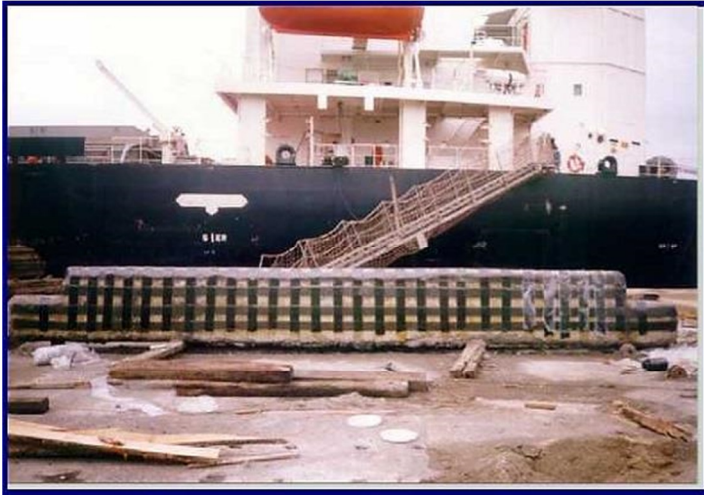
Fig. 4. The edge beam during the carbon stripes adhering process.

Carbon stripes were stuck with special epoxy compositions. Before sticking the concrete surface was coated with a primer composition spread 0,8 kg/m². After that the stripes were cut to fit the sizes, then soaked with adhesive composition (spread 0.4-0.4 kg/m²) and stuck by pressing to the concrete surface and then rolled through polyethylene film.

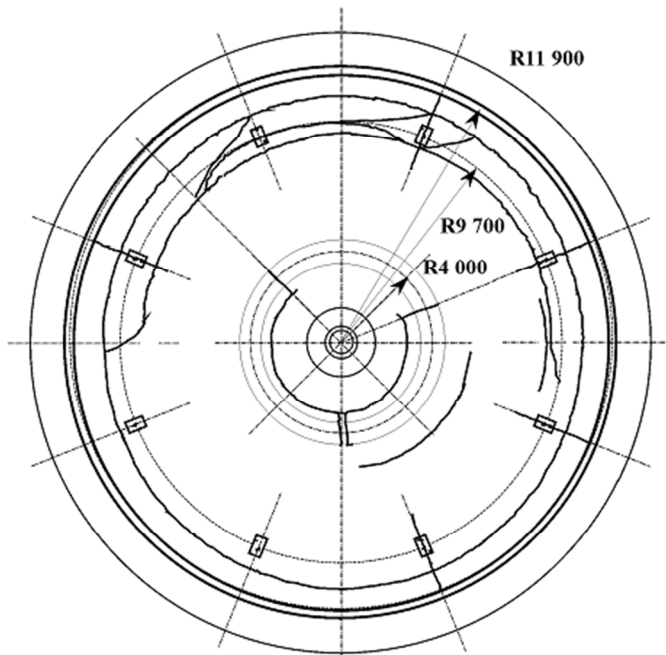
Fig. 5. Cracks arrangement on the inner surface of the bowl.

An examination revealed numerous defects and damages – annular and radial cracks in the area of the support and central support (fig. 2), concrete delaminations up to 8 cm deep on the inner surface of the bowl, hidden cavities (areas making a dull sound when rapping), signs of reinforcement corrosion. Leakage of the process solution indicates the presence of throughwall cracks

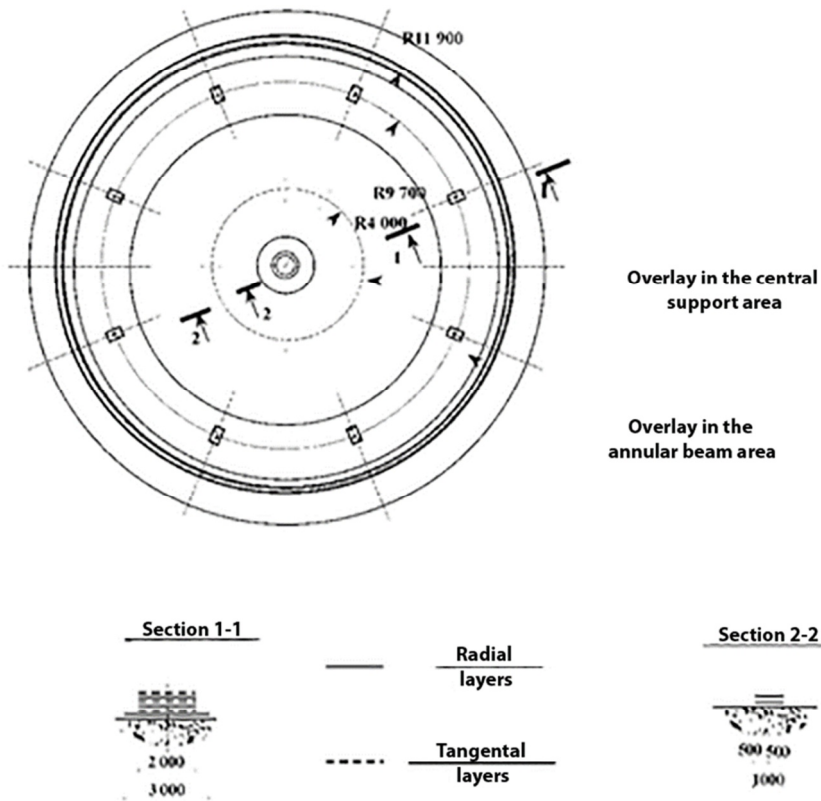
Fig. 6. Bowl strengthening with carbon fiber strips.

Based on the analysis of distribution of the maximum stress areas, the scheme was developed to strengthen the coagulation bowl with high-strength carbon fiber (Figure 6).

The calculations showed that in order to restore the bearing capacity of the structure, it is necessary to stick the carbon fiber in two areas along the inner surface of the coagulation bowl:

1. Along the perimeter of the support beam
2. In the area about the central support

The overlay in the area of the annular support beam must consist of six monolayers of stripe, three of which are laid in the radial direction and three in the tangential one. The width of the lower radial layer is 3 m, the two following ones are 2 m each. The width of all 3 layers of the tangential overlay is 2 m each.

Annular overlay in the area of the central support with radius of 4 m is made of two radial layers 1 m wide each.

The carbon-fiber overlays act as external reinforcement and are formed by adhering carbon stripes to the bowl's surface using special epoxy compounds. The carbon fibers content in the composite is about 60%, the main physicomechanical properties of the carbon fiber after polymerization are as follows:

1. Tensile strength – 1450 MPa
2. Modulus of elasticity – 126,000 MPa
3. Elongation at break – 0.8%

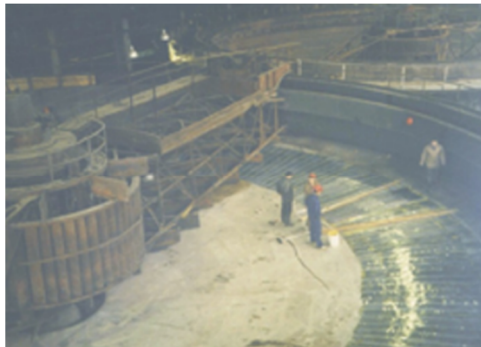
Fig. 7. Overall view of the coagulation unit during the strengthening.

The process of applying the carbon stripes is shown on figures 7 and 8.

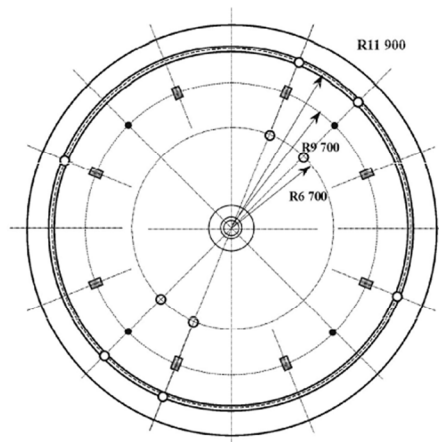
Fig. 9. Leveling arrangement: • – dowsels in the columns; ° – dowsels in the bowl's bottom.

Metal dowels were fixed to determine the deformations of the bowl at 10 points of the lower surface of its bottom and at the top points of 5 support columns. Metal roulettes with millimeter graduations were suspended to the dowels. The deformation values were determined by leveling and calculating the difference in the levels of the dowels. The

difference of similar dowels corresponds to the vertical deformations of the bowl's bottom points and supporting columns' points, where the dowels are fixed. The dowels' levels were oriented in the relative system of heights agaiings three reference points located outside the bowl's load area.

To assess the degree of rigidity and quality of the bowl's watertightness after the repair works, tests were performed by filling the bowl with a saline solution with a specific weight of 1.23 g/cm^3 . The deformability is estimated by precise geometric leveling of some points on the bowl's bottom and on the columns [9]. The leveling scheme is shown in Figure 10.

The leveling of deformation points and reference points was carried out 9 times by the same arrangement with different filling volumes of the bowl with saline solution.

The first leveling cycle was performed before the primary filling of the bowl. Cycle 2 - after filling the bowl at 1/3 volume with a load of 420 tons. Cycle 3 - after filling the bowl at 2/3 volume with a load of 840 tons. Cycle 4 - after filling the bowl to the full, which corresponds to a load of 1260 tons. Cycle 5 is performed after complete emptying of the bowl [6].

As a result, deformations of the bowl at maximum loads did not exceed 4 mm, which is more than 2 times lower than expected. No leakage and waterproofing damages were recorded [10].
