Full changing of the load-bearing wall of the bunker's building of the coal mine

The main purpose of the investigation is to suggest the strategy of the reconstruction, which allows changing the load-carrying wall of the upper floor of the building of the bunker without the stop of the main technological process.

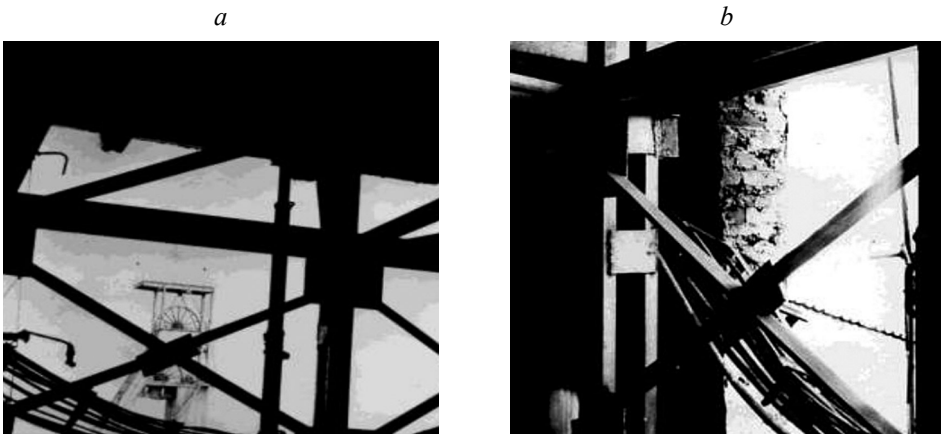
Fig. 4. The main supporting beam, raising by shaft lining upwards (a) and the rack of the supporting panel and unmounted wall (b).

This beam leans on a hydraulic shaft lining (Figs. 3 – 5). By means of supporting beam and hydraulic shaft lining, the covering slabs of the building of the bunker were lifted under the load-bearing wall on 50 – 80 mm. Such a system has allowed us to upload and completely unmount whole the load-carrying wall. The main supporting panel has allowed holding covering slabs during the installation of the new wall and then sailed to lower them on the wall. For providing the vertical position of the main supporting panel during execution all reconstructions work, was provided an additional panel of the provision of stability of the system (Fig. 6).

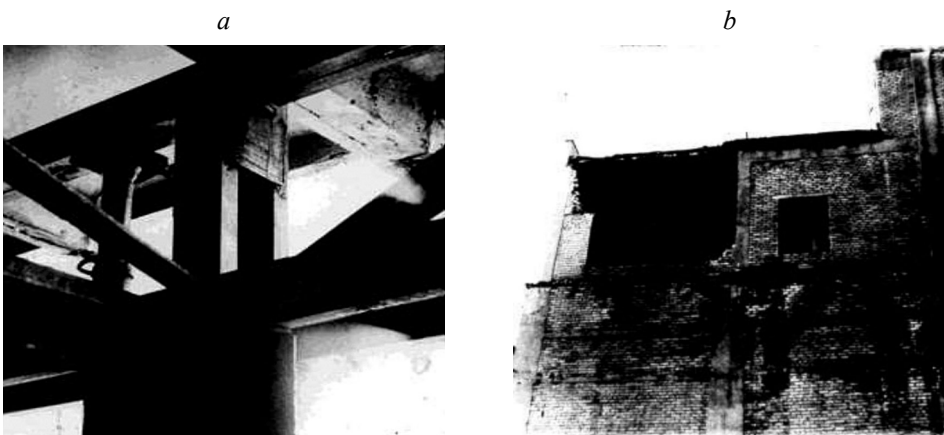
Fig. 5. The lifting supporting beam and hydraulic shaft lining (a) and completely unmounted load-bearing wall of the building of the bunker (b).

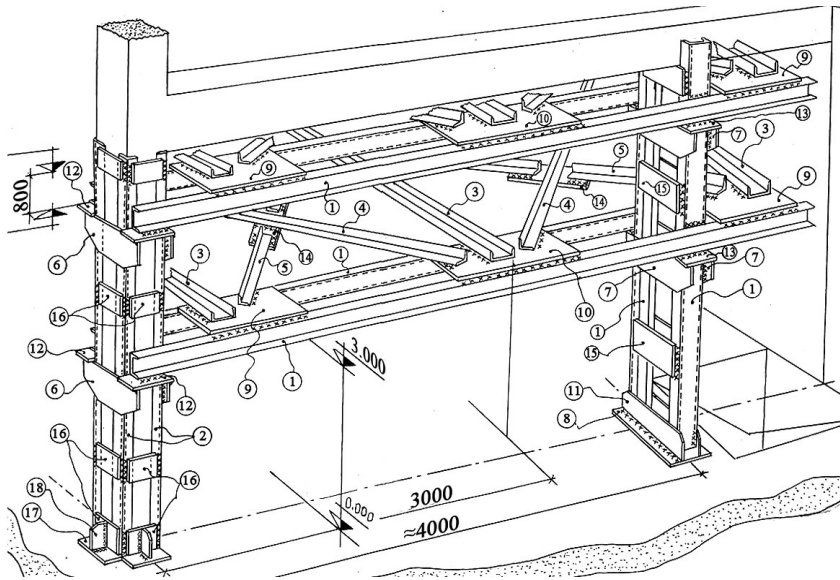
Fig. 6. The panel of the provision of stability of the system, where 1, 2,...,18 are numbers of steel members.

Table 1 contains the specification of the steel members that need for the system. More details can be found in [27].
