Defects of steel crane beams and methods of their strengthening

Abstract. Crane structures are the most vulnerable in buildings and structures because of their early wear in comparison with other building structures. The wear of crane structures is because of the appearance and the development of fatigue damage nature.

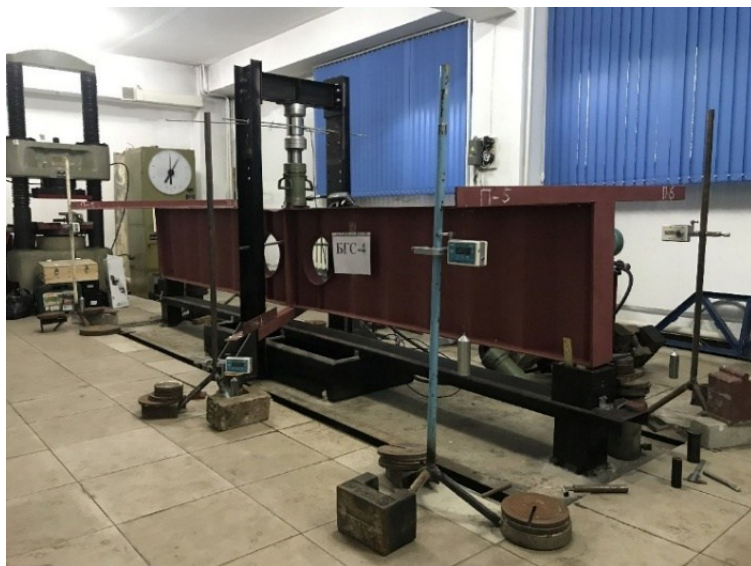
In 2019, in the laboratory of KazGASA LLP (Almaty), on the load-bearing floor, 5 models of beams with corrugated walls (BGS-1,2,3,4,5) were tested, weakened by round technological holes with various reinforcement options holes [2]. Tests [3] were carried out according to a single-span scheme for lateral bending by a concentrated force applied in the middle of the span (Fig. 3) while the beams are based on the supports.

Fig. 3. General view of the installation for testing the BGS-4 beam.

Based on the research program and in accordance with the theory of optimal planning of experiments, 5 models were made, including 4 models with two round holes $0.5h_w$ and a step between the centers of the holes $2d$ [1] and 1 model without holes. The length of all beams is assumed to be 4.2 m, the height of the walls is 0.6 m, the wall thickness is 2 mm, the width of the shelves is 0.15 m, the thickness is 6 mm. The effective step and high corrugation in accordance with the results of the third chapter of this dissertation work for a wall thickness of 2 mm were taken as 280x45 mm. In the course of the experiment on models with round bordered holes which are used in design practice for the passage of technological equipment within the height of beams the influence of various methods of reinforcing the holes on the bearing capacity and deformability of the models was investigated.

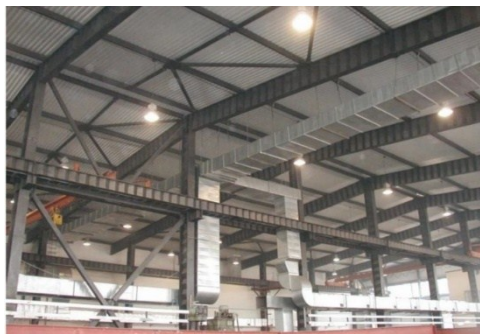
Fig. 5. One-story steel frame of the industrial building, in which the roof girders, columns and crane beams are made of welded I-beams with corrugated walls. Seismicity 10 points. 2007.

It can be used crane beams with corrugated walls to solve this problem. Kazakhstan has accumulated a lot of experience in the use of such beams (Fig. 5, 6).

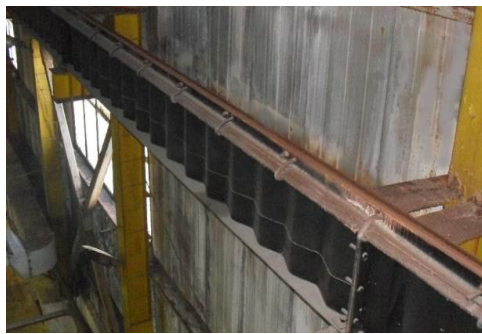
Fig. 6. Crane beams in the main building of the plant in Almaty region. The height of the beams is 640 mm, the thickness of the corrugated walls is 6 mm. 2001.

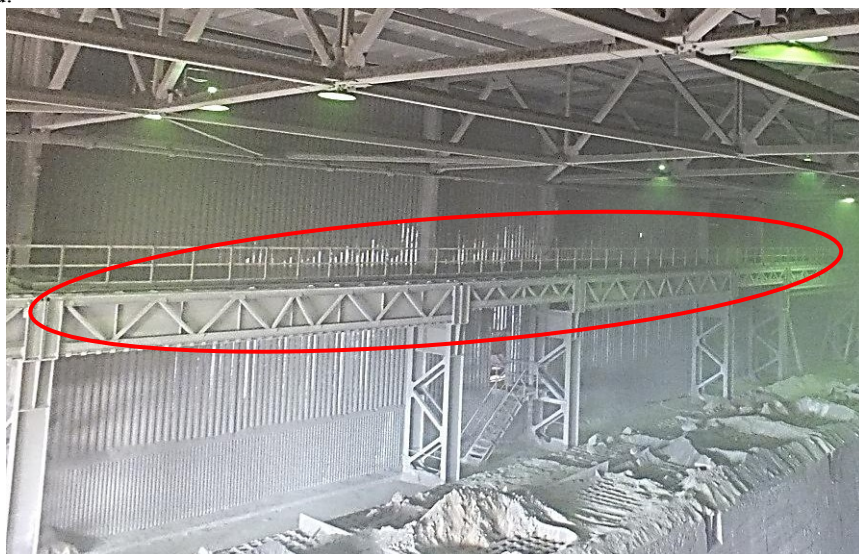
The authors developed and implemented a project to restore their operability by strengthening the walls of damaged steel beams without stopping production which made it possible to significantly reduce the stresses in walls of beams from the moment caused by the eccentricity of load application from the crane wheels. Reinforcement of the crane beams is made on the outside of the eccentricities of the application of loads from the crane rails by creating a truss structure parallel to the I-beam (Fig. 8). The truss belts are made of I-beams, the diagonal lattice is made of steel bent closed welded square profiles (GOST 30245).

Fig. 8. General view of reinforced steel crane beams along the A axis with spans of 12 and 6 m.

The constructive solution of reinforcement made it possible to significantly reduce the magnitude of local stresses from moments, the magnitude of transverse forces and, consequently, shear stresses, which are the main factors in the appearance and development of fatigue cracks in their walls [7]. When the reinforced beams were re-examined along the A axis in 2017 after 8 years of operation, no new fatigue cracks were found in their walls.
