Experimental trial on the electrical characteristics of photovoltaic panels under the effect of a simulated failure

Abstract. In this work we measure electrical characteristics of different panels following the addition of a simulated failure, namely cracks on the protective layer of photovoltaic cells. The objective is to see its influence on the electrical production of panels on one side, and to see if it is possible to diagnose this failure on the other. The cracks are simulated using broken transparent plates that will be positioned on each solar panel before measuring its real characteristics. The results show that despite the continuity of the operation of the photovoltaic equipment in the presence of cracks, those last clearly influence the electrical power supplied by the panel. Among other things, they give a very particular form to its I-V characteristic which can be used to detect this failure.

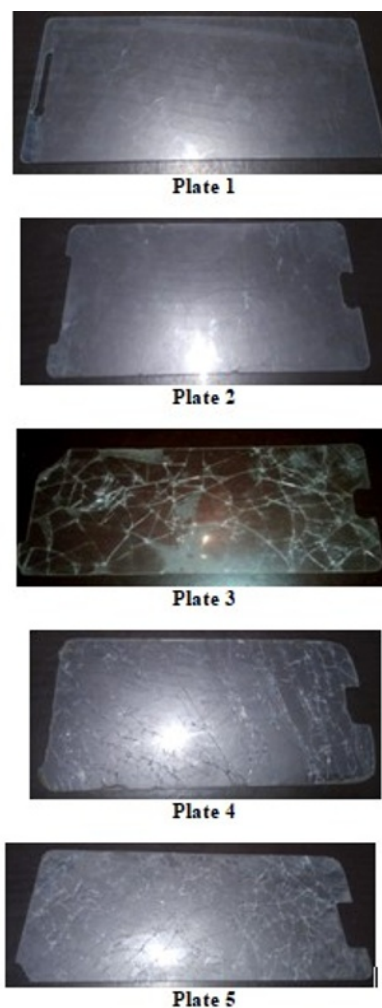
Fig. 1. The cracked plates.

- Five (05) plates of dimension 7x15cm² containing different scales of cracks, numbered according to the proportion of cracks (1: very little cracks - 5: Completely cracked) were used (Figure 1).

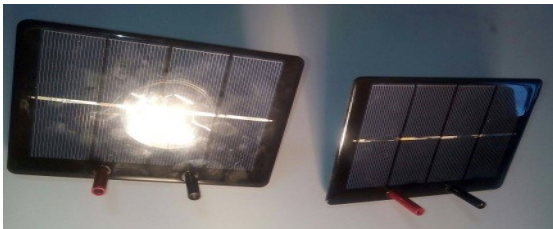
Fig. 2. Photovoltaic panel of the first experiment.

Witness experiment No. 1: Panel of dimension 12.6x9.4 cm², with eight (08) cells, subjected to a radiation of 120 W/m² (Figure 2).

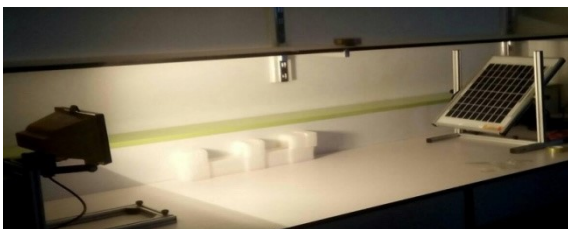
Fig. 3. Photovoltaic panel of the second experiment.

Witness experiment No. 2: Panel of dimension 32x21 cm², consists with 72 cells and inclined at an angle of 49.7°. The temperature sensor (pyrometer) at the study site is tilted at the same angle (Figure 3).

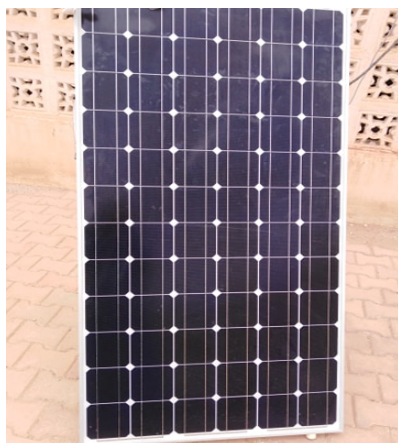
Fig. 4. Photovoltaic panel of the third experiment.

Witness experiment No. 3: Panel of dimension 0.8x1.75 m² (real model) under real conditions (Figure4):

- *Test N° 1:* Temperature of 27 °C and solar radiation of 892 W/m².
- *Test N° 2:* Temperature of 20 °C, radiation of 260 W/m² and an inclination of 25°.

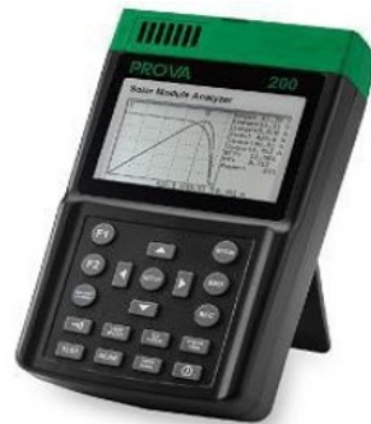
Fig. 5. The photovoltaic panel analyzer.

- The photovoltaic panel analyzer (Figure 5) makes possible to trace the I - V characteristic and to note the various electrical values associated to the operation of the panel: the open circuit voltage (Vopen); circuit short current (Ishort); the max

current, the max voltage and the max power; energy efficiency (EFF) and form factor (FF). It also gives, when a load is connected, the coordinates (V, I, P) of the operating point.

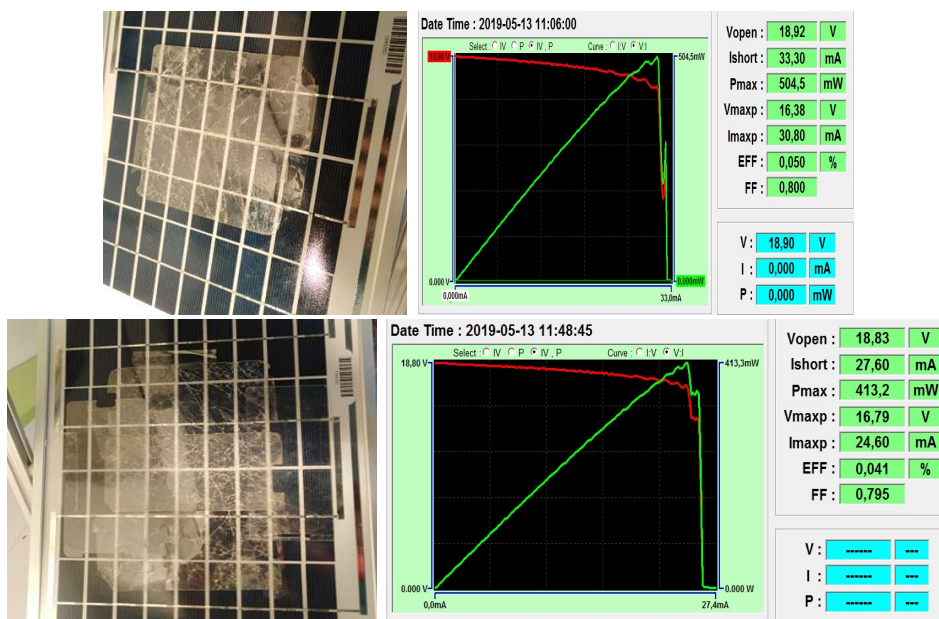
Fig. 7. Results of experiment No. 2: Electrical characteristics of the second type of photovoltaic panels in normal state and with the cracked plates

By placing successively the cracked plates on the panels, we obtain their characteristics in degraded mode. Figures 6, 7 and 8 show the comparisons between the characteristics of the three types of panels in normal mode and under failure condition.

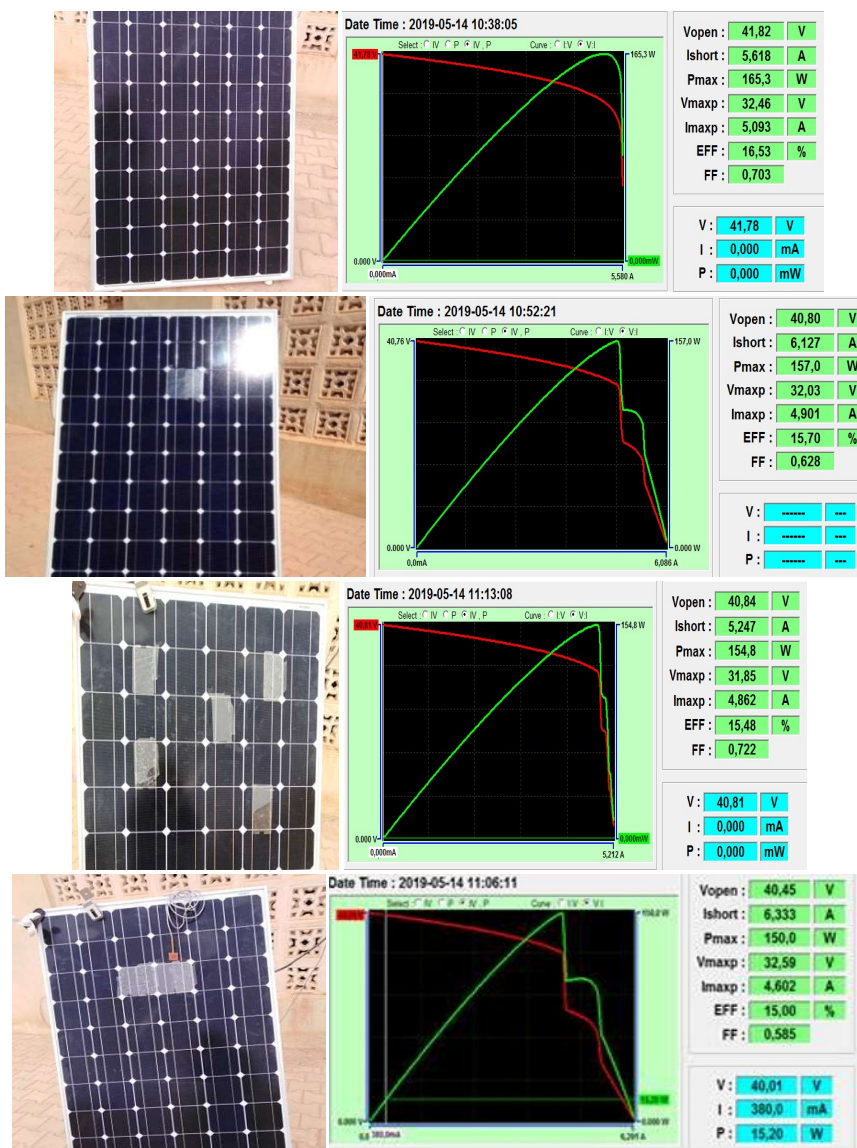
Fig. 8. Results of experiment No. 3: Electrical characteristics of the third type of photovoltaic panels in normal state and with the cracked plates

In this experiment we used large solar panels (real model) under real conditions. The experiments were carried out in a limited time period time (less than 40 min) so as not to be affected by the change in sunshine or temperature.

However, these may have affected the results. We found that:

- Plates with few cracks do not introduce significant changes to the electrical characteristics of the panel. This is why several plates are used at the same time for each experiment.
- When the plates are separated, they have less impact than when they are grouped. This means that several small cracks are less harmful than large one.
- No quantity shows a monotonic tendency (except Vopen for test 2). These values cannot be considered as health indicators of the solar panels on site for this failure mode, and cannot be used for the calculation of their remaining useful life (RUL).

Qualitatively, and as in previous experiments, the cracks introduce a symptomatic change in the shape of the I–V characteristic of photovoltaic modules that can be used to diagnose this failure.

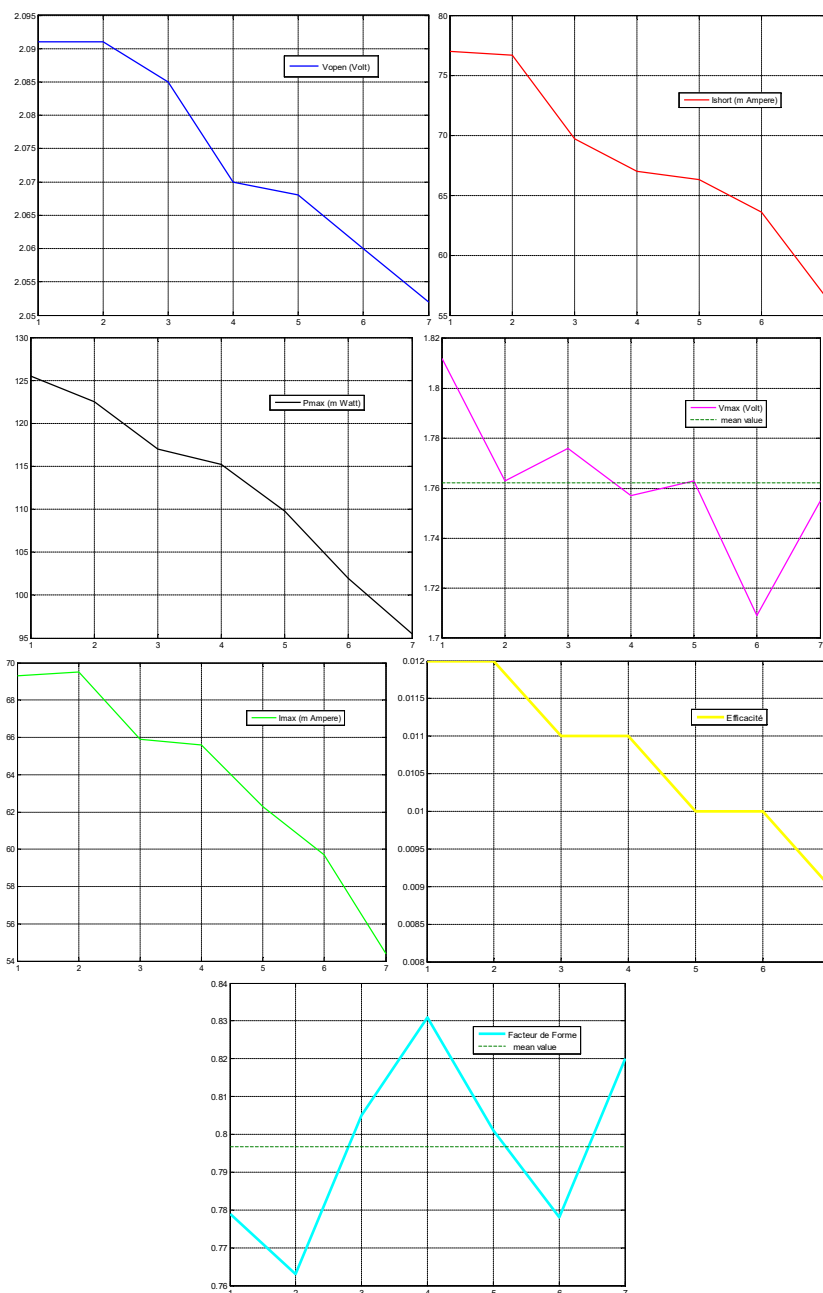
Fig. 9. Graphical representation of the experiment 1 results.

The results of the three experiments are summarized in the tables bellow. Figures 9 and 10 give graphical representations of these results.

We note that almost all the curves decrease monotonously, which confirms the correlation between the size of the cracks and the decrease in the electrical production (more there are cracks, more the electrical production characteristics decrease).

The maximum voltage (Vmax) and the form factor (FF) oscillate around their average values which are 1.762 Volt and 0.7967. Therefore they cannot be considered as a health indicators for the failure mode: cracks on the photovoltaic panels.

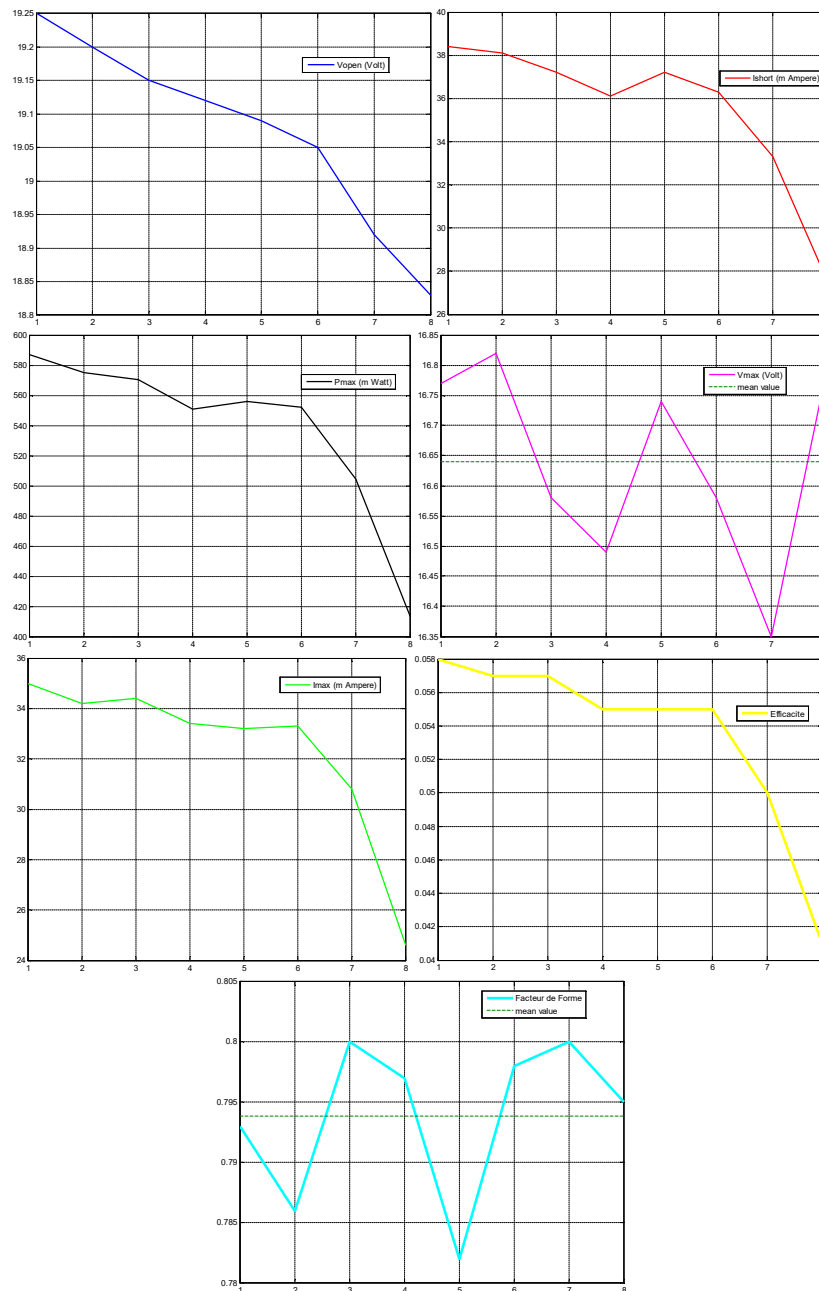
Fig. 10. Graphical representation of the experiment 2 results.

Except a few minor irregularities, Experiment 2 confirms the results of Experiment 1: almost all the curves decrease monotonously, which confirms the correlation between the size of the cracks and the decrease in the electrical production. The maximum voltage (Vmax) and the form factor (FF) oscillate around their average values which are 16.64 Volt and 0.7939. The FF is relatively stable. These two quantities cannot be health indicators for this failure mode.

It is also noted that, if the cracks are small (plates 1 and 2), the reduction in yield is small too, and the losses are not as great as for the first experiment. This means that the dimension of panels compared to the size of the cracks plays a role in the change of PV modules electrical characteristics.
