Corrosion resistance of steel for coiled tubing units

Abstract. The gravimetric method was used to determine the corrosion rate of a pipe for coiled tubing. Scanning electron and optical microscopy were used to study the microstructure and to determine the nature of corrosion damages. It has been found that corrosion processes of different nature occurred in the studied systems “metal – environment”, in particular, in acid solutions, corrosion was caused by the of hydrochloric acid and the ambient temperature of 70°C. In solution with a smaller acid content, along with the general corrosion, there is a significant localization of the corrosion process (deep corrosion damage is formed: macro pitting and corrosion ulcers). The general corrosion was observed in the HCl solution (13 mass %), which destroys the pipe walls after 576 h of exposure. The neutral solutions caused the general corrosion of smaller intensity in comparison with the acidic environments, even taking into account the temperature factor. The surface-active substances or petroleum products that are present in the solutions, form barrier films on the steel surface, which prevent the access of corrosive components fro

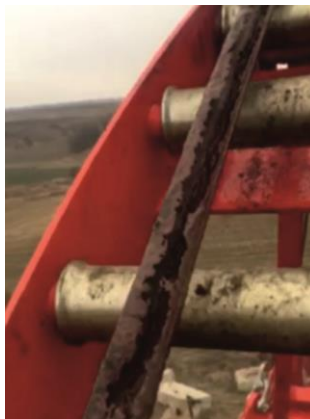
Fig. 1. Corrosion damage to the CT pipe after acid jobs.

- fracture of the pipe by the violation of chemical treatment technology (Fig. 1);
- corrosion damage during long-term storage of pipe with violation of preservation technology;
 - gas hydrates cause of internal pitting corrosion of CT pipes, which is observed as the neutral and so the acidic environments.

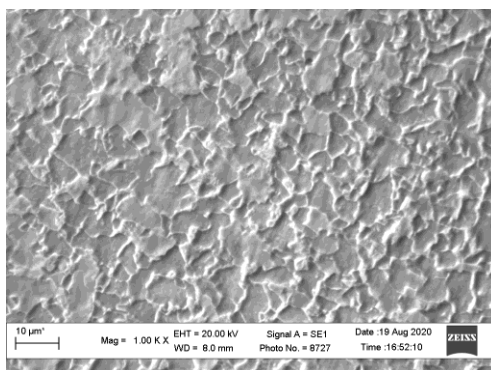
Fig. 2. The structure ($\times 1000$) of QT-800 steel after etching.

QT-800 steel [14], from which CT pipes are made, was tested. It is high-strength low-alloy steel [15] with alloying additives to ensure resistance to atmospheric corrosion. The nominal chemical composition meets the requirements of the standard API 5ST CT80: 0.150 mass % C; ≤ 0.430 Si; 0.820 Mn; 0.570 Cr; ≤ 0.019 P; ≤ 0.001 S; ≤ 0.220 Cu; ≤ 0.08 Ni; 0.19 Mo; 0.017 Nb; 0.010-0.020 Ti; 0.015-0.040 V; 0.070-0.120 Al, remainder – Fe. Mo and Nb increase the hardenability of steel and improve the conversion of ferrite. Steel structure: polygonal ferrite and granulated bainite [16]. Microstructural features of steel are shown in Fig. 2.

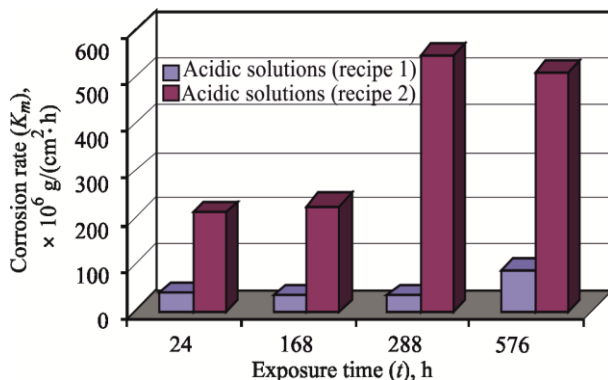
Fig. 3. The corrosion rate of QT-800 steel vs different times of exposure in an acid corrosive environment.

The highest corrosion rate (Fig. 3) was observed in solution II consisting of 13 mass % HCl, this is the most aggressive solution among the studied. Here, an increase in the corrosion rate was observed in time up to 288 h of exposure, after which the corrosion rate decreased slightly. This extreme nature of the change in the corrosion rate is due to several factors. The corrosion process is a surface phenomenon, in which the metal surface dissolves. Since the primary surface area is taken into account when calculating the corrosion rate, then under an extremely active working environment (13 mass % HCl and 70°C) the active surface area will increase due to the increase of surface relief (Fig. 4) during exposure to aggressive environments. (Fig. 3).

After 288 h of exposure, the corrosion rate slightly decreases due to the solution depletion (reduction of the proportion of free corrosive components of the solution) and reduction of the active surface area due to metal dissolution in an aggressive working environment, what is confirmed by significant weight loss of the studied sample (Figs. 3 and 4). The steel corrosion rate in the solution I much lower compared to solution II, due to the lower aggressiveness of this working environment under operating conditions. However, the corrosion process is more active in comparison with neutral working media, and shows a steady increase in rate during exposure from 24 to 576 h, due to, as in the previous case, the increase in the active surface area of the sample during the experiment. Here, as in the previous case, the process of general corrosion is observed which is reflected in a significant loss of material over time, and a significant localization of the corrosion process (deep corrosion damage to the surface of samples such as micro pitting and corrosion pits).

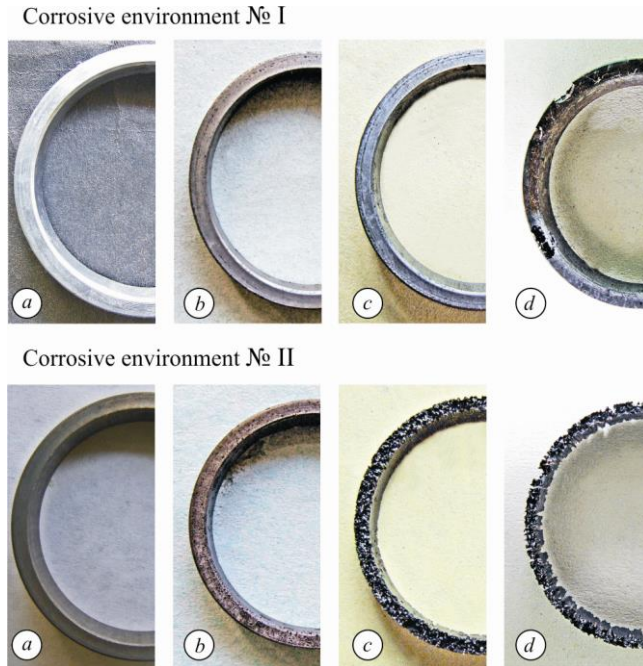
Fig. 4. The surface of the samples after exposure to acidic solutions recipe 1 and recipe 2 duration 24 h (a), 168 h (b), 288 h (c), and 576 h (d).

However, in this case, the process of local corrosion is more pronounced compared to the previous one, which is due to less activity of the working environment, and consequently less intensity of the general corrosion process.

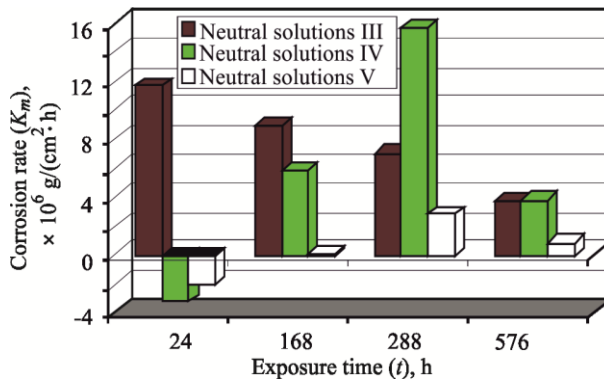
Fig. 5. The corrosion rate of QT-800 steel vs different times of exposure in the neutral corrosive environment.

A classical process of corrosion rate decrease during exposure in solution III was observed (Fig. 5) due to the reduction of the active surface over time because of the passive oxide and hydroxide film formation on the metal surface. Here, the corrosion rate is higher as compared to standard experimental conditions, resulting from the high ambient temperature (70°C).

The presence of SAS in environment IV influences the steel corrosion (Fig. 5) in the working environment. During the first 24 hours, barrier films are formed on the steel surface, which is reflected in the conditionally negative corrosion rate. The corrosion rate was

determined by the gravimetric method, so the mass of the samples after exposure to 24 h in the working environment is greater than the initial one, due to the deposition of SAS on the material surface and the formation of a barrier film. It makes it difficult for corrosive active components of the environment to access the surface of the material. As exposure to high temperatures increases, the barrier films gradually break down. After exposure for 288 h, the corrosion rate is higher even than NS4 (environment III) after 24 h (Fig. 6).

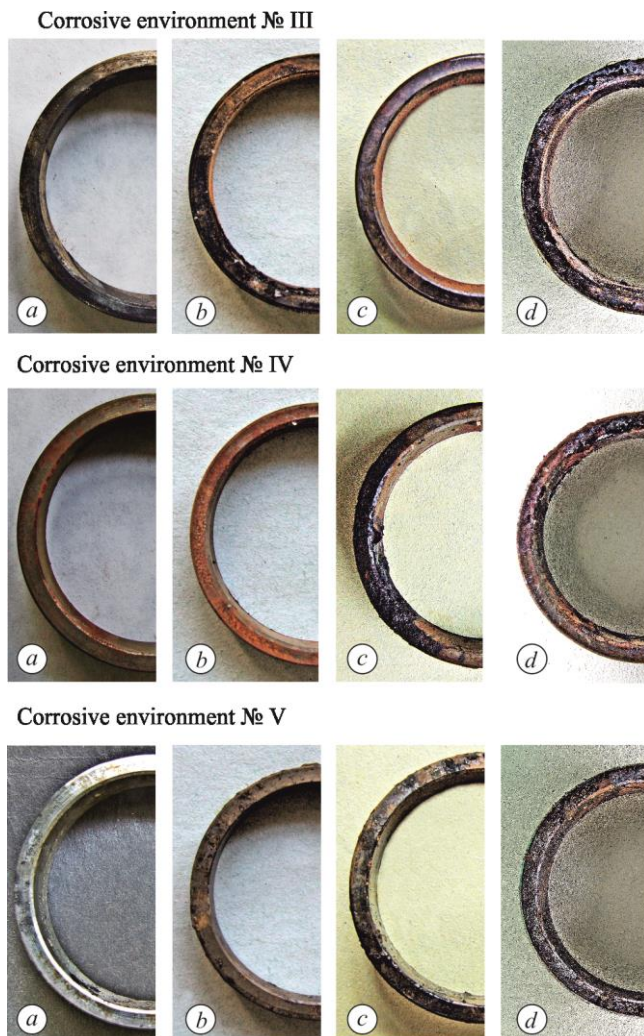
Fig. 6. The surface of the samples after exposure in the neutral solutions (III, IV, V) duration 24 h (a), 168 h (b), 288 h (c), and 576 h (d).

This is due to the higher corrosion activity of the medium compared to NS4, and a fairly significant porosity of the formed barrier film at a temperature of 70°C, which accelerates corrosion processes. After exposure to 576 h, the corrosion rates of the test material in media III and IV, in NS4 and in formation water, respectively, are practically equalized, which is explained by the loss of barrier properties of the formed film.
