# Experience in the design and operation of retaining walls of overpasses of the Central Ring Road on the base with soil improvement by vibro stone columns

**Abstract.** Reinforced retaining walls were used on the overpasses of the Central Ring Road. To reduce the sedimentation of the base of these walls, to reduce the time of consolidation of the base, the transformation of soil properties by reinforcing vibro stone columns was used. In order to obtain an optimal result for the transformation of the properties of the base soils, increasing the reliability of the reinforced structures, comparative calculations were carried out with the variation of the parameters of the reinforcing elements. The method of quality control of the device vibro stone columns is improved.

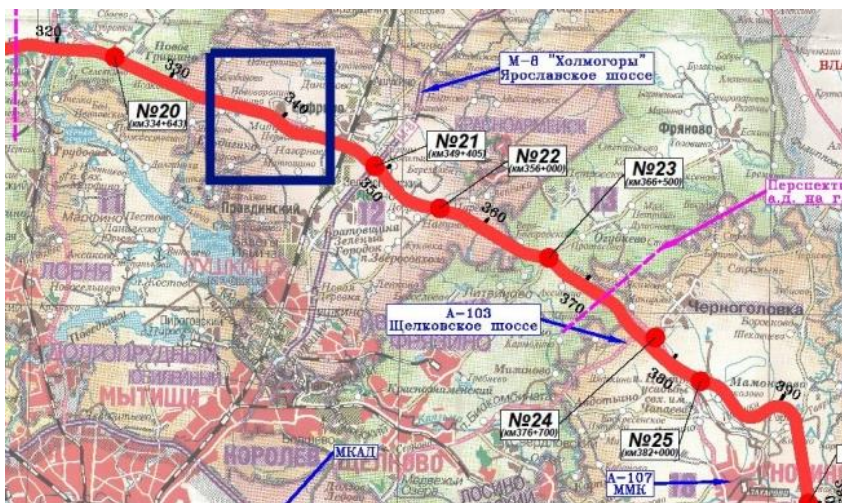
**Fig. 1.** A fragment of the plan of the Central Ring Road (the position of PK 490 is shown by a rectangle).

The construction sites of the Central Ring Road (SKAD) overpasses are characterized by the presence of highly compressible soils. A fragment of the plan diagram of the Central Ring road is shown in Figure 1.

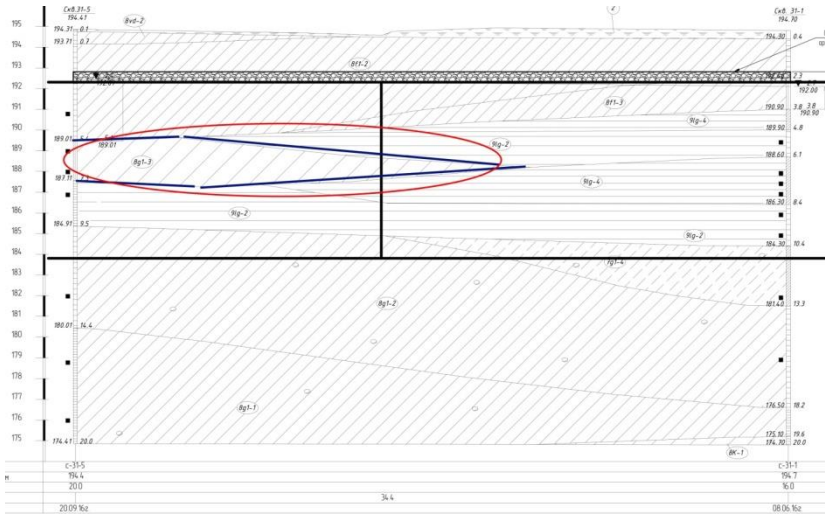
**Fig. 2.** A characteristic geological section on the example of the MSE-wall at the support No. 2 PK 490+49.61 SKAD (the zone of weak soils is circled by an ellipse).

A characteristic geological section for the MSE-wall at the support No. 2 PK 490+49.61 SKAD is shown in Figure 2.

The geological conditions of the site belong to the II category of complexity [17]. At the base of the MSE-wall of the overpass is located soil № 8g1-3 with a deformation modulus  $E=7$  MPa (in Figure 2, highlighted by an ellipse).

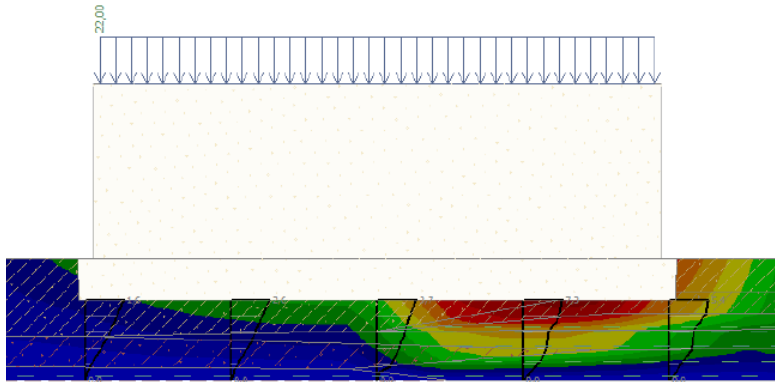
**Fig. 4.** Precipitation of the base of the MSE-wall (the draft on the right is 220 mm, on the left-50 mm).

the calculated draft of the base of the right side of wall (in two calculated software systems) was ~220 mm, the left side-up to 50 mm (Fig. 4) taking into account [18, 19].

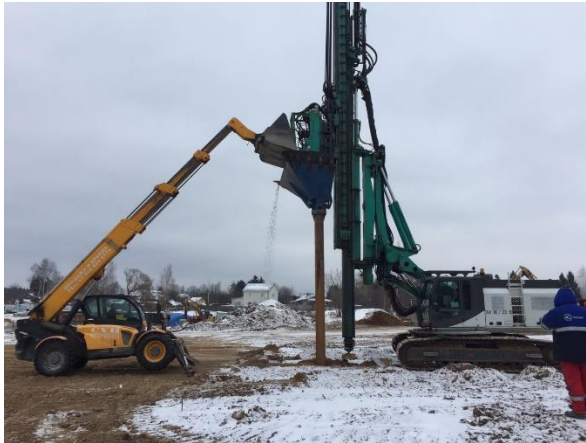
**Fig. 7.** General view of the equipment for installation of vibro stone columns.

General view of the equipment for installation of vibro stone columns is shown in Figure 7.

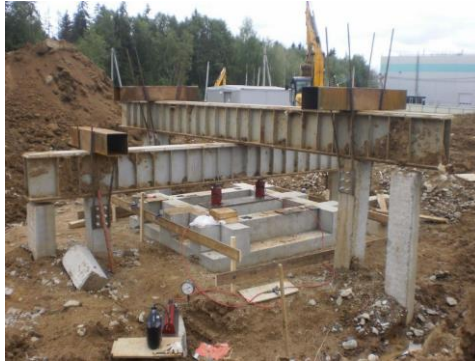
**Fig.8.** Stamp tests for determining the modulus of deformations of the transformed soil

Previously, field tests were carried out with stamps measuring 3x3 m [4-6]. Such tests provide a more reliable estimate of the modulus of deformations of the transformed soil, but they are more time-consuming and require the installation of an anchor system (Figure 8).

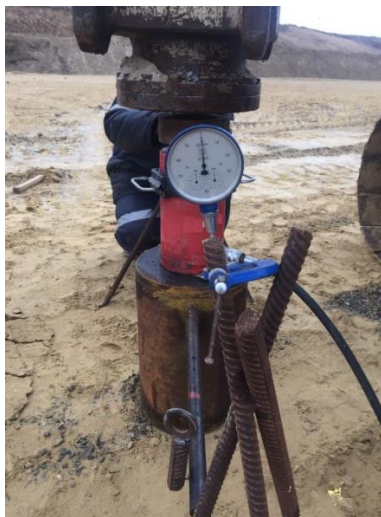
**Fig. 9.** Die tests for determining the deformation modulus of a vibro stone columns

In this regard, there was a need to improve the control methods, which involved performing SPT and stamp tests to determine the deformation modulus of the vibro stone columns itself for subsequent recalculation of the reduced deformation modulus of the reinforced base (Fig. 9).

According to the results of stamp tests (Fig. 9), verification calculations were carried out in a flat formulation by the finite element method to assess the stabilized settlement of the base of the MSE-wall, taking into account with soil improvement. The calculated model took into account not discrete elements, but the reduced modulus of deformation for each geological element. According to the results of calculations, the maximum settlement was 9 cm during the construction of the embankment, 10 cm during additional loading with a temporary load taking into account [4, 5].

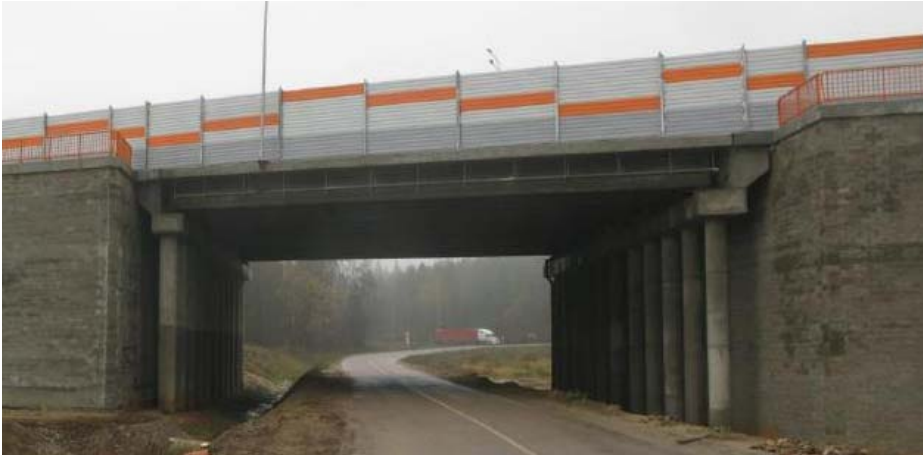
**Fig. 10.** Implemented version of the MSE-wall

The implemented version of the MSE-wall is shown in Figure 10.

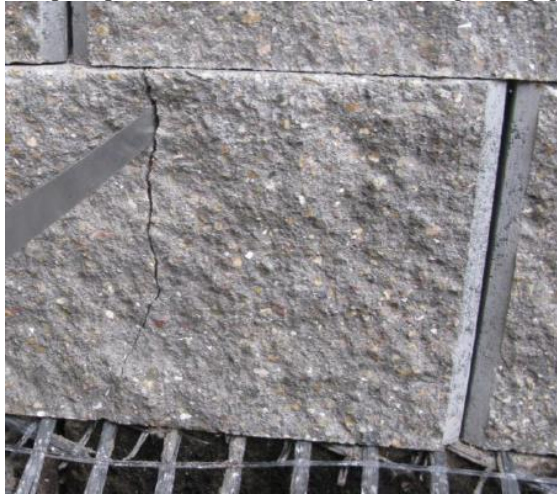
**Fig. 11.** Fragment of the MSE-wall lining with a defect

During the first year of operation in MSE-wall was revealed the following defects: the offset from the horizontal rows facing walls, cracks in blocks up to 5-6 mm (Fig. 11), chipped corners, partial precipitation of rubble drainage through the gaps formed to 15 mm.

settlement. A possible cause of the identified defects is the use of frozen non-cohesive soil when performing the MSE-wall itself.

In case of defects in the cladding and to exclude the possibility of collapse of its individual elements, it was necessary to strengthen the facade and side walls, as well as to seal the gaps between the individual blocks.
