# The essence of thermovision research in the prevention of fires in underground workings

Marta Stempniak<sup>1,\*</sup>

<sup>1</sup>Faculty of the Geoengineering, Mining and Geology, Wrocław's University of Science and Technology, ul. Na Grobli 15, 50-421 Wrocław, Poland

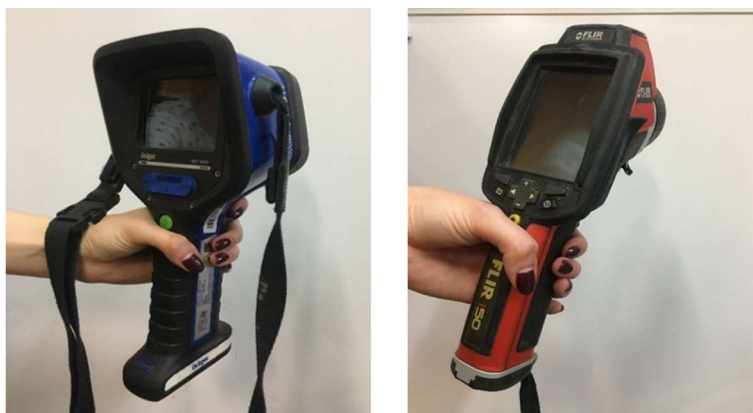
In the research in KWK ROW Ruch Chwałowice thermal cameras Dräger UCF 9000 i FLIR i60 were used. Those two types are approved for use in underground mine conditions.

**Fig. 2.** Thermal cameras used in KWK ROW Ruch Chwałowice.

Thermal imagers work in several modes: thermal scan (locating hot spots); fire (fire fighting); persons (for search and rescue operations); Scan PLUS (search for heat sources-real image); hazardous substances (leak detection and determination of leakage levels allowing the identification of various hazards) [6].

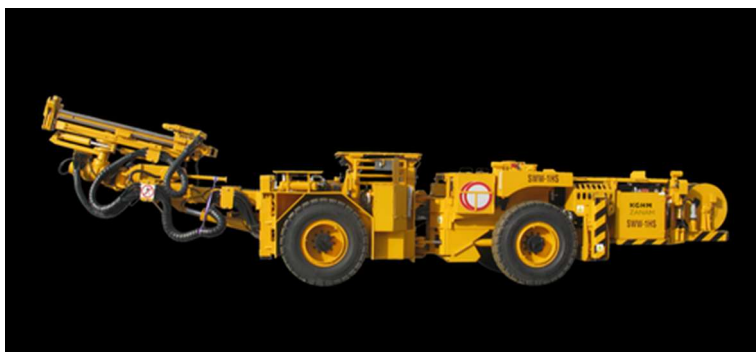
**Fig. 5.** Self-propelled drilling car KGHM [11].
