Research and Analysis of concrete facilities' corrosion in coastal substation of fujian

Abstract: Corrosion problems of outdoor concrete facilities was summarized through research on coastal substation of Fujian, such as serious corrosion of steel ring and weld in the joints of cement poles, exposure and corrosion of reinforcement, cracking and falling off of concrete cover. The information of concrete facilities' assessment reports was summarized, and it was found that concrete compressive strength of present age satisfied early design drawings. In addition, appraisal of reliability revealed that all facilities couldn't satisfy the requirements of current standards and seismic appraisal revealed that all facilities couldn't meet the seismic requirements. The analysis of concrete facilities' corrosion mechanism was made, and it was found that concrete facilities in coastal substation suffered triple effects of carbonation, chloride corrosion and stray current corrosion. The power failure schemes needed for present repairing and strengthening measures of concrete facilities lack of feasibility. Research on repairing and strengthening measures of concrete facilities that requiring n

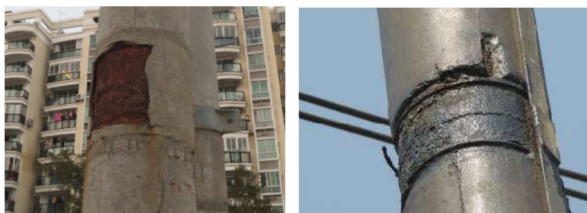
The concrete truss column is assembled by butt welding of the steel ring of the rod head of the precast annular cement rod. The steel ring is the key force transfer joint of the concrete truss column. The steel ring and the weld seam are seriously corroded (Figure 1), which weakens the stressed area of the cross section at the joint and reduces the bearing capacity of the truss column. Prefabricated circular concrete pole configuration of longitudinal reinforcement and spiral stirrups to improve the bearing capacity of normal section and inclined section, section bar shaft cover off cause longitudinal reinforcement and stirrup the leakage and corrosion (Figure 2), weakened the reinforcement stress area, and rust particles can also cause the burst loss of concrete protective layer, forming " rebar corrosion steel corrosion protection layer burst loss -" the vicious circle. The on-site survey of the substation found that the concrete protective layer fell off the body of most cement poles (Figure. 3). This part of the bar is in the early stage of corrosion development, if left untreated, it will lead to the exposure of reinforcement and further corrosion, and the lack of protective layer will also cause adverse effects on the stability of longitudinal bars. The above-mentioned multiple problems often occur at the same time in a single cement pole. For example, the exposed steel bar means that the concrete protective layer has fallen off. Some rods are even found in the same place with serious corrosion of steel ring and weld seam and exposed steel bar (Figure. 4),

Figure 1. Serious corrosion of steel ring and welding seam

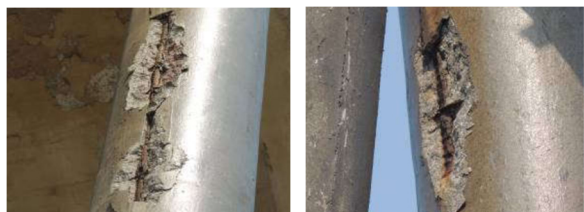
Figure 2. exposed corrosion of steel bar

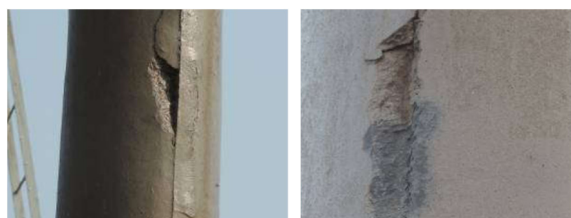
Figure 3. Concrete protective layer bulges, cracks and falls off

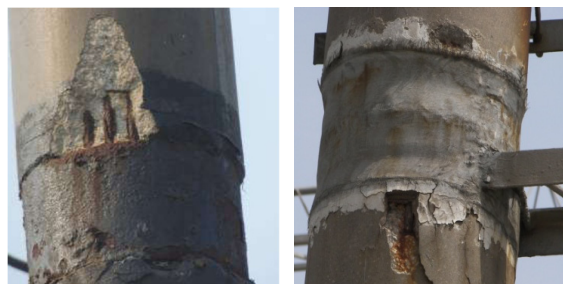
Figure 4. Triple corrosion coupling

In general atmospheric environment, concrete carbonation is the main reason for the corrosion of concrete cement pole and steel bar. For the concrete frame column in the coastal substation, it is simultaneously subjected to the triple coupling effect of concrete carbonation, chloride ion corrosion and stray current corrosion.
