In-situ rock tests for fault gouge zone: A case in Fengman hydropower station, China

Abstract. The existence of faults in the dam site area threatens the stability and safety of large-scale hydropower projects in China. The fault argillaceous zone is the worst kind of fault fracture zone, and the determination of its deformation and strength parameters is the key point of rock engineering investigation. In this study, the in-situ bearing plate test and direct shear test were carried out on the gouge zone of F67 fault in the dam site of Fengman Hydropower Station. The test results show that the deformation and shear law of each test point is good, which is basically consistent with the actual condition of the measured rock mass. However, due to the limited number of measurements, the results are limited in terms of macroscopic representation. The experimental results provide scientific basis for subsequent engineering design and further enhance the understanding of mechanical properties of fault gouges.

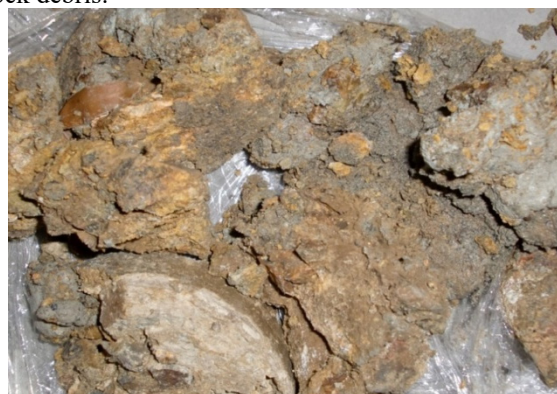
Fig. 2 The fault gouge of the F67 fault.

argillaceous zone has a width of about 0.5~0.7 m, and can be up to 2.5 m locally (revealed by drilling FZK138). As shown in Fig. 2, the fault gouge is composed of grey to grayish yellow mud and rock debris, which is plastic when wet. The widths of the argillaceous zone of F67-2 fault and F67-3 fault are 0.4~0.6 m and 0.05~0.1 m, respectively, and both of them are composed of mud and rock debris.

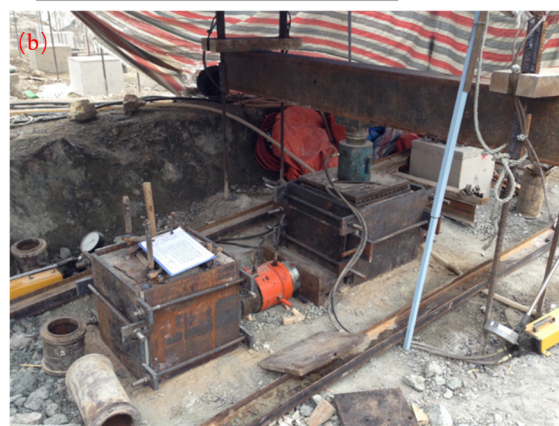
Fig. 3 Test equipments.

The main instrument and equipment used in this study include: the specimen processing equipment, reaction force device, normal load system, shear load system, measurement system and calibration system (Fig. 3a). Among them, the reaction force device uses anchor rods to provide the reaction load (Fig. 3b).

(a) Diagram of direct shear test. (b) The reaction force.

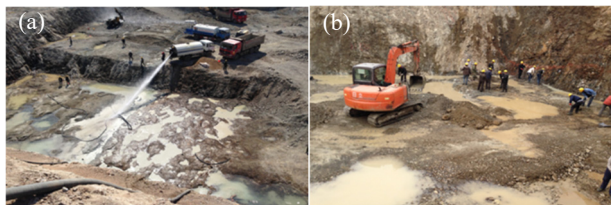
Fig. 4 Test site cleaning.

In order to accurately select representative test sections and test points, it is necessary to clean up the gravel left by the excavation of the test site. As shown in Fig. 4, the cleaning method adopts waterwheel scouring and manual cleaning.

(a) Waterwheel scouring. (b) Manual cleaning.

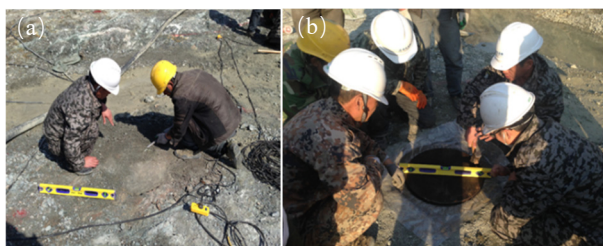
Fig. 5 Processing of on-site deformation test points.

According to the requirements of “Rock Test Regulations for Hydropower and Hydraulic Engineering” (DL/T 5368-2007), the bearing plate method was used in the deformation test in this study. According to the requirements of test point processing, the steel drill and hand hammer were used to remove loose rock mass at first, and then flatten the $\Phi 200$ cm area centered on the test point, with the undulation difference controlled within 3~5 cm. A total of 6 test sites were set up. For specific operation, refer to the “Rock Test Regulations for Hydropower and Water Conservancy Engineering” (DL/T 5368-2007). The on-site work photos are shown in Fig. 5.

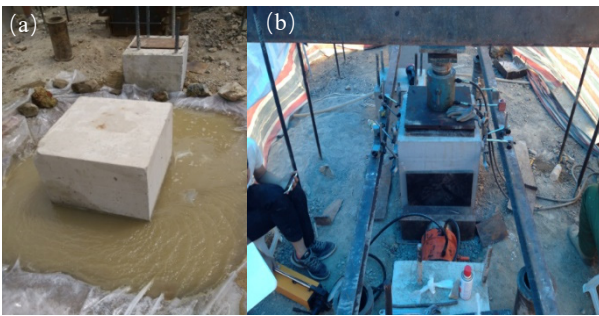
Fig. 8 In-situ direct shear test.

The direct shear test of rock mass was carried out by horizontal pushing method under the condition of artificial water immersion. Significantly, the direction of shear load was consistent with the direction of engineering water thrust. According to the collected data, the foundation stress of Fengman Hydropower Station project is 2.0 MPa. Therefore, five levels with a difference of 0.4 MPa were adopted in this study. It is preliminary determined that the stresses at all levels are 0.4 MPa, 0.8 MPa, 1.2 MPa, 1.6 MPa and 2.0 MPa. The actual normal load varies with the area of the specimen, but it does not affect the final test results (reference). The corresponding shear stress was obtained by tests under various normal stresses, and then the mechanical parameters of shear strength were obtained. The field test photos are shown in Fig. 8.

(a) Artificial water immersion. (b) Test in progress.
