Research on Safety Evaluation and Sustainable Conservation Strategy of Tunbao Buildings--An example of residential buildings in Benzhai, Anshun, Guizhou

2 The existing problems of the residential buildings in this cottage are summarized

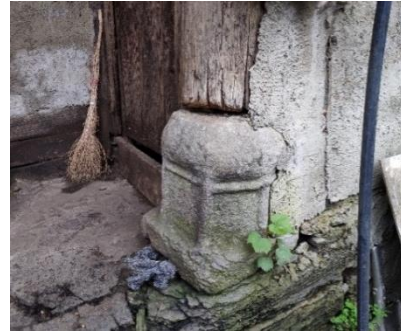
Figure 2-1-1 Column foundation appears
Source: Author's own photos

Second, the local occurrence of column base dislocation, column directly resting on the column base, because of uneven settlement and other reasons to produce column base dislocation, coupled with the humid climate and precipitation weather led to water penetration between the column base, accelerating the column tilt, stone softening, reducing its weighing compressive resistance

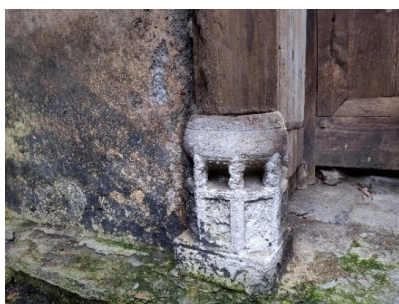
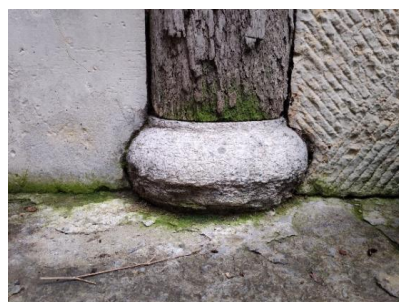
Figure 2-1-2 Damage to wood column
Source: Author's own photos

The research found that the traditional buildings in this cottage generally have wooden pillars with cracked bodies, and the next problem is the rotten bottom of the pillars (Figure 2-1-2). Most of the wooden pillars in this cottage are still in "diseased" working condition, and some of them have reached the level of damage at the point of dilapidation and still have not been properly repaired. The gua pillars and square in the rows of frames have not seen any obvious damage

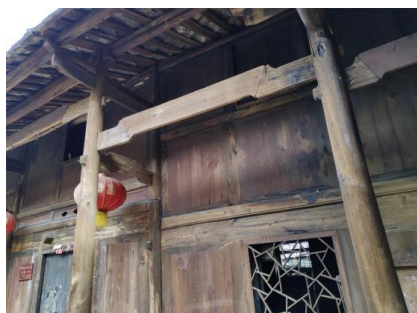
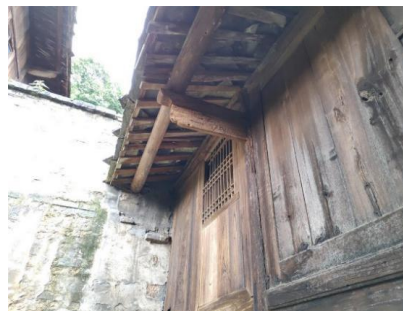
Figure2-1-3 The stigma purlin bearing method of traditional buildings in Benzhai
Source: Author's own photos

The roof cover of the traditional building of this cottage includes arch ow (see beam), purlins, rafters, and the way of bearing purlins on the pillar head is picking square bearing purlins (Figure 2-1-3), the specification of purlins is about 150mm in diameter, and the section form of purlins is mostly round, but there are also square and other forms. The roof cover is transferred by the purlins on the respective pillars, the purlins rest on the pillars, the golden purlins on the golden pillars are also arranged under the arch ow (see beam) as its middle bearing load members, using a combination of ridge rubbing and arch ow (see beam) way of connection, other pillars and purlins using the chisel excavation sandalwood bowl connection method. The damage of the roof cover of this traditional building is mainly caused by the damage of the roof slate (tiles) and the damage of the sliding purlins (Figure 2-1-3). Damage to the roof slate (tile) often forms a hole in the roof, and sliding purlins cause damage to the rafters and slate (tile) as well.

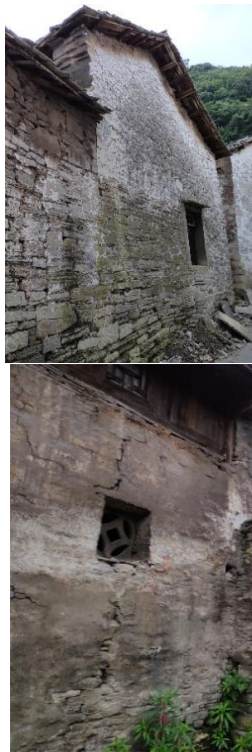
Figure 2-2-1 Breakage of wall
Source: Author's own photos

The load-bearing walls of traditional buildings in this cottage contain both masonry structures and brick masonry structures. The stone masonry structure is generally built along both sides of the street or the external wall of the village, with a height of 1.8~2.5 m. It is made of small block-shaped stones or large stones piled up (Figure 2-2-1), or a thin ash masonry is laid between the stones, and the masonry method is either ordinary piling or masonry with aesthetic effect, and the choice of stones and the masonry method reflect the economic strength and social status of the Tumbao family. The choice of stone and masonry method reflects the economic strength and social status of the Tumbao family [5]. The masonry also plays a role in overcoming the poor bearing capacity of the weak foundation by virtue of the thickness of the wall. The main problems of cracking and tilting of the masonry walls in this cottage are that the structural damage of the masonry will produce a chain of damage, which is attributed to the way the stone structure is arranged, once the wall has through cracking or tilting beyond the limit will bring safety hazards, the towering hill wall tilts inward, while the street side of the street wall tilts, the direction of tilting is not regular.

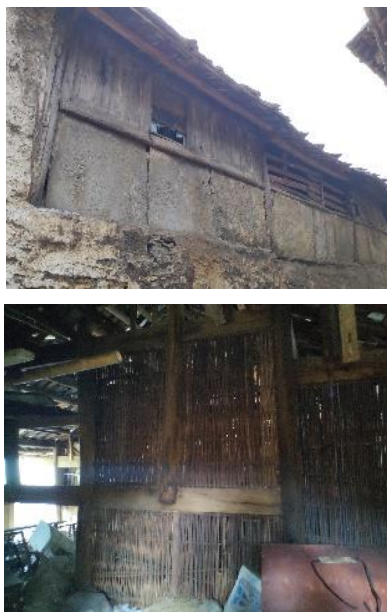
Figure 2-2-2 Types of non-load bearing walls
Source: Author's own photos

Non-load-bearing walls of traditional buildings in this cottage include wood-paneled walls, combined walls composed of stone and wood panels, and bamboo-woven walls and bamboo-clad mud walls (Figure 2-2-2), which are important components of the enclosure structure between the two columns of traditional buildings. Plank walls and combination walls are common wall types in traditional buildings in this stronghold and are also widely used in traditional buildings in Guizhou region.

Wooden panel wall is a common enclosure structure in this cottage. The plank wall of this cottage is in the form of vertical arrangement, and the wall structure made of about 20mm thick plank and border splicing has good stability. The combination wall located on the second floor of the building is less damaged, and only two pieces of the wall are found to have cracked slabs; however, the combination wall located on the second floor of the building is more seriously damaged, and part of the wall is located on the street side, and two to three adjacent walls have been tilted at the same time, and such walls have become a safety hazard.

The number of bamboo woven walls and bamboo woven sandwich mud walls in this cottage is relatively small compared to the wooden panel walls, but his damage is more serious. Bamboo woven walls are often arranged as partition walls in the second floor interior. The bamboo woven walls as interior partition walls are relatively well preserved, with only some of them showing deformation and decay. However, the large area of bamboo woven sandwich mud wall as an exterior protective wall produces deformation in the middle and lower part of the wall protruding to the outside, the indoor bamboo woven sandwich mud wall has decayed due to humidity and other reasons, the mud and sand filled in the wall appears to fall off locally or in a large area, there is a bending deformation of the wall due to environmental factors.
