Research on the application of epoxy surface in the pavement maintenance of the Yilaga Tunnel in Guizhou Province

Yilaga Tunnel is located on S77 Weiban Expressway in Guizhou Province, it is 2.52km long and 21.5m wide. The pavement in the tunnel was constructed as the standard of expressways, with a design speed of 80km/h. According to the road condition investigation and detection analysis of the tunnel, it has been found that the overall technical condition of the pavement was acceptable and there was no structural damage. The typical diseases were mainly transverse cracks, longitudinal cracks and obvious decline of anti-sliding ability. Meanwhile, the pavement structure depth was unevenly distributed due to the separation of mixture in the early paving process, and the coefficient of variation of anti-sliding performance on the same section was large, which affected the comfort and safety of driving. In order to effectively improve the service performance of this section, and provide reference experience for the selection of appropriate maintenance measures for Guizhou Expressway in the future, after the traditional maintenance measures were adopted to repair the pavement crack

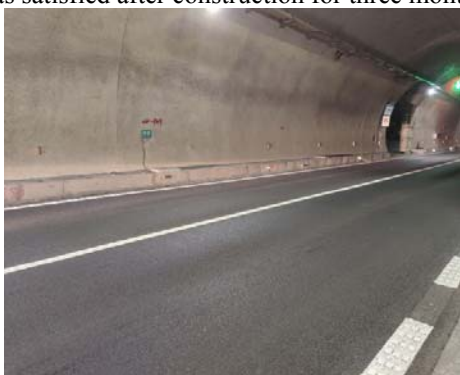
Fig. 2. Effect of one month after construction.

The appearance quality has been observed, pictures are shown in Figure. 2 and Figure 3. It could be seen that after using the epoxy surface treatment technology on asphalt pavement, the appearance of the pavement was smooth and dense, the color was uniform and consistent, and there was no oil spillage and grain dropping. The overall appearance quality was satisfied after construction for three months.
