Indoor environmental quality of the Valli Theatre: outcomes on sound, light and thermo-hygrometry

Antonella Bevilacqua^{1,*}, *Sara Francesca Gelati*^{2,†}, and *Francesca Merli*^{3,‡}

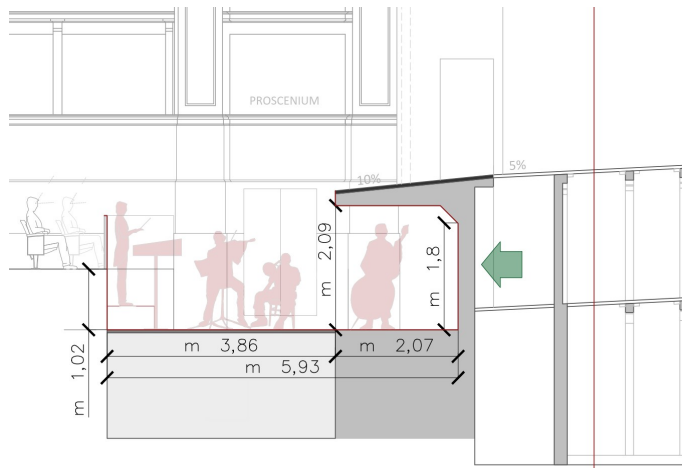
Fig. 2. Transversal section of the orchestra pit of the Valli theatre.

The stage has dimensions of 20.5×31.2 m [L \times W] and the proscenium arch 14 m large and 22.5 m high. The wooden planks of the stage are inclined of 5%, against the 2% of the stalls floor. The orchestra pit is 2.09 m high and 5.9 m deep, with 2.07 m of its depth located below the stage floor, as shown in Fig. 2.

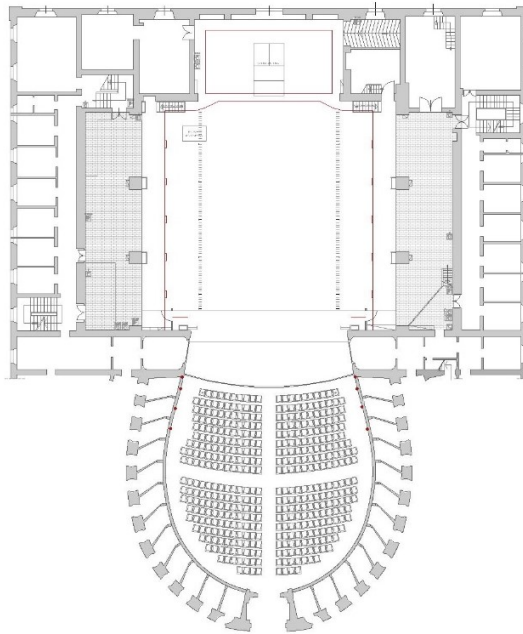
Fig. 3. Plan layout of the Valli theatre of Reggio Emilia

The Valli theatre has a horseshoe shape plan layout, as visible in Fig. 3, where the geometry of the performance space and the audience area is herein indicated.

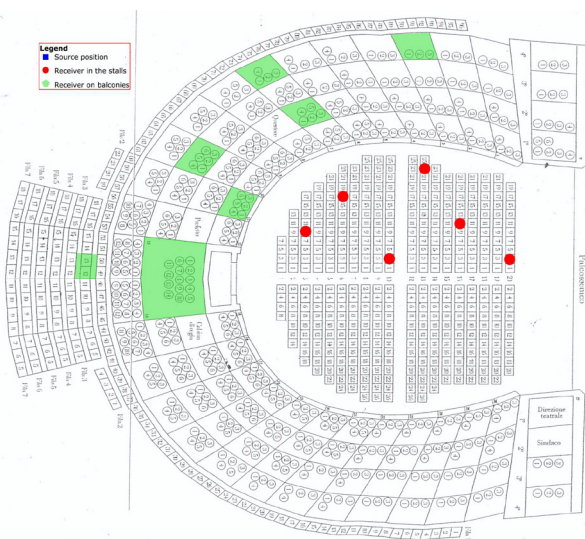
Fig. 4. Scheme of the acoustic equipment location during the measurements in the Valli theatre of Reggio Emilia.

The sound source was placed at 1.4 m from the finished floor, while the receivers were installed at the height of 1.2 m on stalls and boxes. The excitation signal emitted by the sound source was the Exponential Sine Sweep (ESS) [40-44] having a duration of 15 s in a uniform sound pressure level for the range between 40 Hz and 20 kHz. Fig. 4 shows the measurement positions of sound source and receivers across the sitting areas.

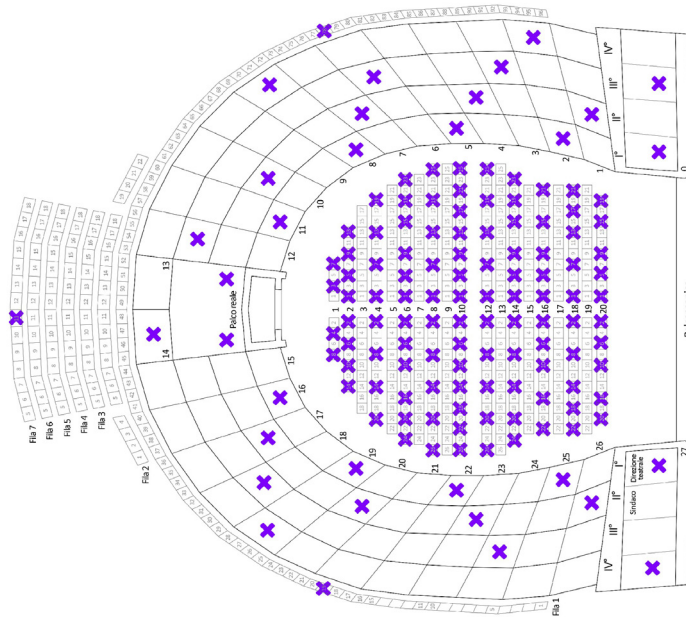
Fig. 5. Scheme of the lighting and thermo-hygrometric equipment location during the measurements in the Valli theatre of Reggio Emilia.

The equipment has been installed at 1.4 m from the finished floor in different positions across the stalls area. All the lights of the main hall were on at the time of measurements. Fig. 5 shows the position of the lux meter and the thermo-hygrometric meter.

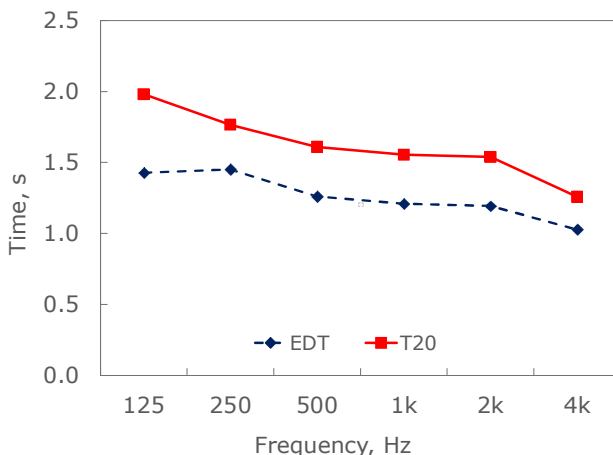
Fig. 6. Measured results of Early Decay Time (EDT) and Reverberation Time (T_{20}).

Fig. 6 shows the frequency response of the EDT and T_{20} parameters. If it is considered that the optimal values of EDT range between 1.8 s and 2.6 s, as defined by Jordan and

others [14-18], this target has not been achieved by the measured values related to the selected bandwidth.

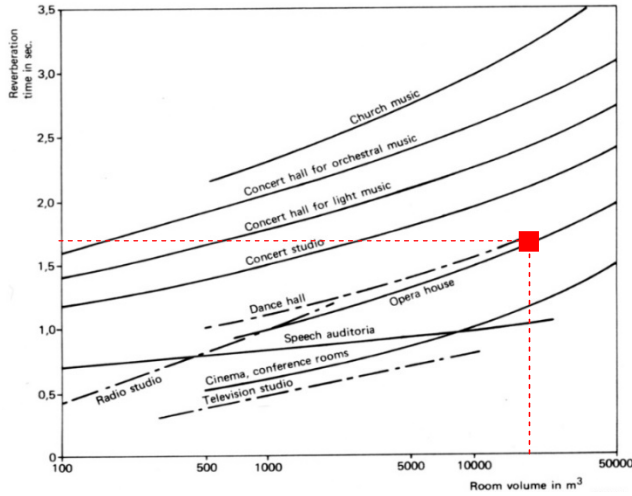
Fig. 7. Optimal reverberation time values in function of room volume

In terms of reverberation time (T_{20}) the averaged value of all the frequency bands results within the target assigned to an Opera house of such volume size [11-13; 39, 40, 43], as shown in Fig. 7, even though it is within the lower limit. This means that the Valli theatre has a good response for both speech and music performance.

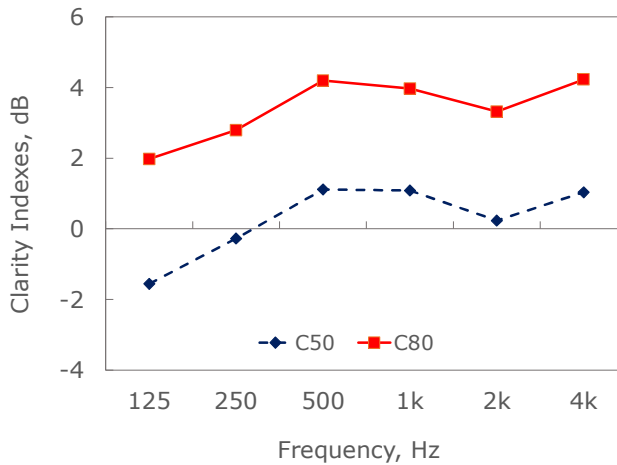
Fig. 8. Measured results of clarity indexes (C_{50} and C_{80}).

Following the research studies by Reichardt and others [11-13, 41], the optimal values for speech clarity index (C_{50}) would be ≥ 3 dB. In the Valli theatre, this parameter floats between -2 and +2 dB at low and high-frequency bands, respectively, as shown in Fig. 8. However, this shortfall slightly below the lowest range limit is not to be intended as a negative result. In this case, the listening perception of speech finds a balance between the sound energy arriving within the 50 ms and the reflections coming after 50 ms.

In terms of music (C_{80}), the optimal values should be comprised between -2 and +2 dB, according to Jordan [40]. This target has been achieved only at 125 Hz, where the value is equal to +2 dB, while the values related to the other frequency bands are up to 2 dB higher

than this latest one. Translated in other words, this outcome means that the music would be very clear, especially at high frequencies.

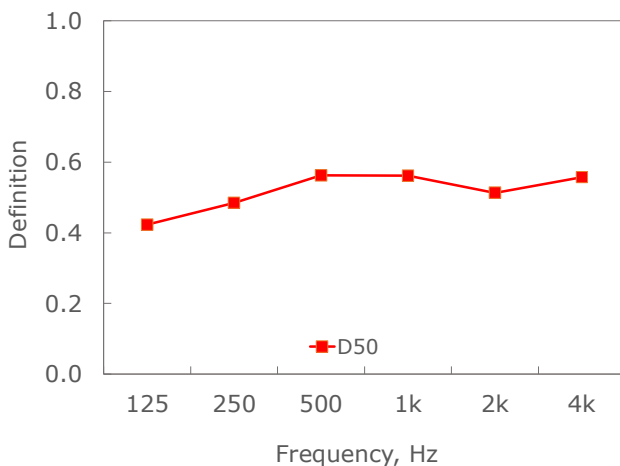
Fig. 9. Measured results of Definition (D_{50}).

A good speech definition is achieved for values higher than 0.5 (i.e. 50%), while the optimal values for music definition are lower than 0.5 (i.e. 50%) [40]. On this basis, the results obtained in the Valli theatre, as shown in Fig. 9, are found to be around 0.5, meaning that the listening conditions are suitable for both speech and music.

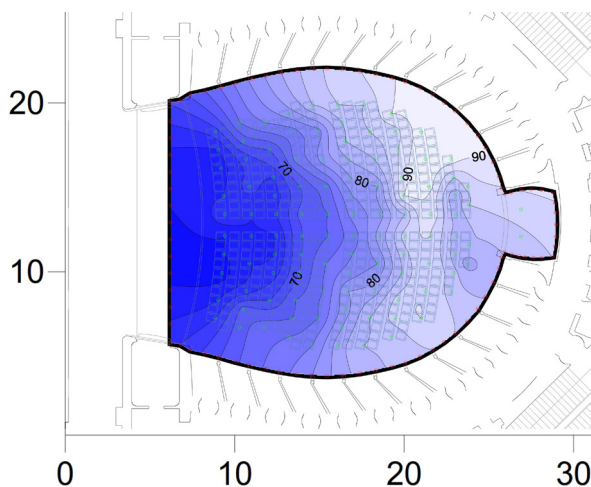
Fig. 10. Lighting levels maps obtained for the Valli theatre of Reggio Emilia

The lighting data have been elaborated with the Surfer software, where the input data of the lux scenario were necessary to create a coloured map as indicated in Fig. 10. The input data consisted of the plan layout of the room, the coordinates of the points where the measurements were undertaken, and the values obtained for each selected position [48]. The colour scale ranges between blue, indicating a low level of light, and clear/white shades, indicating high levels of light.

The results shown in Fig. 10 are comprised of between 62 and 90 lux. These values are found to be below the lower range limit indicated by EN12464-1 [48], which outlines a lighting range between 150 lux and 250 lux for theatres and concert halls [48]. However, based on experience on a similar room type, the lighting levels inside the Valli theatre are found to be higher than any other historical Opera house [49].

Rather than focusing on the absolute values, the authors consider furthermore the unbalance lighting conditions across the main hall. Fig. 10 shows a difference of 30 lux between the back seats of the hall and the area in proximity of the stage. This lack of uniformity is perceivable by the users, even if the theatre had both the main hall and stage equipped with lights on [3, 4, 48].

In terms of lighting levels, all the values result below the lower range limit outlined by the standard. Although many of the Opera theatres have similar results because of evoking the candlelight experience as they were intentionally designed by the architects, the difference of 30 lux between the first and the last rows of seats across the stalls is significant. A more homogeneous spread of lighting conditions would be more comfortable. However, the design of the stage lights, to be not affecting the audience, is the right approach for performing arts space. Some considerations on the balance between the two objectives could be revised.

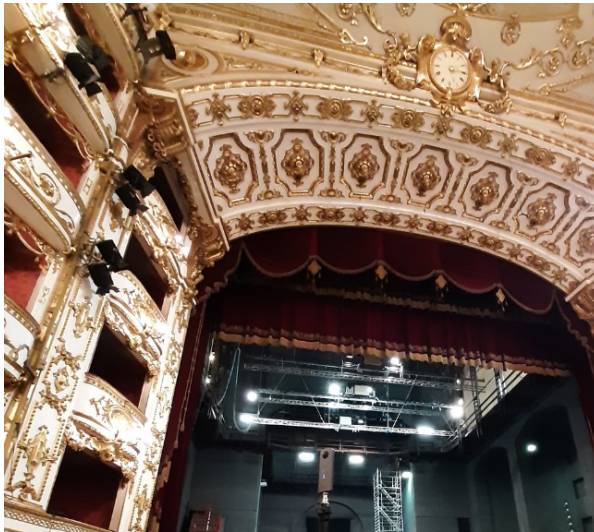
Fig. 11. Lighting difference between the stage and the stalls area.

Fig. 11 shows the difference in terms of lighting between the stage and the sitting area. The directionality of the light beams of the stage has been planned to do not glare at the audience, but to be highlighting the actors moving onto the stage, only.

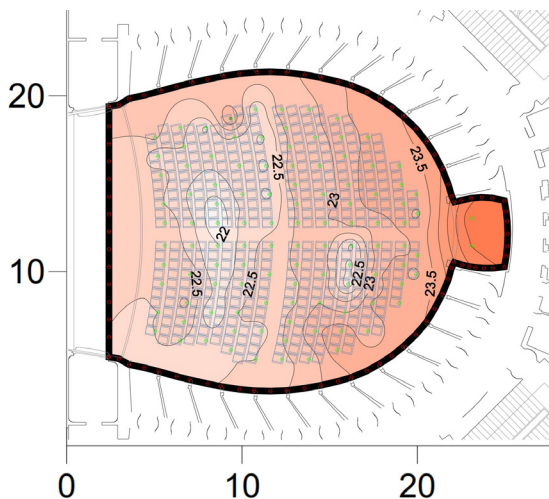
Fig. 12. Temperature variance inside the Valli theatre of Reggio Emilia.

In accordance with the target set by regulations, the temperature range varies between 22°C and 24°C, which is within the optimal range [50]. The low values have been found in two points of the stalls area, while the warmer zone is in the back of the hall, including the main entrance. Fig. 12 shows the temperature variance across the stalls area having a colour range comprised between orange shades, meaning a high temperature, and clear/white tint that stands for low temperature.

Although related to 2°C, the lack of uniformity should not be existing inside a room volume of such size. This outcome can create the effect of a slight discomfort of the users by sitting for all the duration of the artistic performance [11-13, 21-24].

The thermal hygrometry of the existing conditions inside the theatre is found to be within the optimal values set by regulations. However, the difference of 2°C localized in two points of the stalls areas could rise a slight discomfort of the listeners that are to be assisting the live performance for more than one hour.

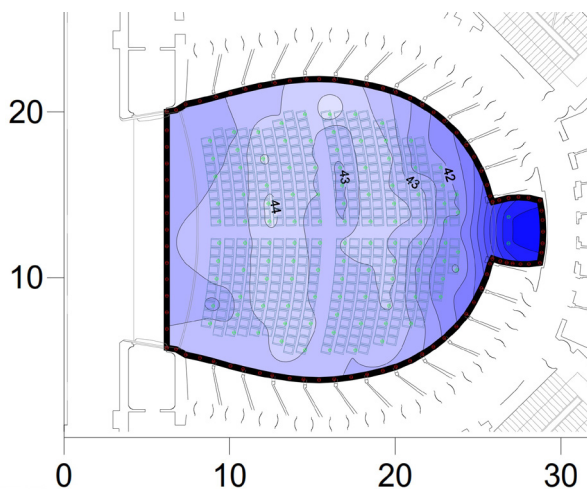
Fig. 13. Relative humidity variance inside the Valli theatre of Reggio Emilia.

In terms of relative humidity, Fig. 13 indicates the values based on the colour scale, going from blue (low relative humidity) and clear/white tinge.

Fig. 13 shows the values measured inside the Valli theatre. In particular, the range varies between 38% and 44%, to be pretty steady across the sitting area and considerably lower at the entrance. This zone distinction is created by the concentration of the relative humidity in this corner of the hall.

A better outcome has been found in relation to the relative humidity, which is more uniform across the seats except for the entrance, where a concentration of low values unbalances the even conditions. However, the measurements have been undertaken without any mechanical ventilation in operation.
