# Visually low-impacting methods for the measurement of parameters related to IAQ risk indicators in exhibition halls

**Abstract.** Microclimate for cultural heritage plays a fundamental role in the degradation process of artefacts exhibited in museums. Generally, the Indoor Air Quality (IAQ) monitoring inside museums is based on conventional measurements of thermo-hygrometry parameters and long-time averaged measurements of atmospheric pollutants' concentration. Unfortunately, all these approaches require electric supply and are usually characterized by a noticeable visual impact on the exhibition space, which clearly negatively affects the visitors' experience. This paper intends to revisit and discuss a methodology (and its test application on field, to estimate the risk of damage of three artefacts displayed in an old museum of Palermo – Italy) perhaps prematurely underestimated that could usefully be re-proposed in particular contexts in which it is necessary to be careful to be as less invasive as possible, as in the case of museums housed in buildings of particular historical-cultural prestige. The discussed approach uses a non-destructive (or minimally invasive, at least)

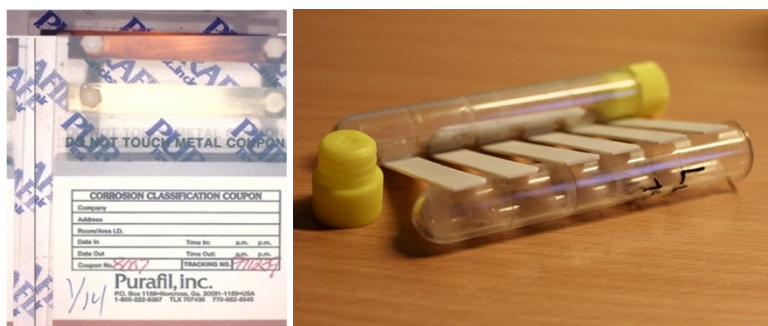
**Fig. 1.** *Purafil*<sup>TM</sup> bi-metallic reactive coupon (on the left) and marble coupons (on the right; courtesy of prof. Livio De Santoli, Università di Roma Sapienza), used for the IAQ monitoring.

The bi-metallic coupons used in the test application were the *Purafil*<sup>TM</sup> (Figure 1); it was therefore chosen to use the environmental classification proposed by *Purafil*<sup>TM</sup> company to correlate the obtained results with the levels of danger for the artefacts; in particular, the warning limits are 250–350  $\text{\AA}/30$  days for copper corrosion and 200–300  $\text{\AA}/30$  days for silver corrosion [28, 29]. As a precaution, the overall threshold for which attention is required was set at 200  $\text{\AA}/30$  days.

The second IAQ off-line measurement method consists in the use of marble coupons in the form of small marble strips (Figure 1), also in this case the air pollution is evaluated on the basis of marble reactivity to the considered environment; in particular the pollution levels are related to the mechanical degradation of the marble on display (together with the artefact) after a certain period of time.
